Bridge B3769 Inspection Report

Asset #B3769(Routine, Underwater type 2)

I-40EB/Se51/226.19 over Big Creek

Team Lead: Myron Futrell Inspection Date: 03/13/2024

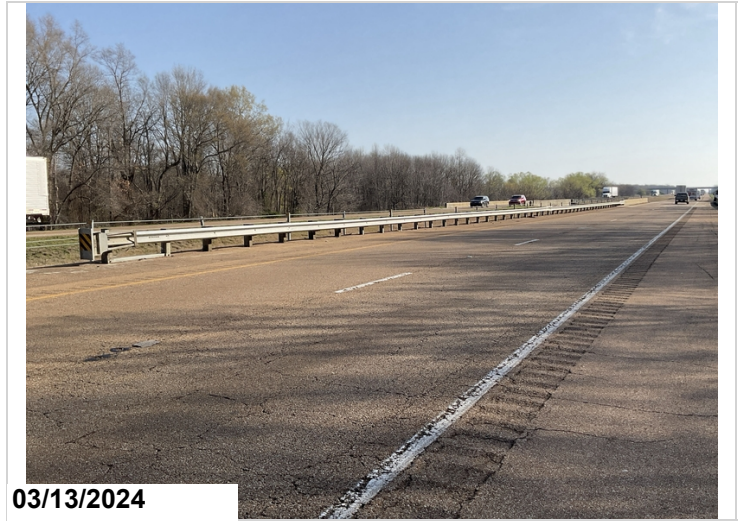
Abutment 1 left approach rail

Abutment #1 left approach rail has 6' of moderate collision damage mid span.

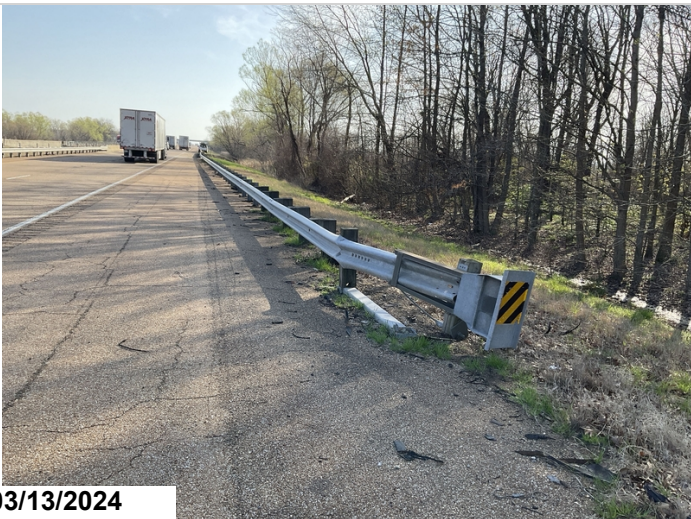
Abutment 1 right approach rail

Abutment #1 right approach rail end, first post broken and rail bent, end treatment out of place.

Abutment 1, right approach rail end: first post broken and rail bent, end treatment out of place.

Type of Work: Repair (General)

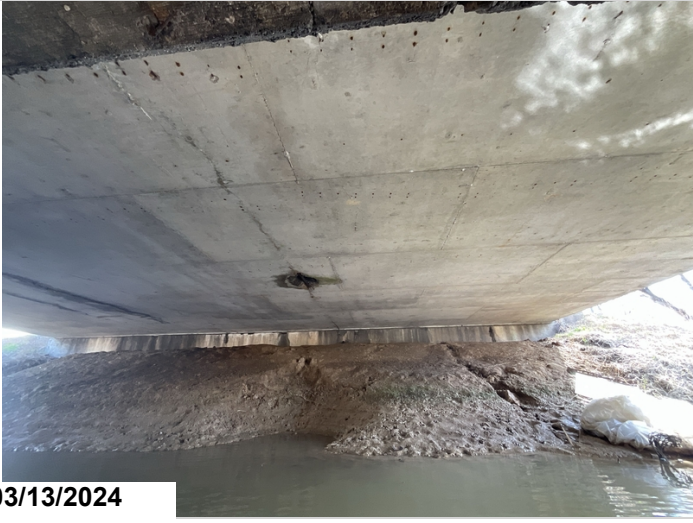
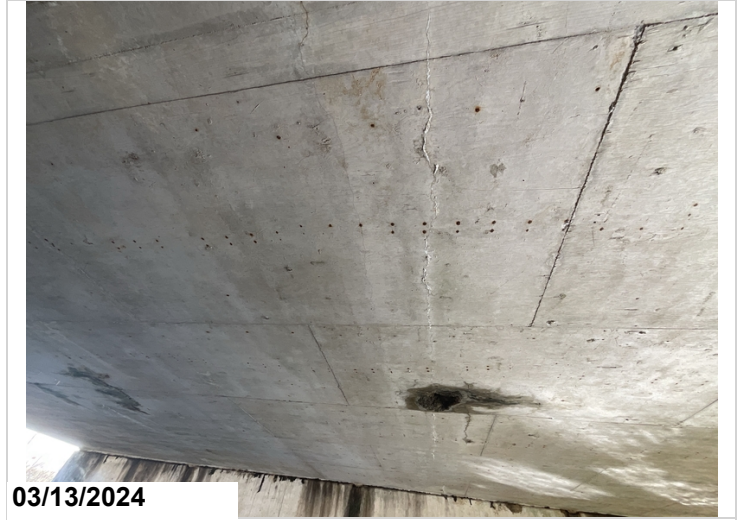
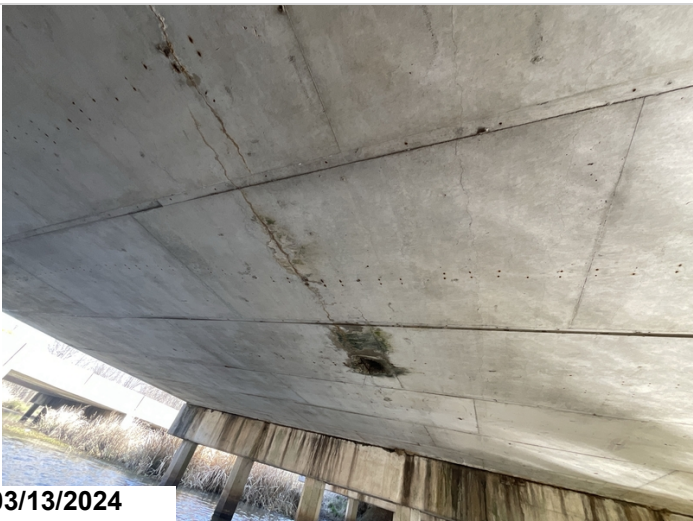
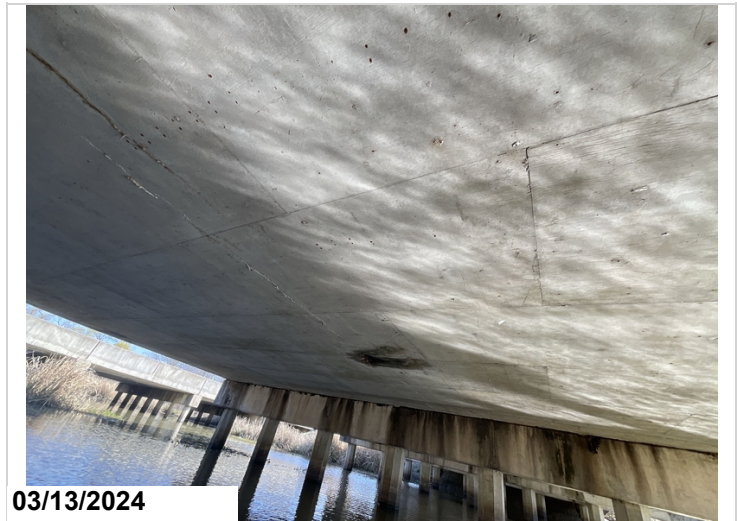
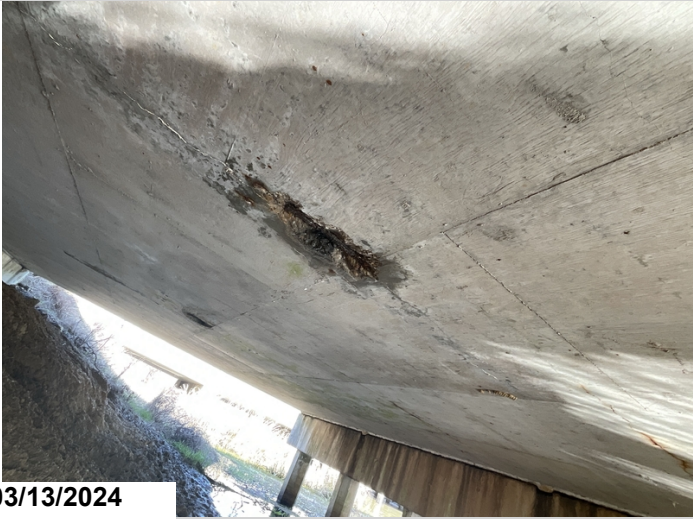
Reinforced concrete voided slab deck is in overall fair condition. Deck surface has multiple wide unsealed longitudinal cracks each span and light to moderate abrasion full length. Soffit / under surface of deck has spalling with exposed reinforcing steel at several sona tube deck drains and longitudinal cracking with efflorescence and rust staining.

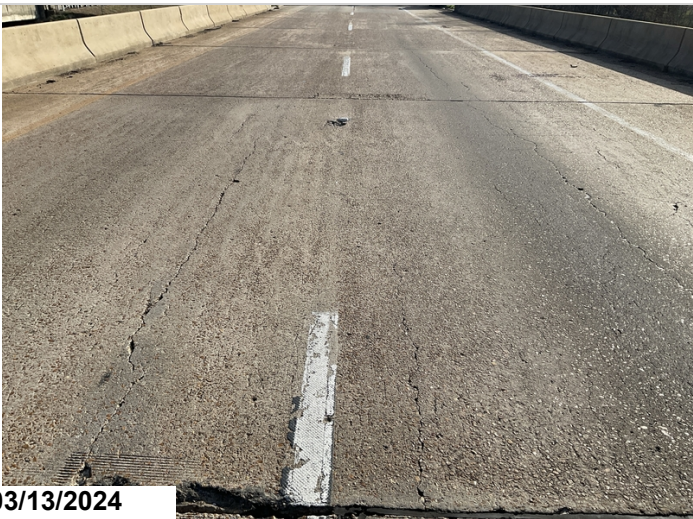
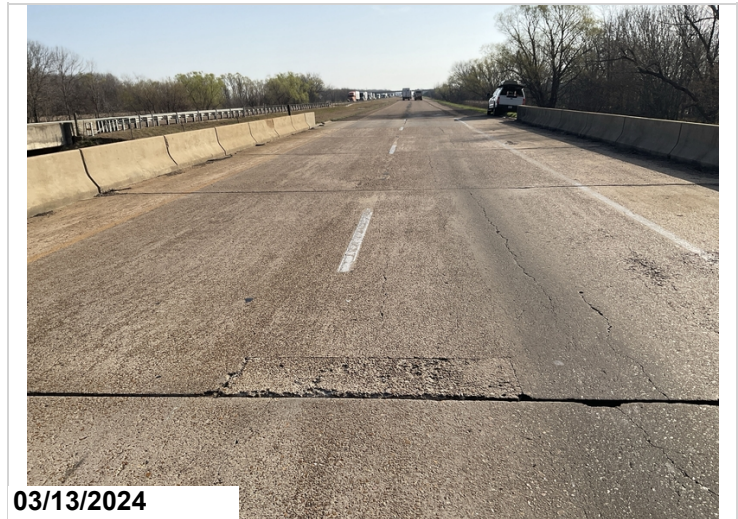
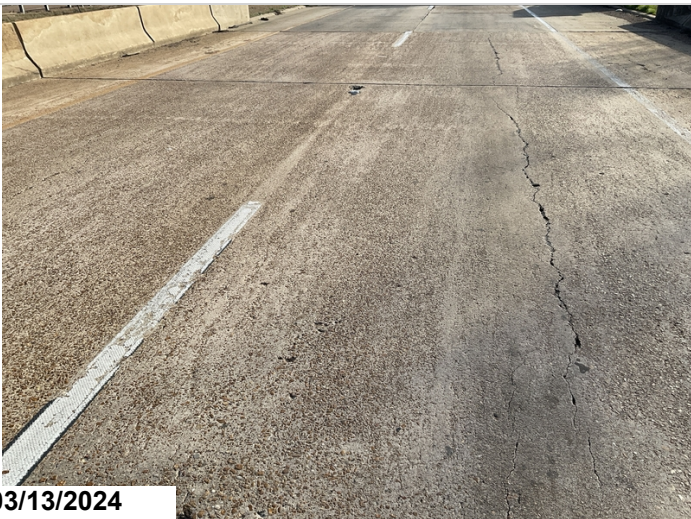
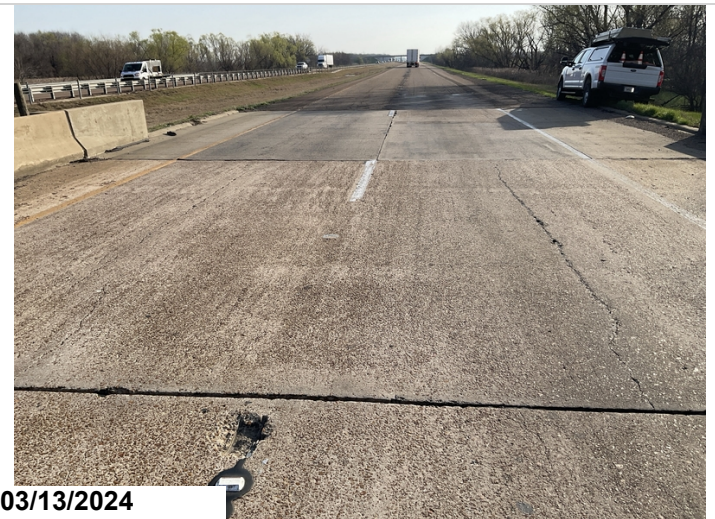
Deck has wide unsealed longitudinal cracking throughout and light to moderate abrasion full length.

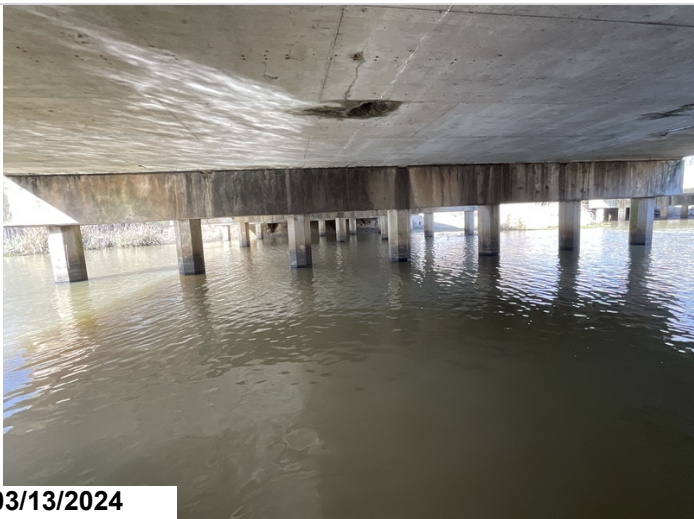
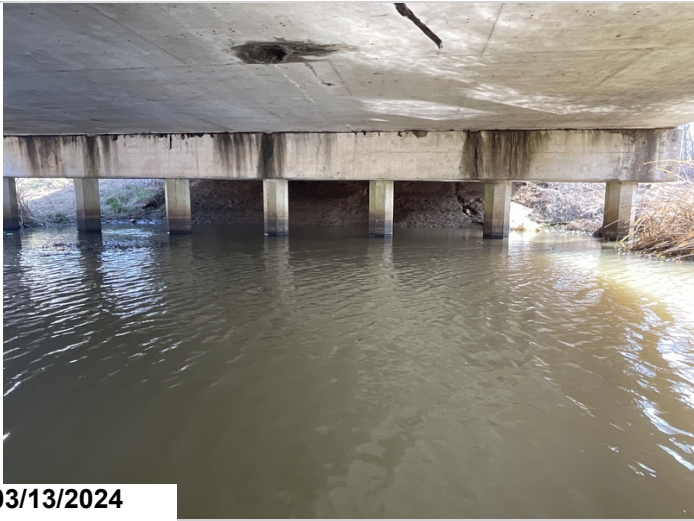
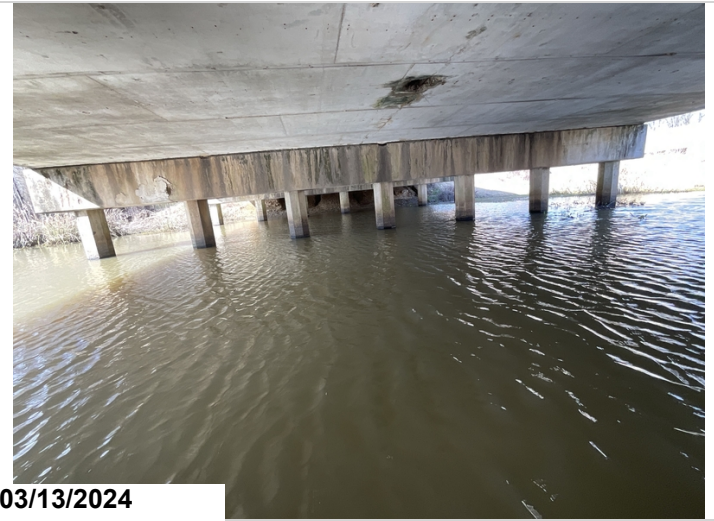
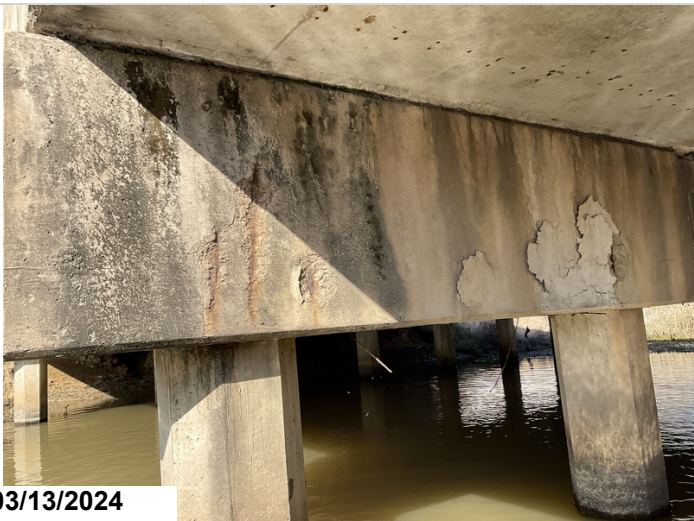
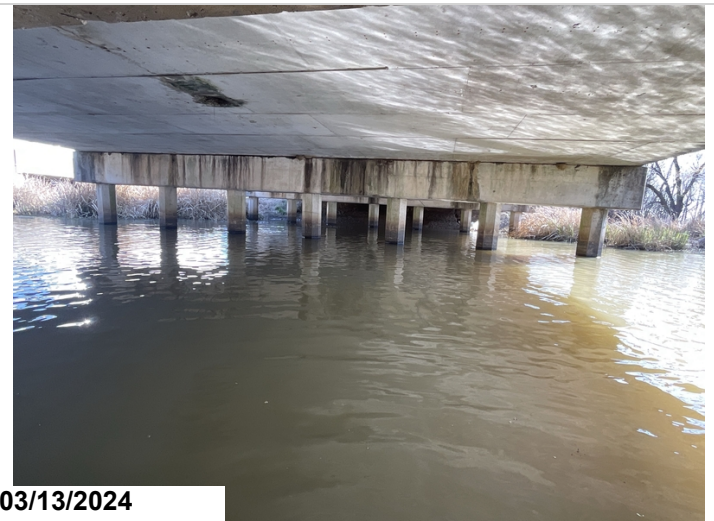
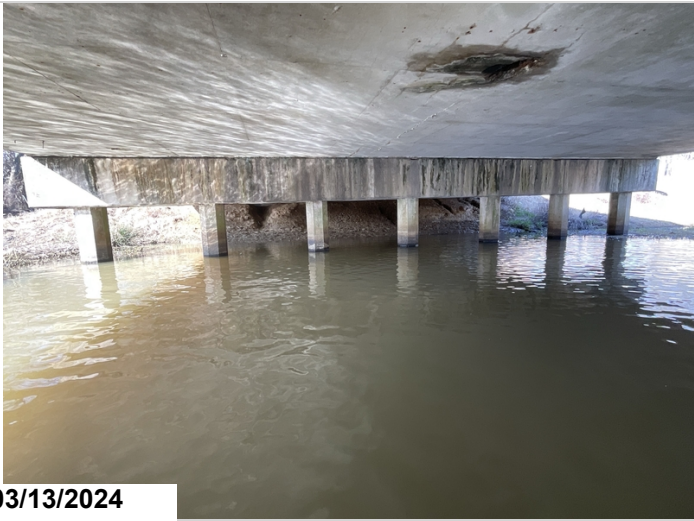
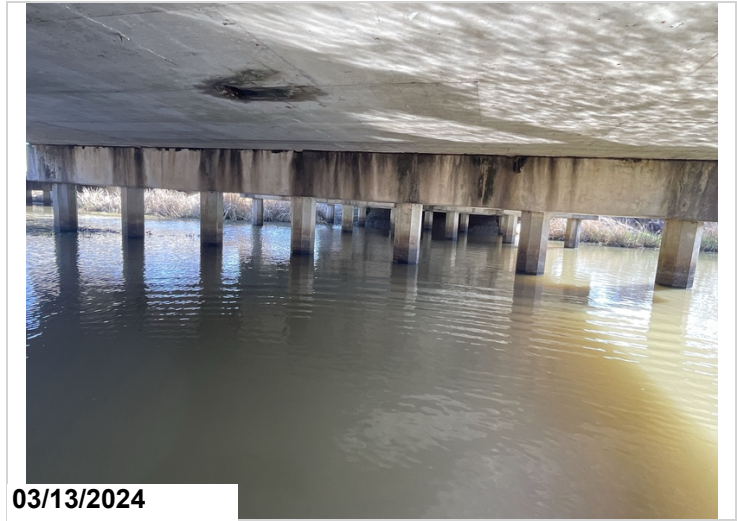
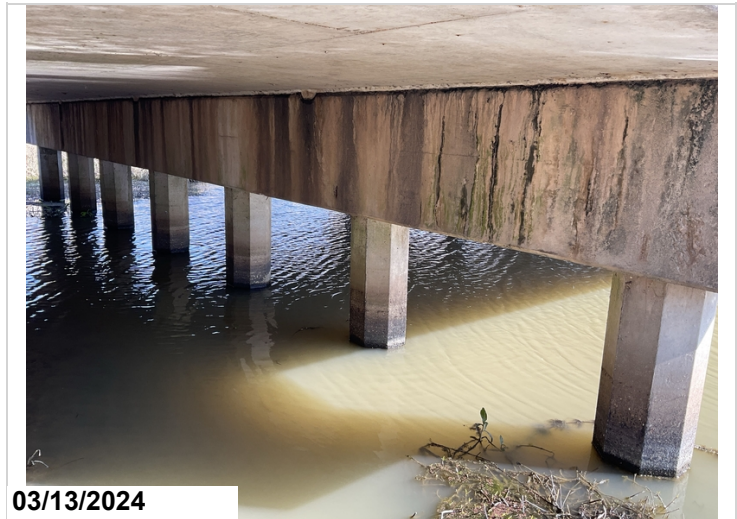
Reinforced concrete substructure is in overall satisfactory condition. Concrete pile caps have several delaminated areas, shallow spalls with exposed reinforcing steel and minor cracking. Abutment slopes have minor erosion.

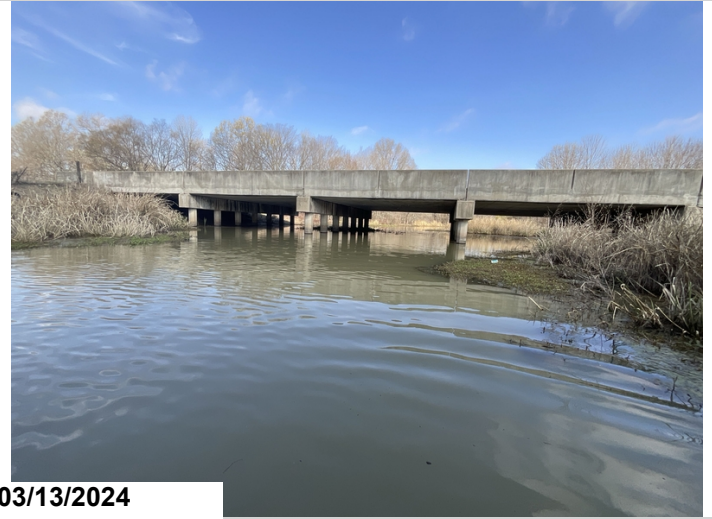
Channel left side

Channel is in overall satisfactory condition. Channel alignment is fairly good at structure, there is vegetation growing into channel and minor erosion at abutment 2 slope.

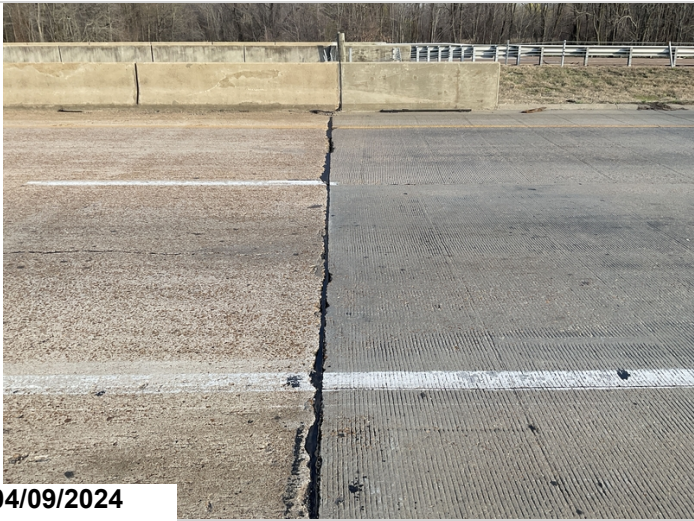
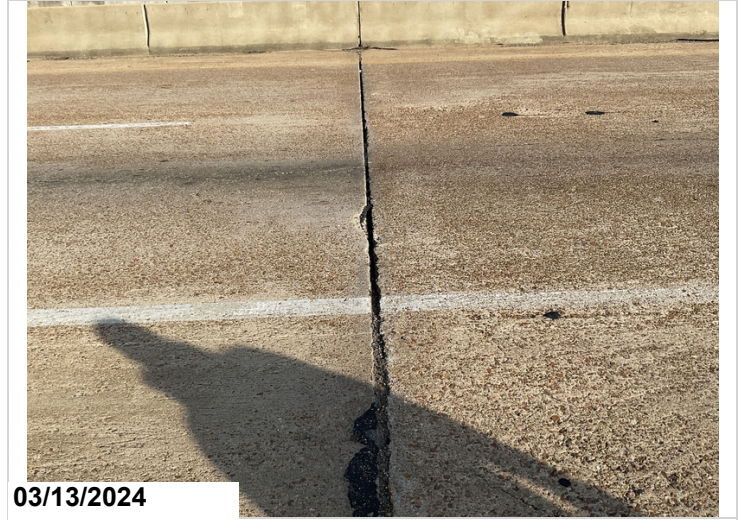
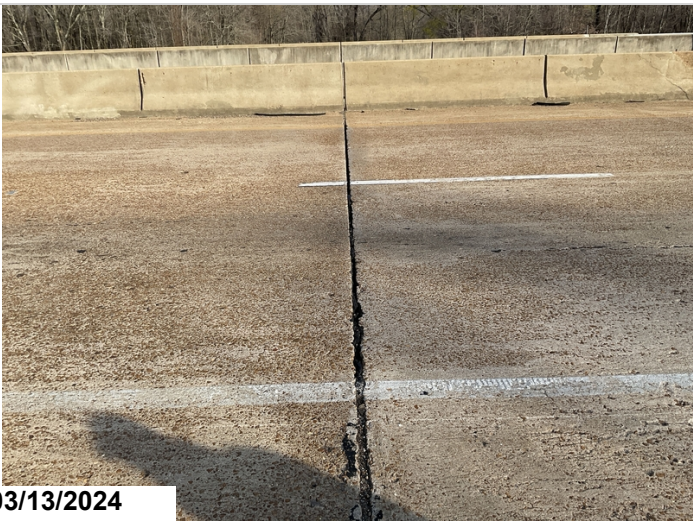
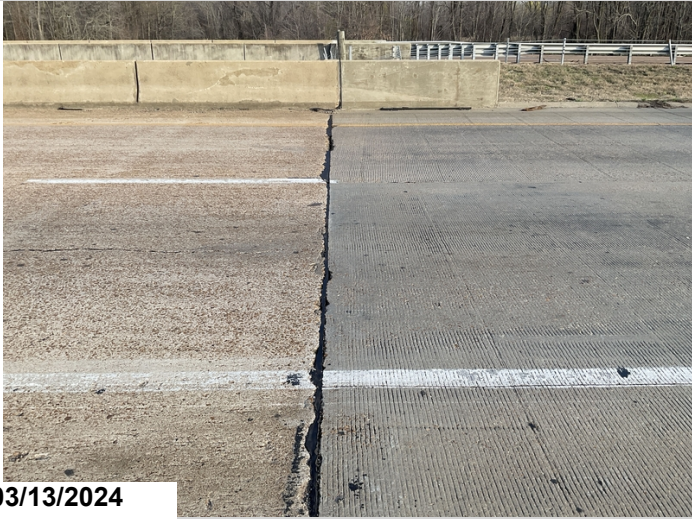
Joint material weathered, cracked or missing allowing debris in joints.

A-59 - Joint Repair Needed (Y)

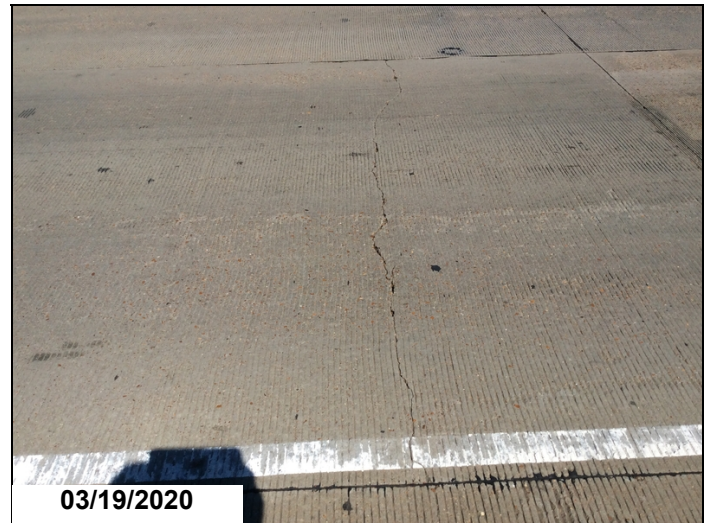
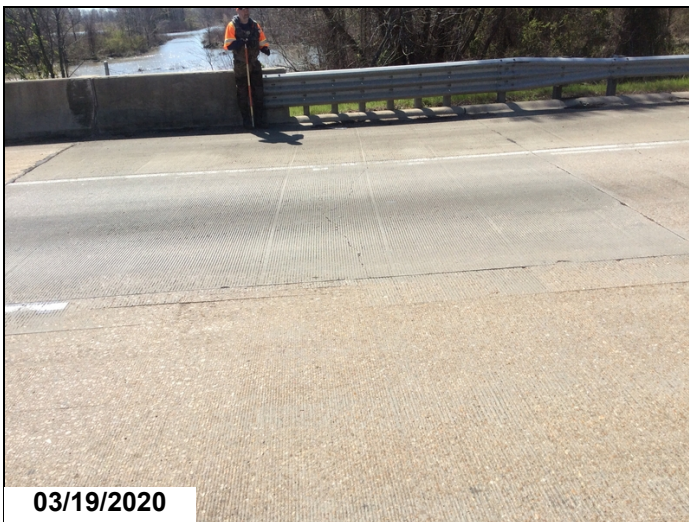
All approach slabs have open transverse cracks.

Typical transverse approach slab crack
