Bridge B6518 Inspection Report

Asset #B6518(Routine, Underwater type 2)

I-40EB/Se51/233.97 over Languille River

Team Lead: Myron Futrell Inspection Date: 04/09/2025

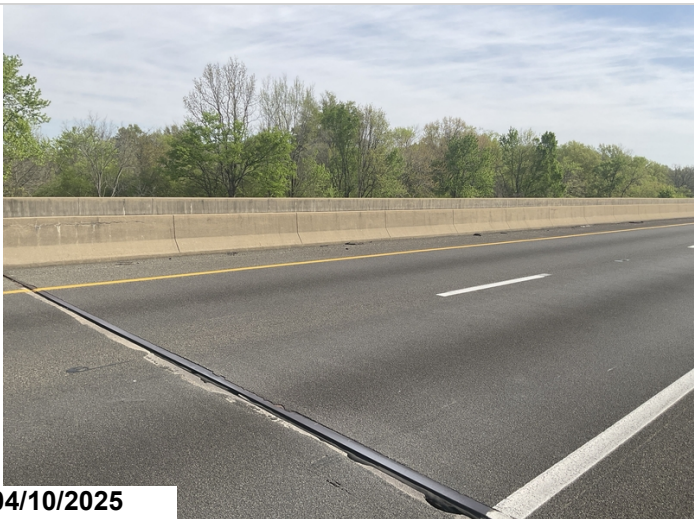
Bridge rail, left side

(331) Reinforced concrete bridge rail: several sections have longitudinal cracking with light efflorescence near top, each rail has vertical hairline cracking some with light efflorescence. Efflorescence 317LF CS2 Span 3, bent 4, bridge rail, left side: 10' minor scrapes.

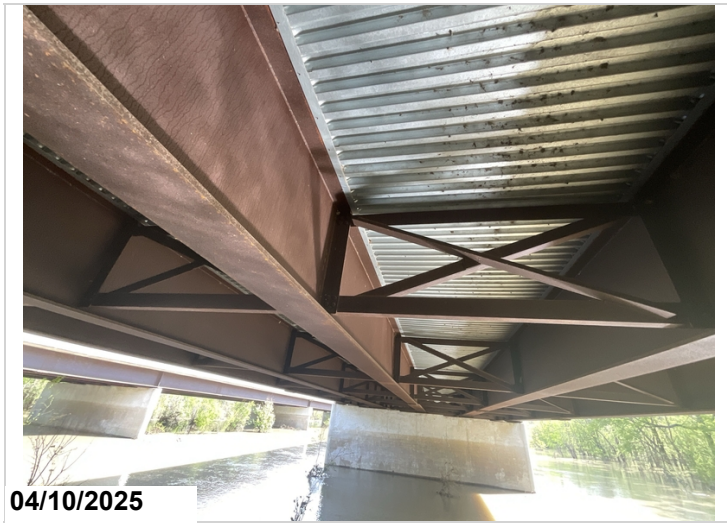
Typical undersurface of deck

Reinforced concrete deck is in overall good condition. Deck has epoxy overlay and metal stay in place forms. Deck surface cracks have been sealed with epoxy overlay, undersurface of overhangs have transverse cracks with light to moderate efflorescence. Span 5 deck has one 1' spall with no exposed reinforcing steel.

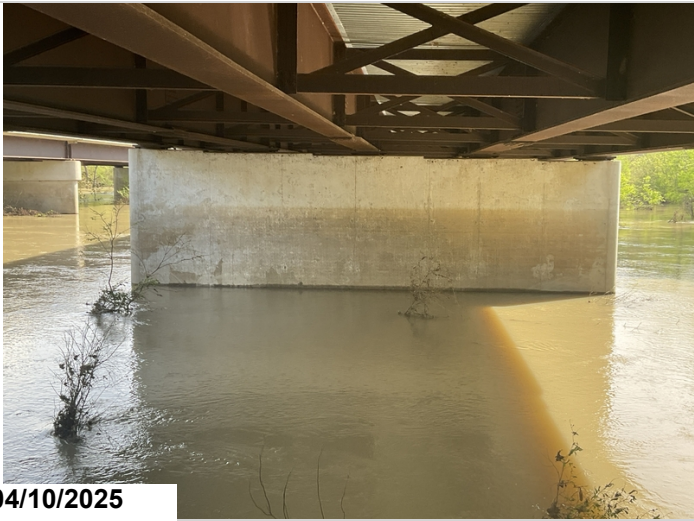
Typical intermediate bent

Reinforced concrete substructure is in overall good condition. Pier walls have some minor abrasion, abutment pier caps and back walls have several hairline vertical cracks some with light efflorescence. Pier walls and pier caps have a few vertical hairline cracks.

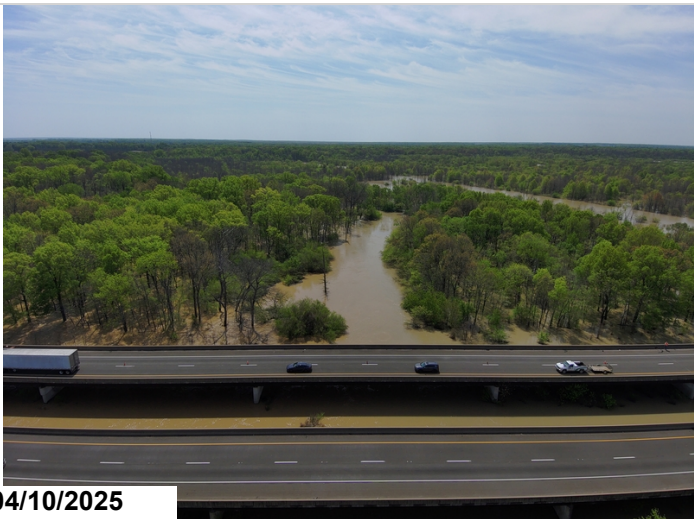
Channel, right side

Channel is in overall fair condition. Channel alignment is fair at structure, slopes are well vegetated however, trees and vegetation growing along and into channel restrict flow slightly.

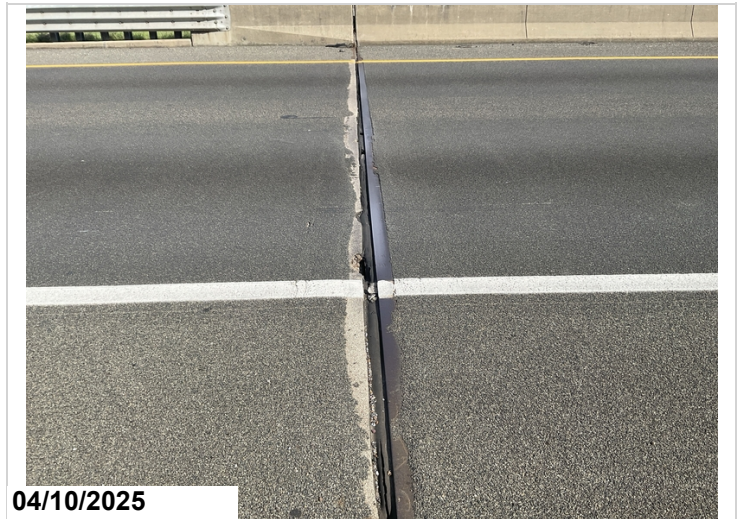
Abutment 1, joint

Abutment 1, pourable joint seal: splits and holes throughout 35LF total. Leakage 35LF CS4

A-59 - Joint Repair Needed (Y)
