Bridge A3614 Inspection Report

Asset #A3614(Routine, Underwater type 2)

I-40WB/Se51/237.82 over Spring Creek

Team Lead: Myron Futrell Inspection Date: 01/29/2024

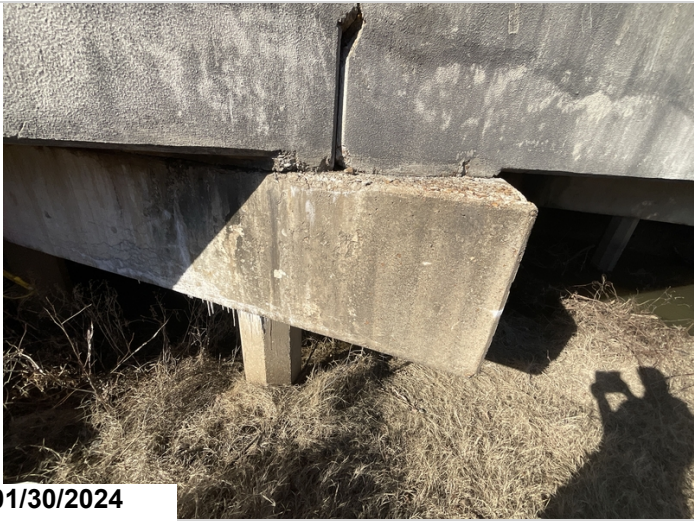
Bent ## cap back face right side

Concrete substructure is in overall satisfactory condition. The caps have some vertical hairline cracking, small to moderate spalling, primarily at keyways and some exposed rebar due to poor concrete coverage.
