Bridge A3617 Inspection Report

I-40WB/Se51/239.44 over Drainage Ditch

Team Lead: Myron Futrell Inspection Date: 04/16/2024

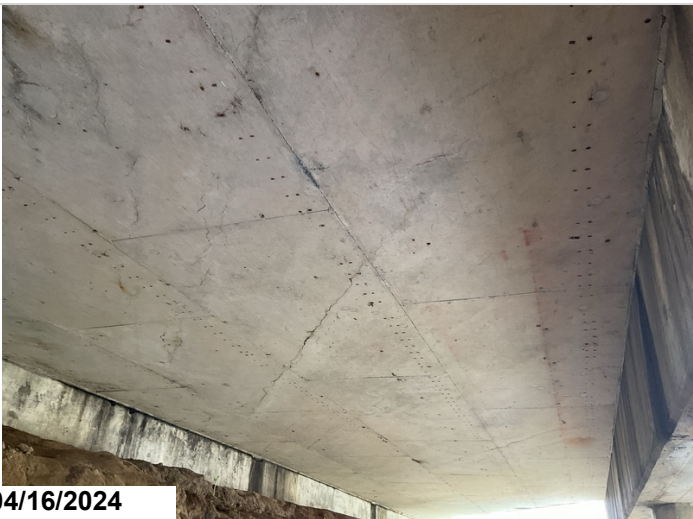
Span 3, soffit / undersurface of deck

Voided slab superstructure is in overall satisfactory condition. Soffit / undersurface has longitudinal cracking, some with rust staining and efflorescence. There is a minor amount of spalling with exposed reinforcing steel and delaminated areas. Top of slab has epoxy wearing surface. Ends of slabs have minor spalling at bents.

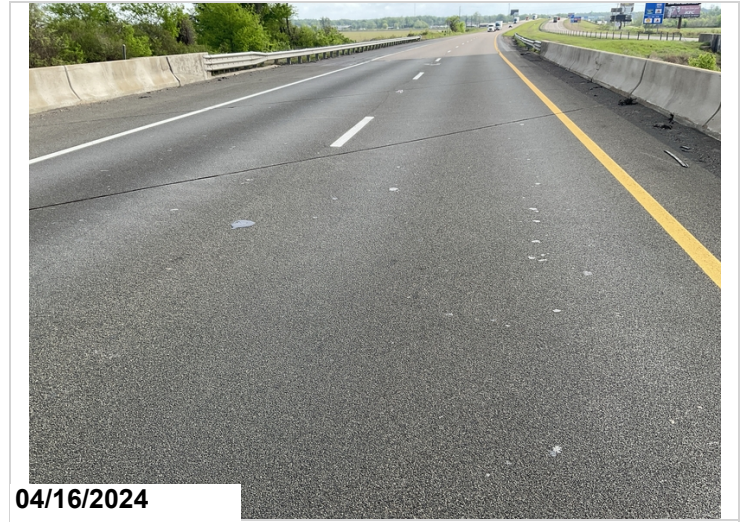
Typical deck

Deck is in overall satisfactory condition. Hydro demolition has been performed on deck and an epoxy wearing surface has also been applied. Only a minor amount of missing joint material is noted as a defect. Deck is rated at 6 due to condition of slab.

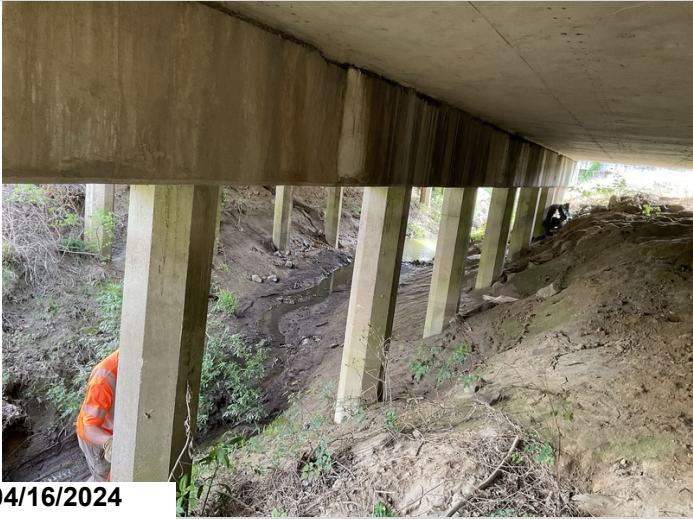
Bent 2, pile cap, back face

Concrete substructure is in overall satisfactory condition. Abutment slopes have areas minor to moderate erosion with several piles being exposed due to undermining of caps. Abutment 1 cap has minor cracking. Bents 2 and 3 pile caps have several moderate spalls, one with exposed reinforcing steel. There are a few pieces of exposed reinforcing steel due to poor concrete coverage.

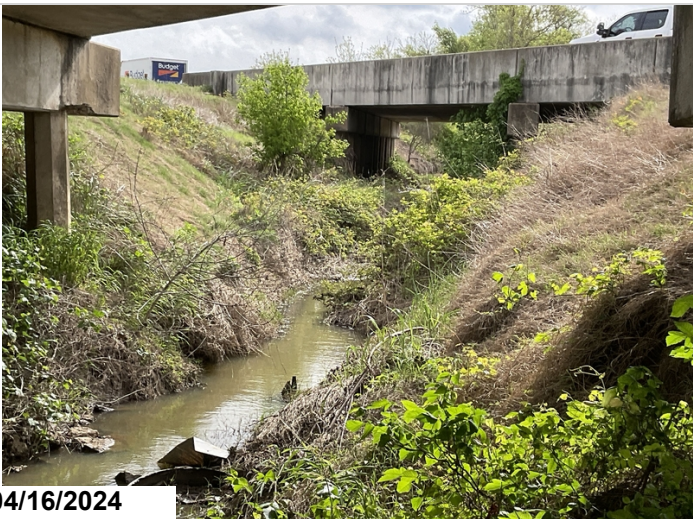
Channel, right side

Channel is in fair overall condition. Channel alignment at structure is fair, bridge has 52 degree skew. Abutment slopes have minor to moderate erosion exposing several piles, otherwise slopes are well vegetated. Channel, both sides, has vegetation growth restricting flow.
