Bridge A3724 Inspection Report

I-40WB/Se43/209.29 over Bayou Deview

Location: 6.37 Miles West Of Us 49

Team Lead: Drew Melton **Inspection Date:** 06/04/2025

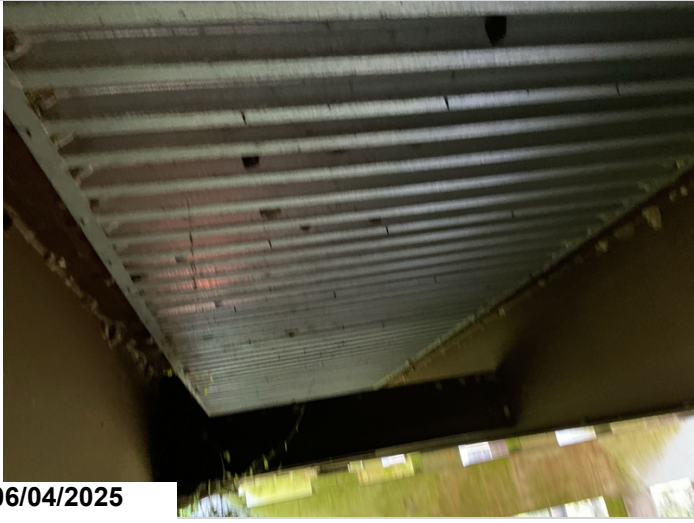
Typical undersurface

Deck is in good condition with deck surface having an epoxy overlay. Undersurface overhangs have transverse hairline cracks, some with light efflorescence.

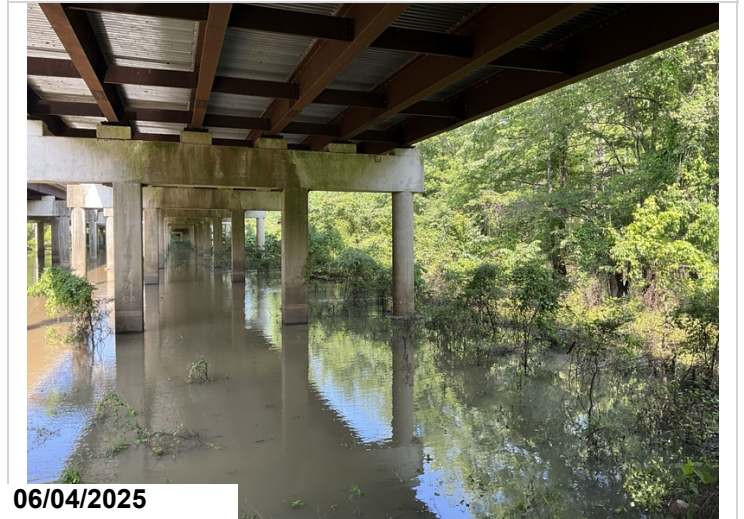
Channel under structure

Channel has good alignment and is in fair condition. An over abundance of trees and vegetation growing under and beside bridge restriction channel flow rate.

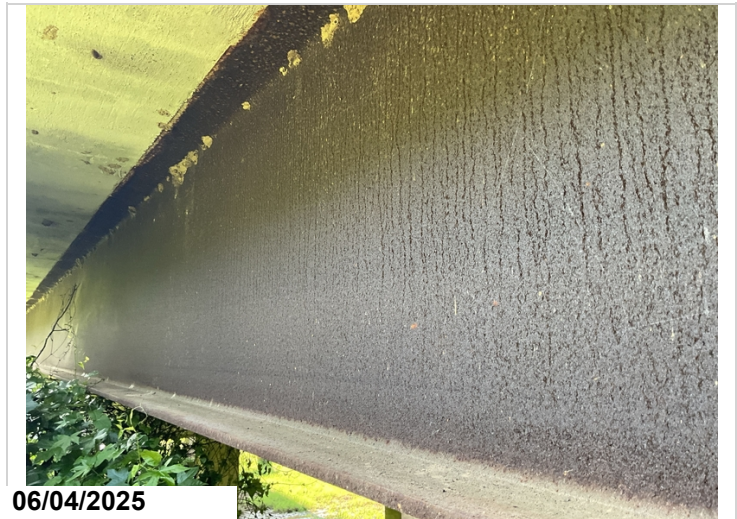
Typical girder condition

Superstructure is in good condition with some minor active corrosion forming on a few girder ends at bents with little to no section loss.

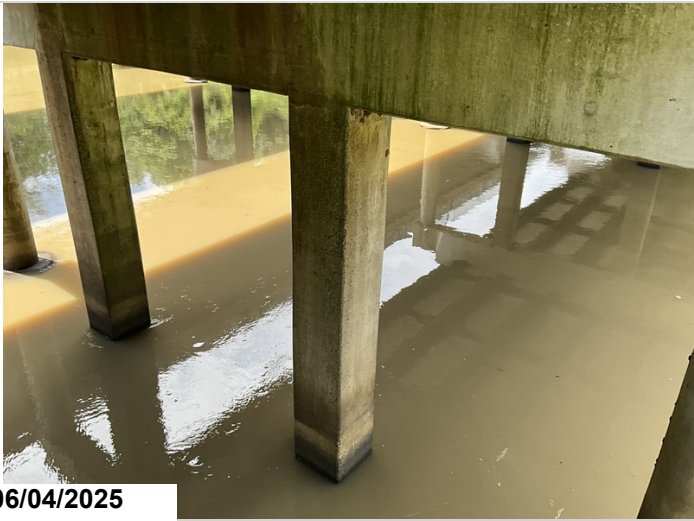
Bent 7 column 2 left top

08/31/2022 - RWF & AMJ - Overall the substructure is in good condition. Bent 7 Column 1 has 2 baseball size spalls in the west face with flaking rust and minor timber debes on the North face. Column 2 has spalling with exposed reinforcing steel 7' below the waterline South face, Column 3 no defects from the waterline down. Column 4 has a cut out section of encasement 8"x10" on the SE-SW corners. Bent 15 Column 1 face of the encasement is broken off 2' above the water line all the way around and has heavy corrosion. Column 2 Has light abrasion all the way around, between column 2 & 3 there is a scour holes 7'6"deep. Column 3 has a baseball size spall in the NE corner 3'5" below the water line, between comun 3 & 4 large pile of riprap from previous collision dame with reinforcing steel protruding outward causing a entanglement hazard. Column 4 has 4 8"x10" windows cut out on all sides with heavy corrosion on the encasement. Defects in condition states 2-4 were noted in the element section of this report.

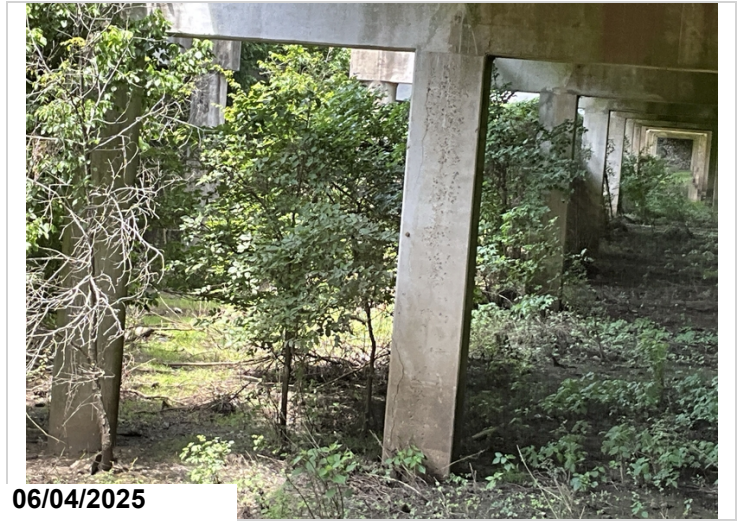
Bent 13 column 3 ahead right corner

Substructure is in satisfactory condition with multiple caps and columns, primarily the original section of cap and columns 2 & 3, having cracks, delaminations, and spalling with exposed reinforcing steel with minor to moderate section loss.

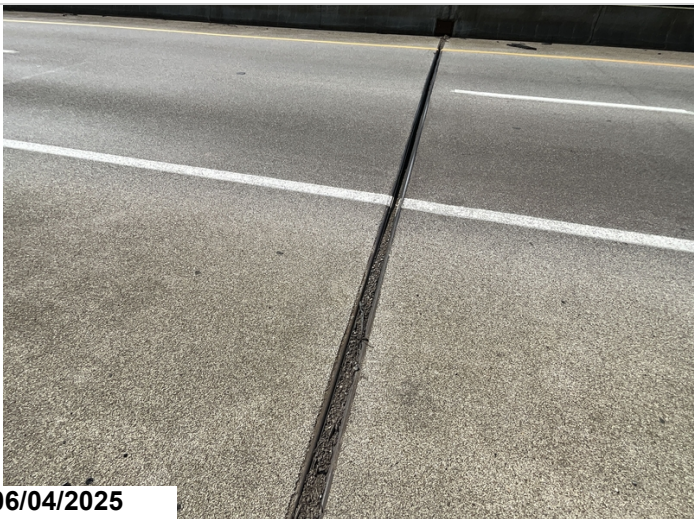
Joint bent 16

Bridge joints are in satisfactory condition with a few small holes, debris impaction, and a couple of drains troughs not hooked up to drains.

Bent 8 & 16, Joint Drain, Under Bridge: Disconnected not working.

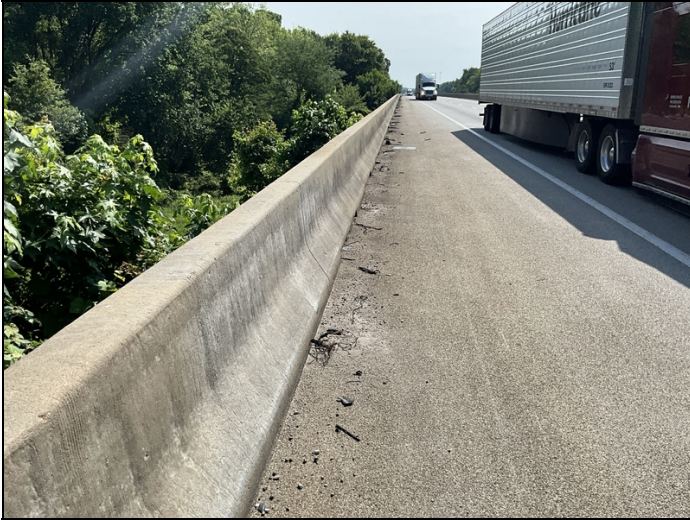
Deck Gutters, Full Length: Dirt and debris.

A-55 - Deck Washing Needed (Yes)

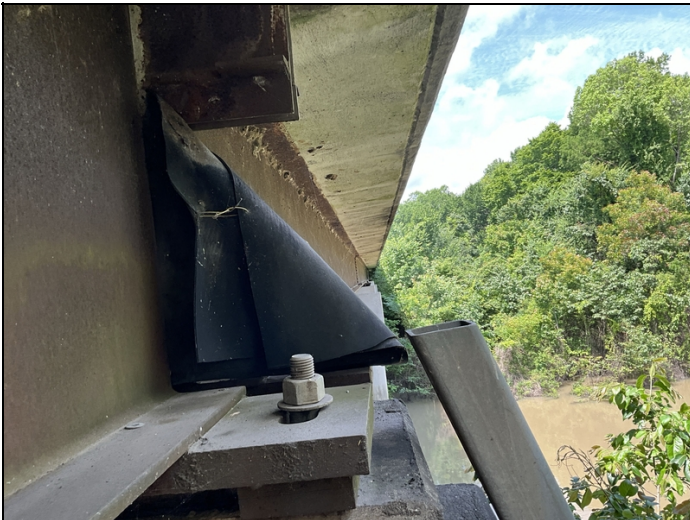
Bent 8 & 16, Joint Drain, Under Bridge: Disconnected not working.

A-56 - Joint Cleaning/Flushing Needed (Yes)
