Bridge B3614 Inspection Report

Asset #B3614(Routine, Underwater type 2)

I-40EB/Se51/237.82 over Spring Creek

Team Lead: Myron Futrell Inspection Date: 01/29/2024

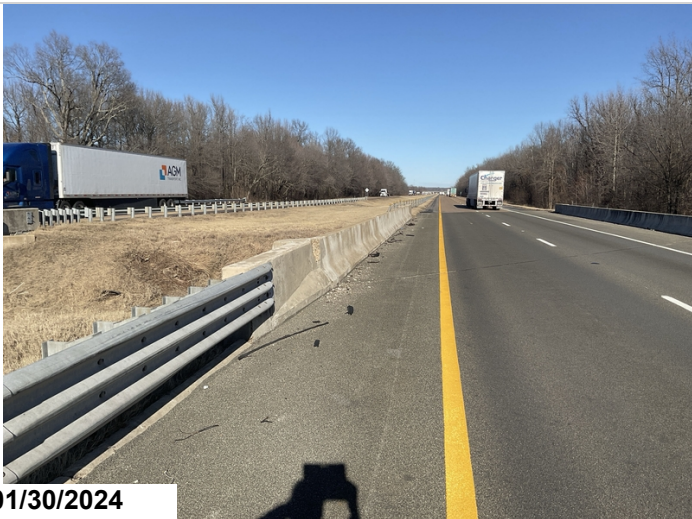
Left bridge rail

(331) Abutment #1 left transition rail has 2' X 2' spall with exposed rebar no section loss. Bridge rails have vertical cracks spaced three feet apart. Bent #2 right side rail at bottom span #1 has six-inch spall no rebar. Span #2 left side outside at bent #3 has three-inch spall with exposed rebar.

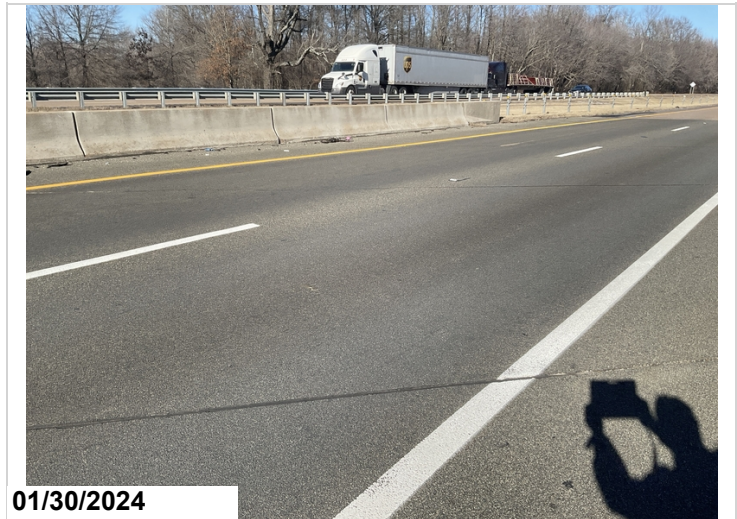
Typical deck

Deck is in overall satisfactory condition. Deck has an epoxy coated wearing surface. Soffit / underside of deck has a few spalled areas with exposed rebar, some cracking with rust staining and efflorescence.

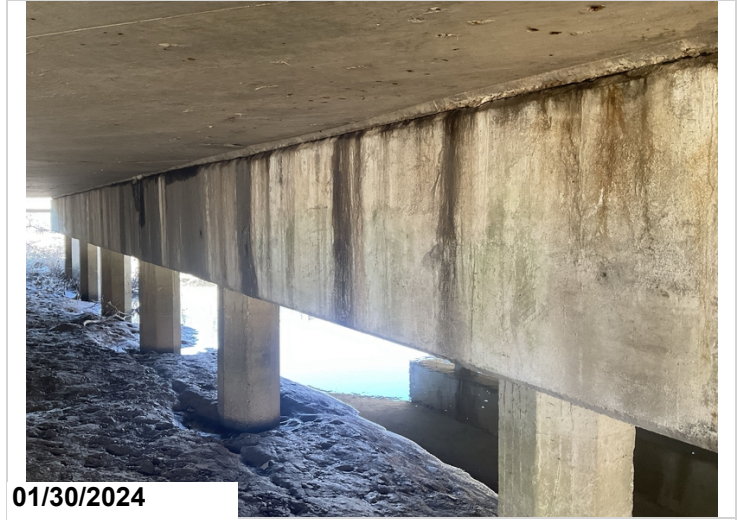
Bent #2 back face

Concrete substructure is in overall good condition. Caps have some minor spalling some with exposed rebar and scaling on ends that are exposed to weather.
