Bridge B3617 Inspection Report

Asset #B3617(Routine, Underwater type 2)

I-40EB/Se51/239.44 over Drainage Ditch

Team Lead: Myron Futrell Inspection Date: 04/16/2024

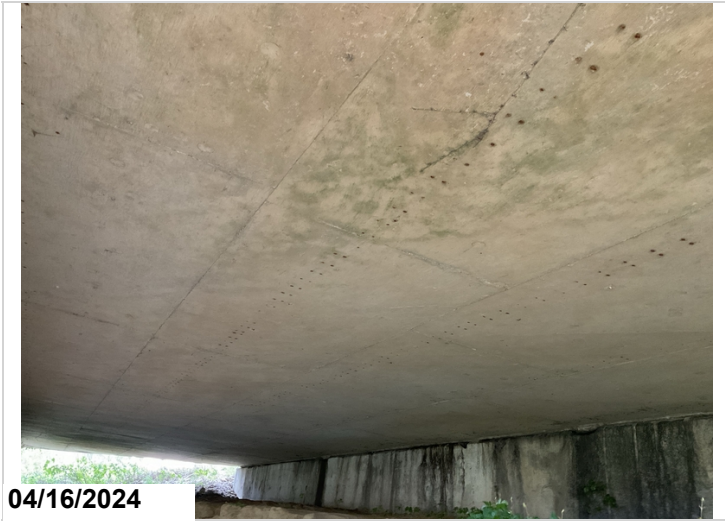
Span 1, soffit / undersurface of deck

Voided slab superstructure is in overall satisfactory condition. Soffit / undersurface has longitudinal cracking, some with rust staining and efflorescence. Top of slab has epoxy wearing surface. Ends of slabs have minor spalling at bents.

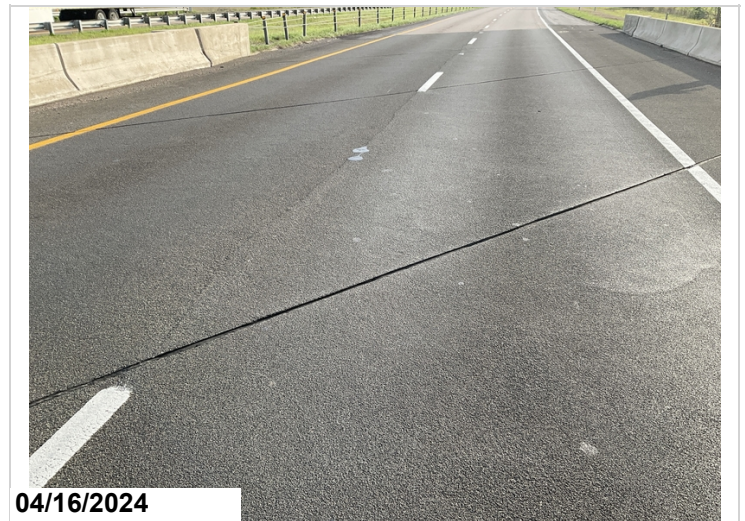
Typical deck

Deck is in overall satisfactory condition. Hydro demolition has been performed on deck and an epoxy wearing surface has also been applied. Only a minor amount of missing joint material is noted as a defect. Deck is rated at 6 due to condition of slab.

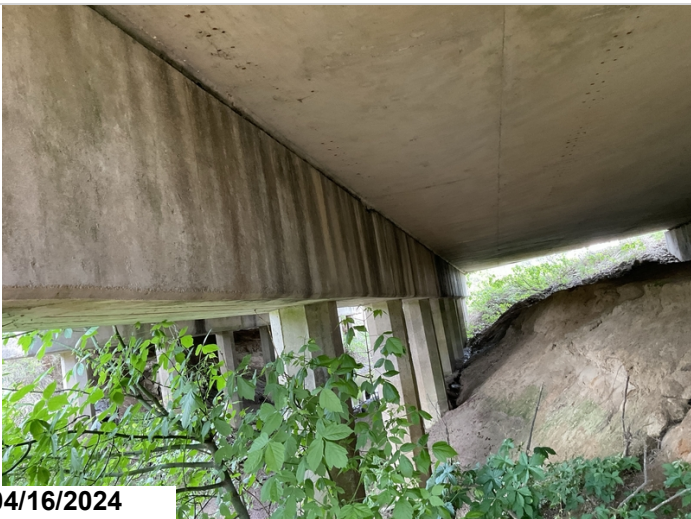
Bent 2, back face

(234) Bent 2, pile cap, back and ahead face, between piles 4 and 5, at keyway: spalled with no exposed reinforcing steel. 1LF CS3 Bent 2, pile cap, back face, bottom edge into face, between piles 4 and 6: has two 4' areas of deterioration. 8LF CS2 Bent 2, pile cap, back face, at right keyway: 1' delaminated area. 1LF CS3 Bent 3, pile cap, ahead face, left end: 3' of moderate scaling and 3LF CS2 cracking. 3LF CS2 Bent 3, pile cap, ahead face, between piles 2 and 3: two 1' spalls with exposed reinforcing steel with minor section loss. 2LF CS3 Bent 3, pile cap, ahead face, above pile 3: 6' longitudinal area of cracking. 6LF CS2 Bent 3, pile cap, ahead face, between piles 5 and 6: 4' of longitudinal cracking/delaminated area. 4LF CS3 Bent 3, pile cap, right end: heavy scaling, spalling no rebar and cracks with heavy efflorescence. Efflorescence 6LF CS3 Bent 3, pile cap, bottom face, between piles 3 and 6 has 30' of longitudinal cracking and a 6' x 1' spall with exposed reinforcing steel with moderate section loss between piles 5 and 6. Cracking 30LF CS2, Rebar 6LF CS3 Bent 3, pile cap, back face: below center keyway has 3' area of scaling and 1' delaminated area, below right keyway has 2' area of scaling and a CS2 vertical crack. Delam 6LF CS3, Crack 1LF CS2

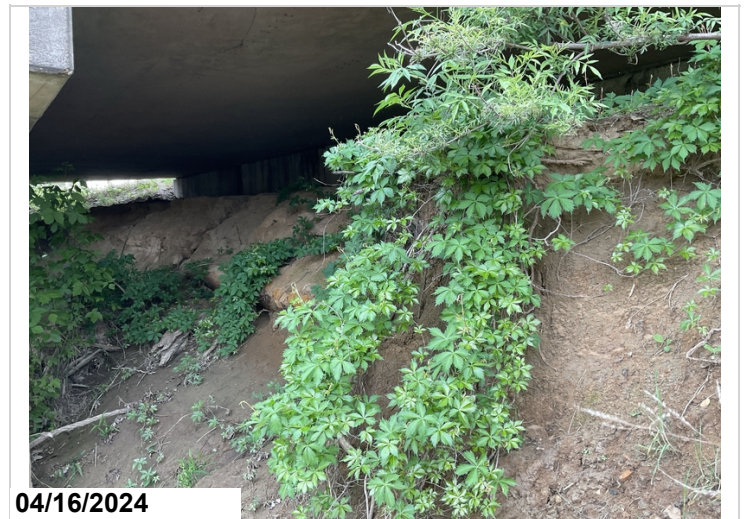
Abutment 1, slope

Channel is in fair overall condition. Channel alignment is fair, bridge has 52 degree skew. Abutment slopes have minor to moderate erosion exposing several piles, otherwise slopes are well vegetated with the exception of a small area right side of bridge that is steep and eroded. Channel, both sides, has vegetation growth restricting flow.
