Bridge B3727 Inspection Report

Asset #B3727(Routine, Underwater type 2)

I-40EB/Se43/211.61 over Creek

Team Lead: Myron Futrell Inspection Date: 01/13/2025

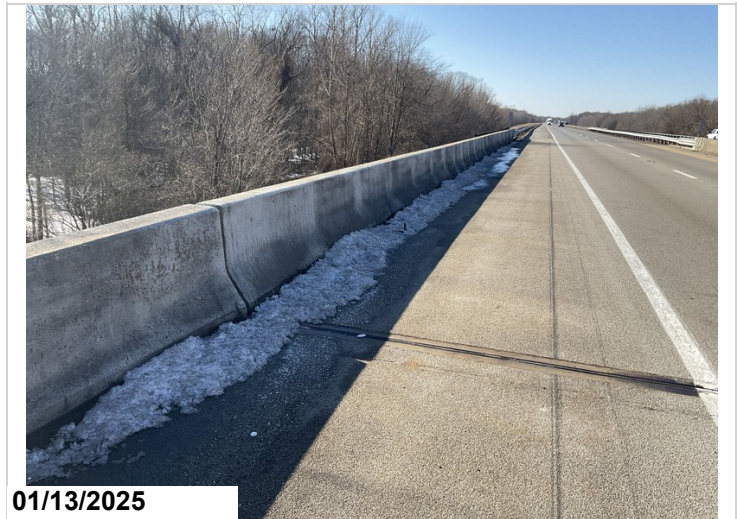
Bridge rail, right side

Cracks and efflorescence in bridge rails.

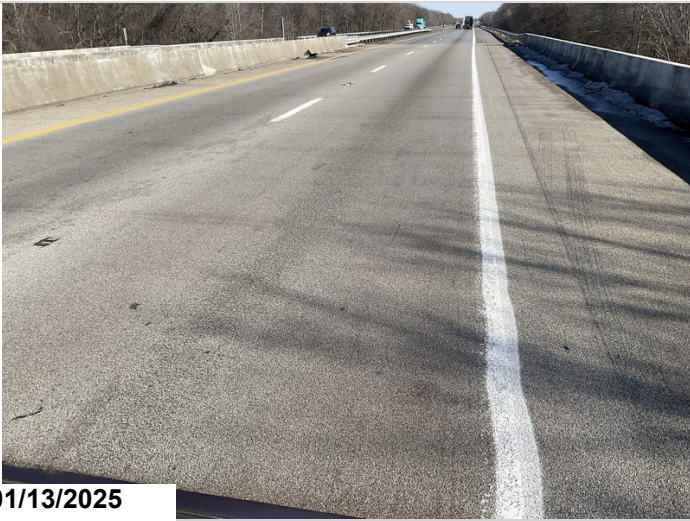
Reinforced concrete deck appears to be in overall very good condition. Top of deck has epoxy overlay; underside of deck has metal stay in place forms. No visible deficiencies.

Typical deck

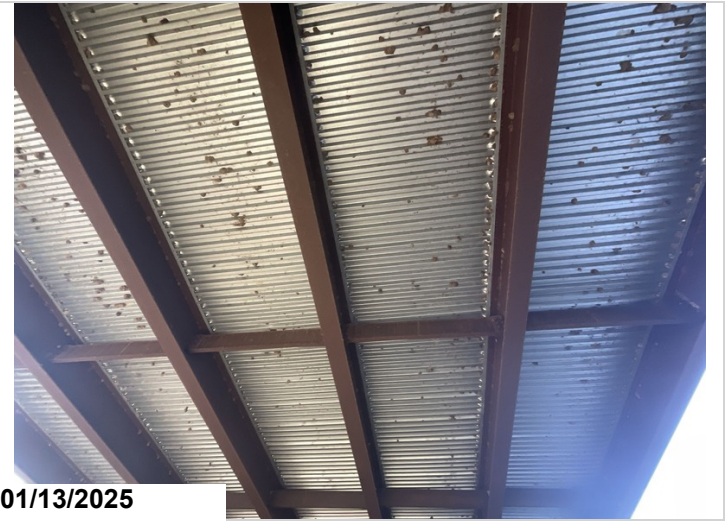
Span 1, underside of deck, typical of other spans.

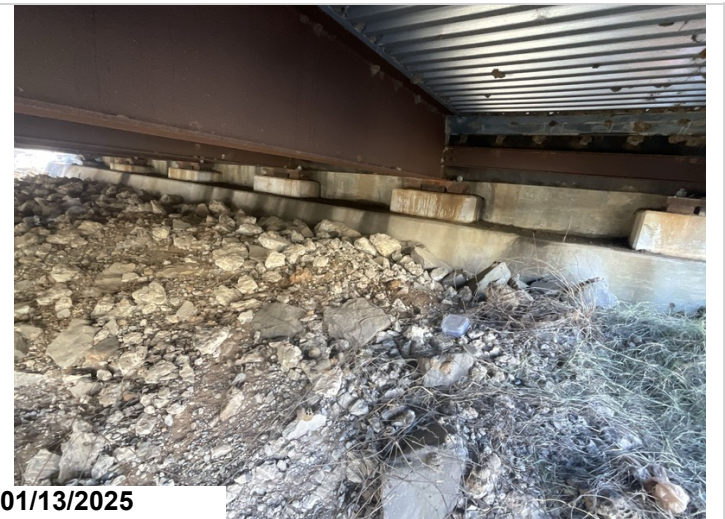
Abutment 1

Reinforced concrete substructure is in overall good condition. Pier caps and columns have no noted deficiencies, abutment backwalls have a few vertical cracks with light efflorescence.
