Bridge B3731 Inspection Report

National Bridge Inventory Data Sheet

Team Lead: Jonathan Gonzalez, Inspection Date: 09/05/2025

Asset #B3731 (Record Change)
I-40EB/Se43/215.99 over Cr-179/Z-D/L-1.73

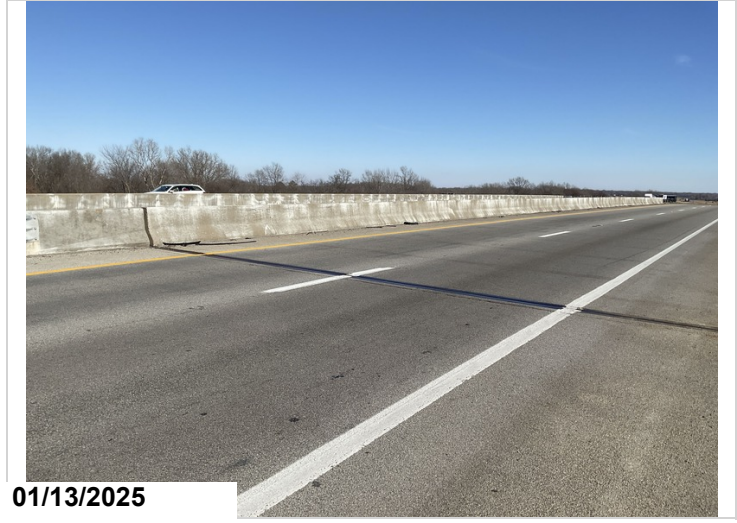
Bridge rail, left side

Reinforced concrete bridge rail has vertical cracking, some with light efflorescence scattered throughout.

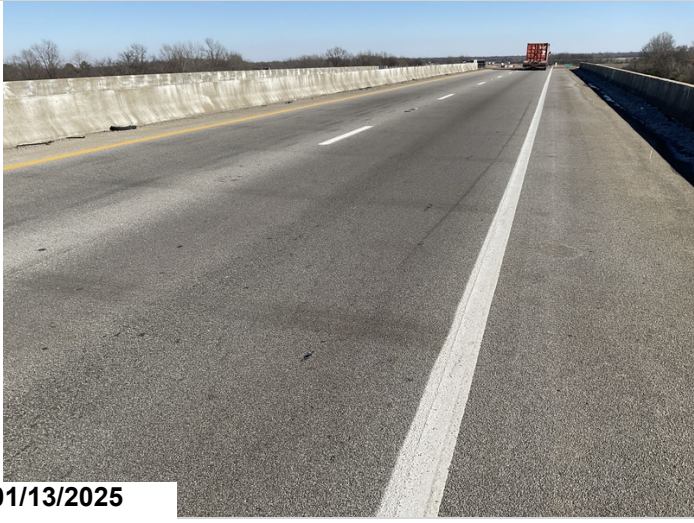
Typical deck

Deck is cast in place concrete with an epoxy overlay. The deck in span 2 center deck has 1' area of epoxy overlay missing with shallow spall, and the undersurface of overhangs have cracks with efflorescence.

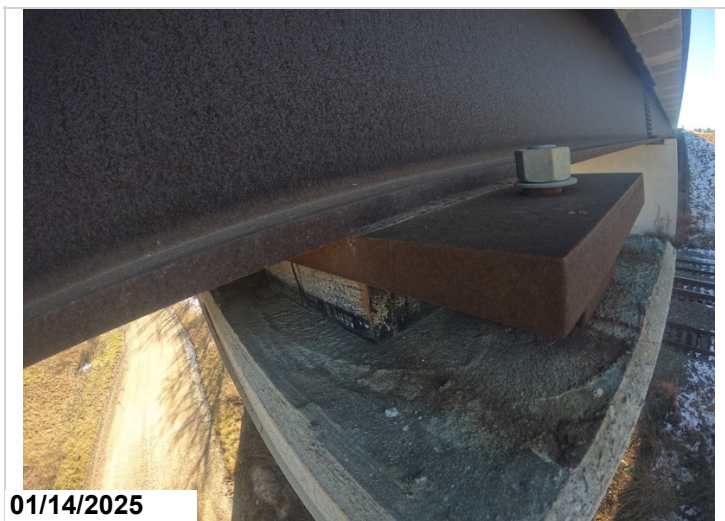
Elastomeric bearings are in good condition with areas of minor corrosion.

Typical intermediate bearing.

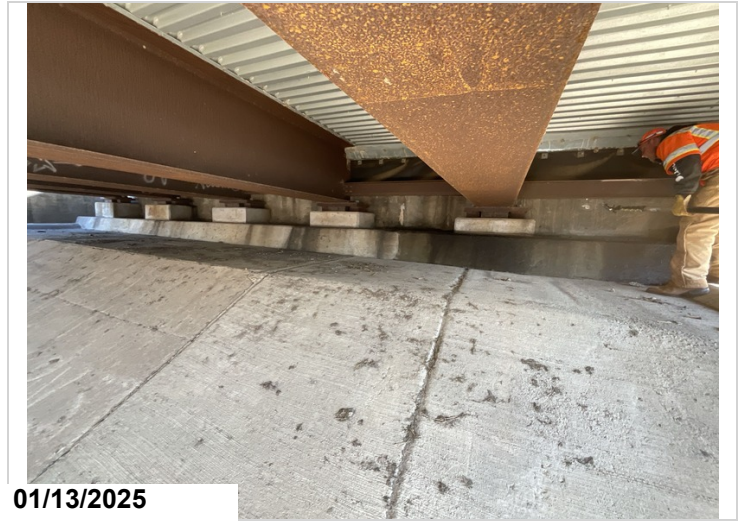
Abutment 2

Reinforced concrete substructure is in overall good condition with the only thing noted on pier walls is graffiti, abutment back walls have a few hairline cracks with light efflorescence.

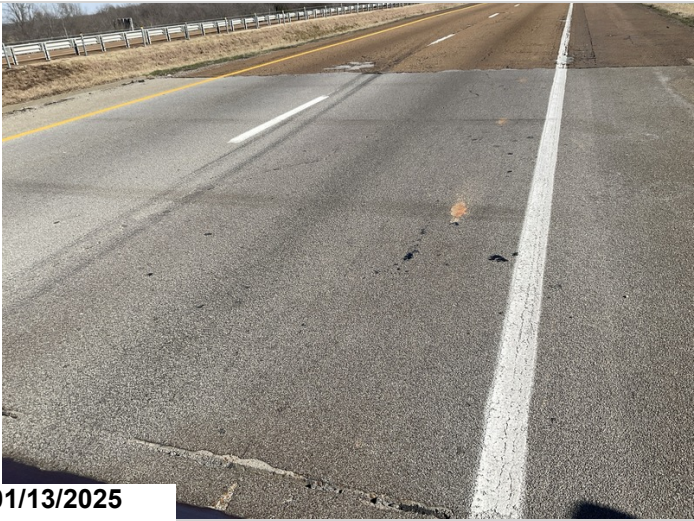
Abutment 2, approach slab.

ELEMENTS	DESCRIPTION	UNITS	TOTAL	CS1	CS2	CS3	CS4
3540	Effectiveness (Concrete Protective Coatings)	SF	40	0	0	40	0
(321) Approach slabs have epoxy overlay.							
Abutment 2, approach slab: CS3 crack coming through overlay. Cracking 40SF CS3							
Abutment 2, approach slab, concrete protective coating: CS3 crack coming through overlay. Effectiveness.							
331	Reinforced Concrete Bridge Railing	LF	520	390	70	60	0
1120	Efflorescence/Rust Staining	LF	70	0	70	0	0
1130	Cracking (RC and Other)	LF	60	0	0	60	0
(331) Concrete bridge rail left side: vertical cracks spaced roughly 10' some with light efflorescence. Efflorescence 20LF CS2							
Concrete bridge rail left side: 60' of longitudinal cracking 8" from top. Cracking 60LF CS2							
Concrete bridge rail, right side: vertical cracks spaced roughly 4' some with light efflorescence. Efflorescence 50LF CS2
