Bridge #A0652(Underwater type 2, Routine)

US 63-03- LM 9.11 over Clear/Chaplin Crk

Team Lead: Tim Myrick **Inspection Date:** August 31, 2021

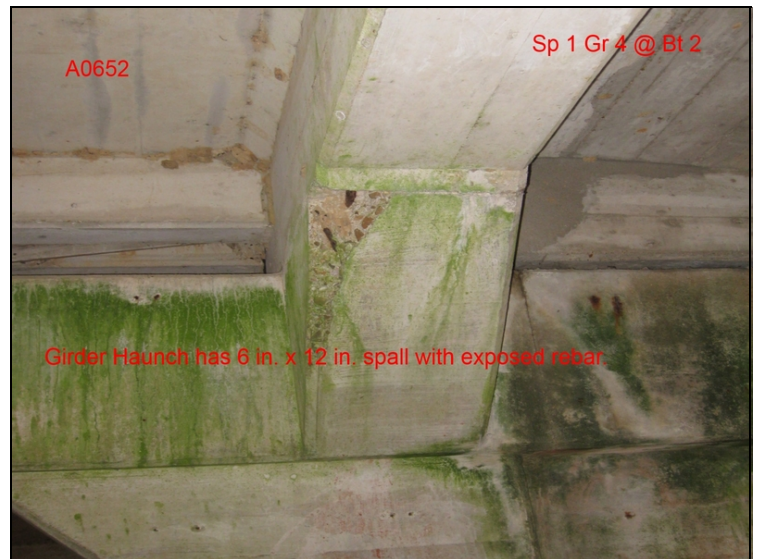
Span 2 girder 5 at bent 2

Span 1 Girder 4 Bent 2 girder haunch is shelled out (6in. x 12in.) with rebar exposed, see 2013 photo.
Span 2 Girder 5 Bent 2 has an open crack on end of girder. See 2019 photo.

Span 2 girder 5 bent 2 has an open crack on end of girder.
