District 10, Mississippi County

**Bridge #01268(Routine)**  
**US 61-02- LM 2.53 over FRENCHMANS BAYOU**  
**Location: 2.53 MI N CRITTENDEN CO**

**Team Lead:** Richard Jones **Inspection Date:** November 01, 2021

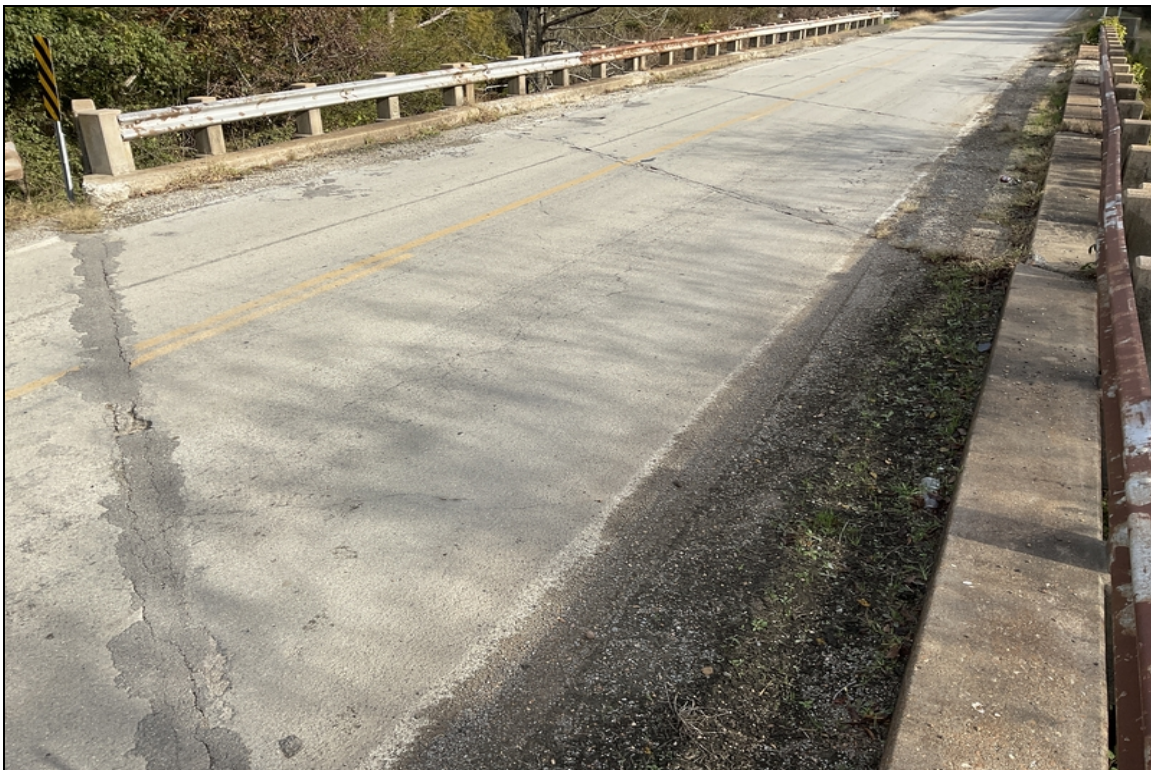
Wearing surface has several longitudinal cracks, map cracks and delaminated areas or patches in wheel paths. Wearing surface is mostly delaminated or spalled/raveling out along gutters and over joints.

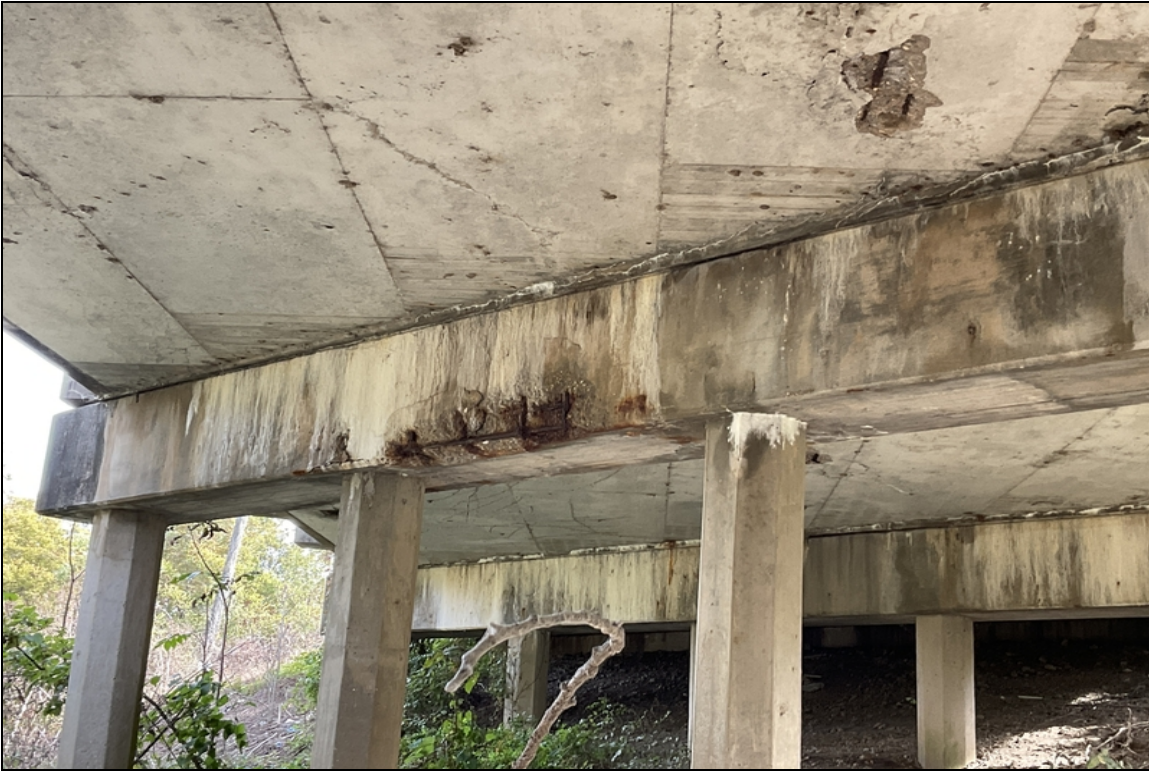
Bent 5 cap has a 4' spall with exposed rebar between piles 1 and 2.

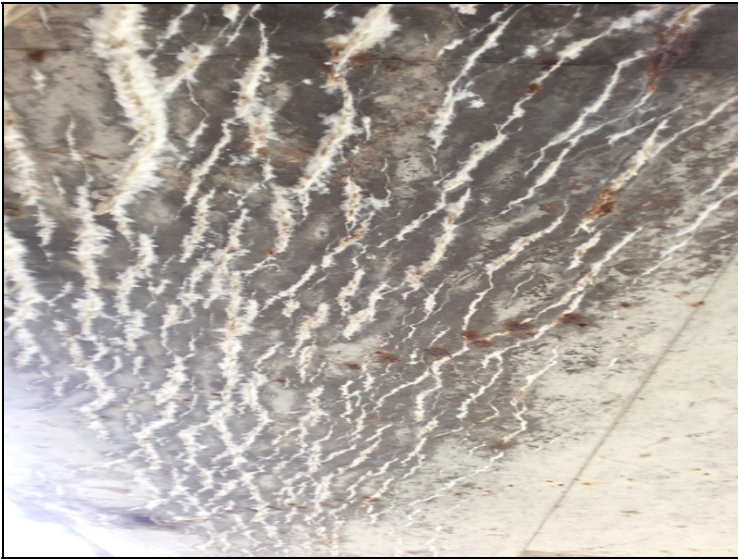
Span 4 soffit RT side

Slab soffit has several longitudinal cracks with heavy efflorescence or rust stains under gutters and outside wheel path. Soffit has several spalls with exposed rebar, mostly near centerline or outside edges at drain openings.
