Bridge #03662(Routine)
SH 90- 01- LM 5.14 over DITCH NO. 11

Location: 5.0 MI E OF RECTOR

Team Lead: Tim Myrick Inspection Date: November 11, 2020

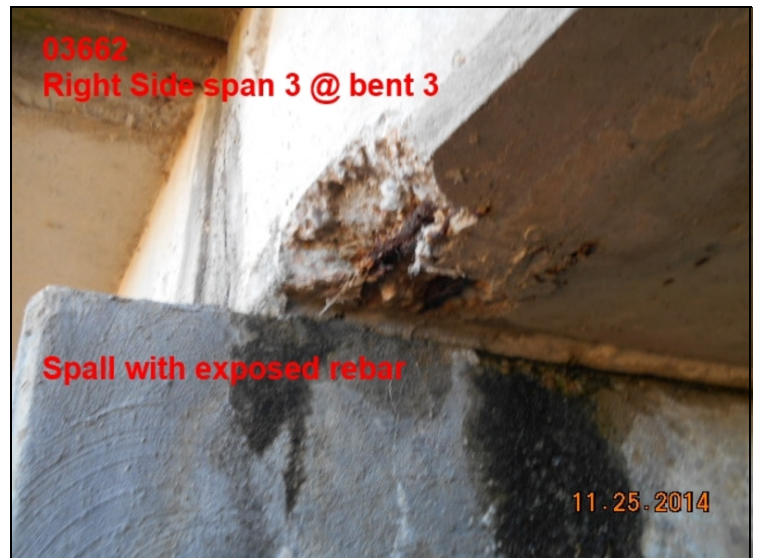
Bottom of Deck Span 3 near Bent 3 has 2 each 8in. x 8in. shelled out area with rebar exposed, see 2014 & 2018 photo. Bottom of slab Span 3 near bent 3 has 2 spalled areas, (1) 10 in. x 12 in. x 1 in. deep, (1) 24 in. x 12 in x 2 in. deep with exposed rebar with section loss, see 2018 photo.

Span 3 soffit RT edge near bent 3

Bottom of slab Span 3 near bent 3 has 2 spalled areas, (1) 10 in. x 12 in. x 1 in. deep, (1) 24 in. x 12 in x 2 in. deep with exposed rebar with section loss.
