**Bridge #M4039(Routine)**  
**SH 158-01-LM 10.35 over NATIONAL DITCH**

**Location: 2 MI W VICTORIA ARK.**

**Team Lead: Richard Jones Inspection Date: March 01, 2022**

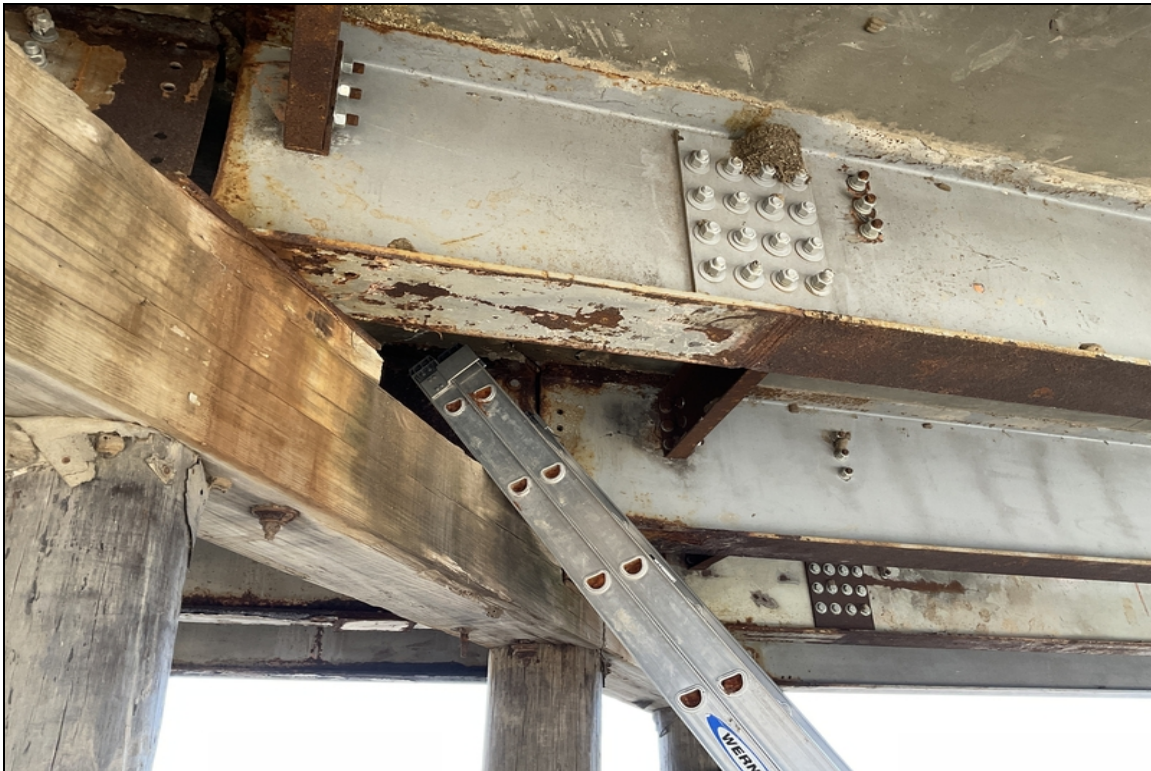
2022 - Span 1 bent 2 girder 3

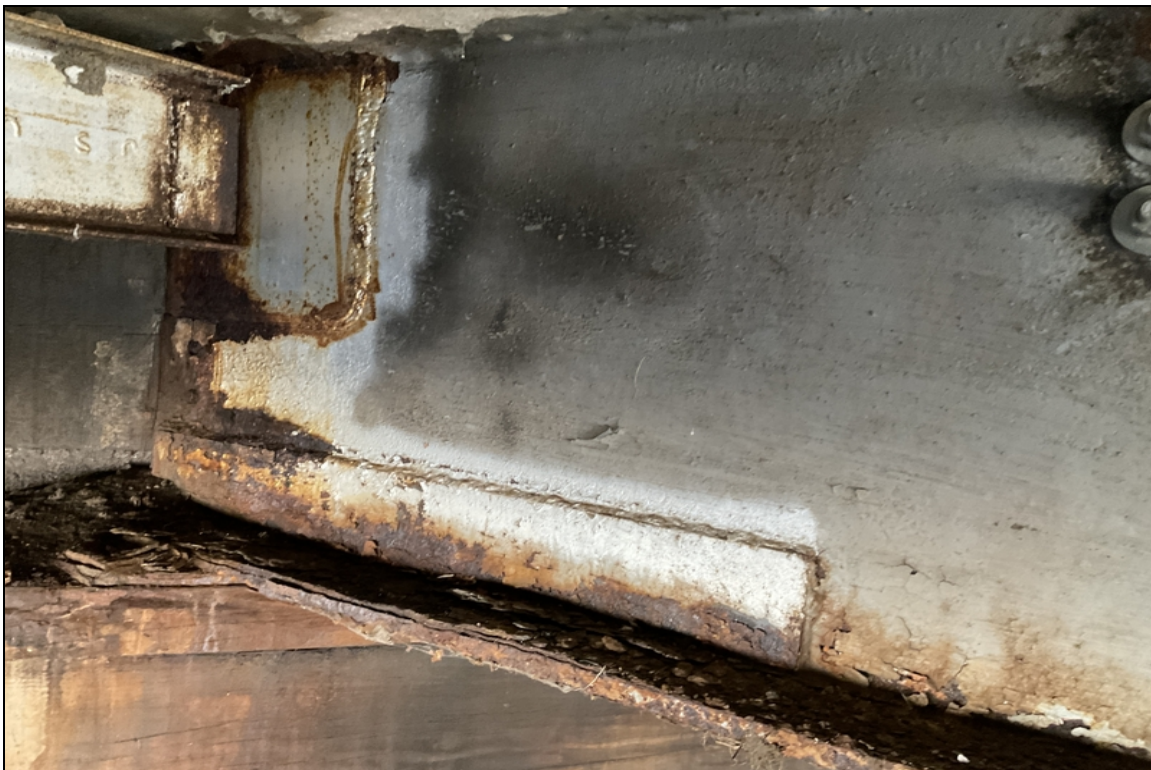
2022 - Span 5 bent 6 girders 5 - 7

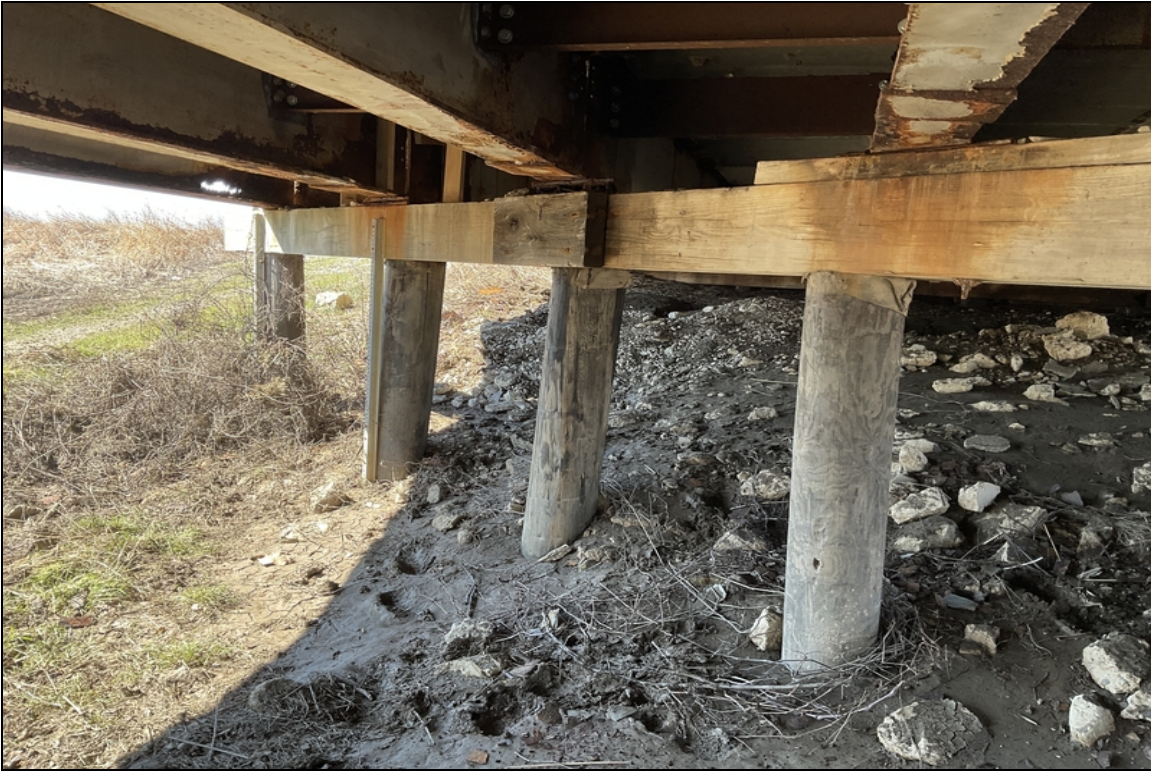
2022 - Span 7 bent 8 girder 4

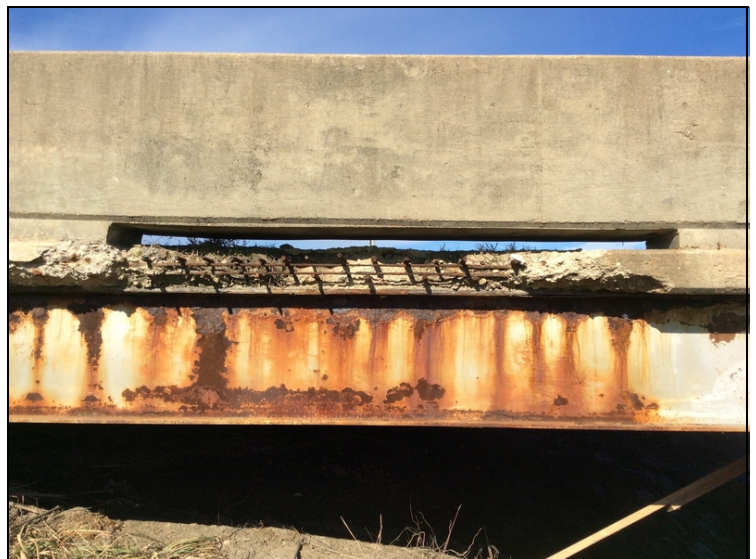
Deck has several surface and full depth patches. Patches are in mostly poor condition. Deck has concrete disintegration along joints, and overhangs at drain openings. Several areas along joints are patched full depth. Majority of gutters and outside wheel path of travel lanes are patched or delaminated.

Span 4 left overhang.

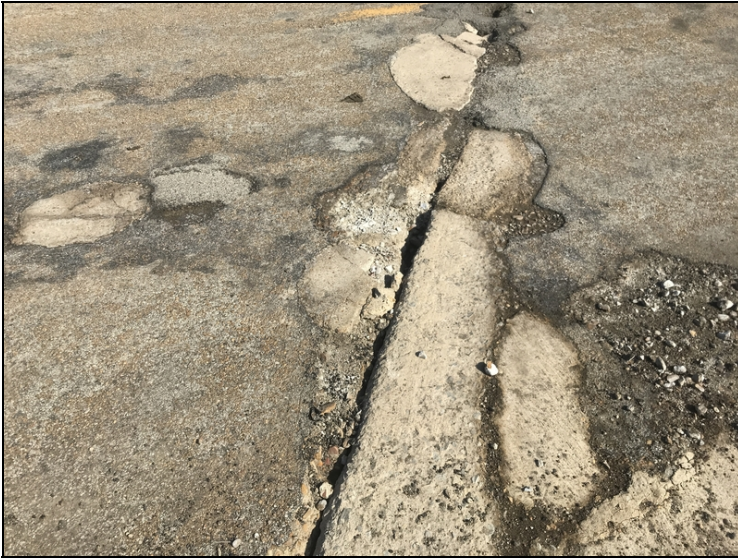
Span 7 left overhang.

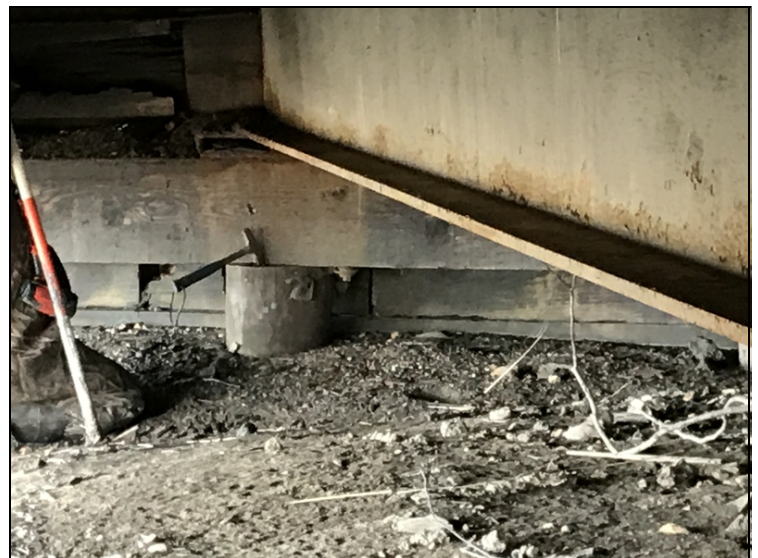
Bent 1 pile 6 is decayed and hollow. 2" shell remains.

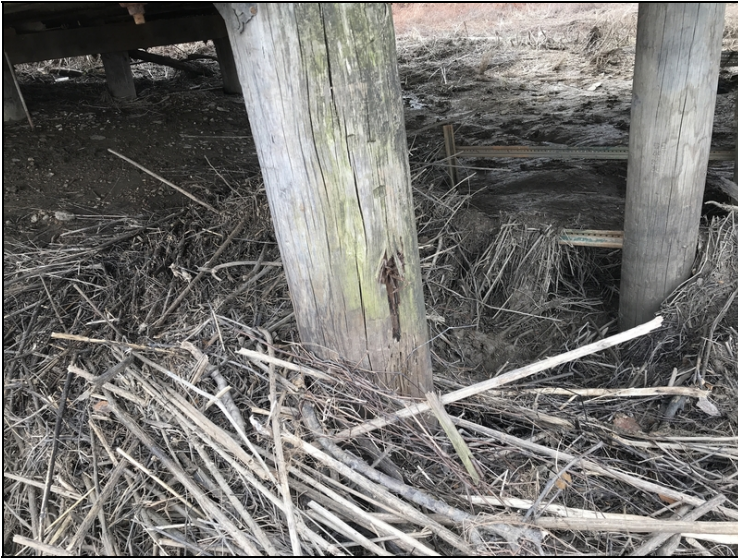
Bent 3 pile 8 has 1" outside decay and some section loss.

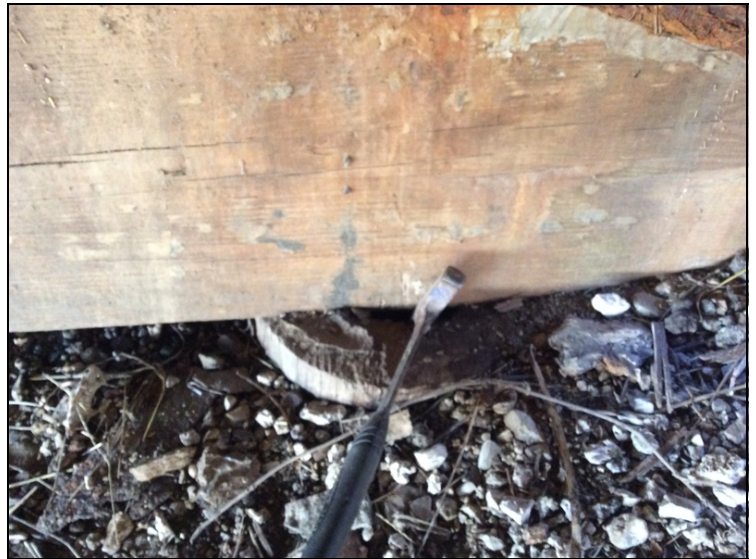
Bent 1 pile 1.

Bent 1 pile 1 has been reported as being decayed and hollow with a 3" shell remaining. Pile is not visible for inspection due to being covered with embankment.

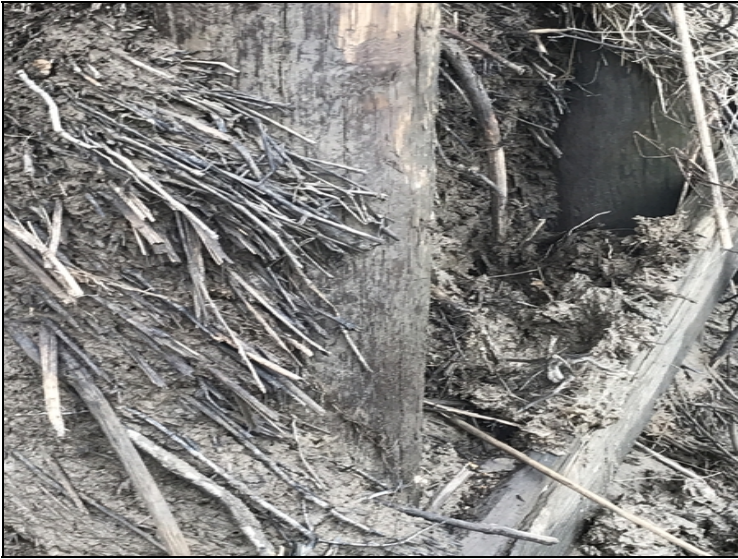
Bent 4 pile 8 has 1" outside decayed with some section loss. (Possible past fire damage.)

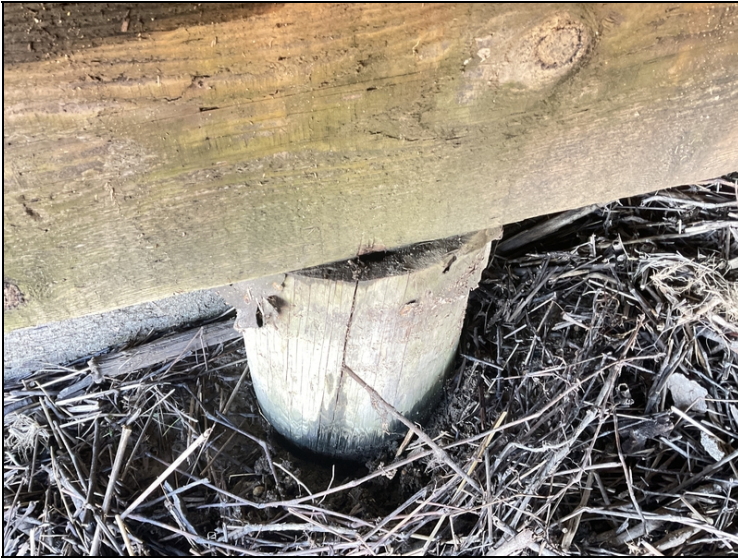
Bent 1 pile 7 is decayed and hollow. 1.25" shell and soft core remain.

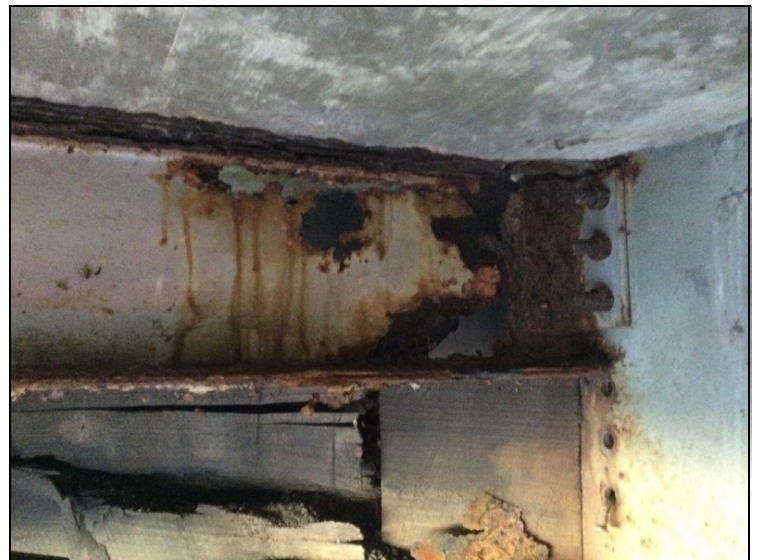
Span 1 bay 6 diaphragm 1.

Majority of diaphragms have heavy section loss with holes rusted through, some diaphragms are missing.

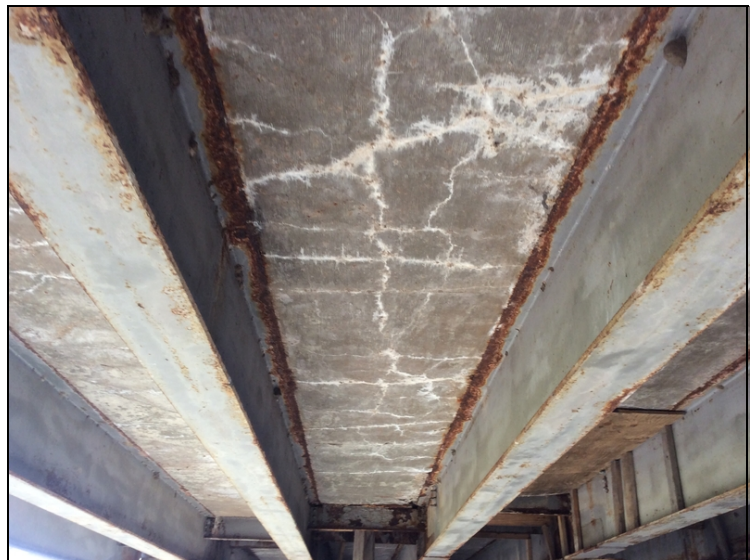
Span 6 bay 3.

Soffit has a few areas of map cracks with efflorescence.

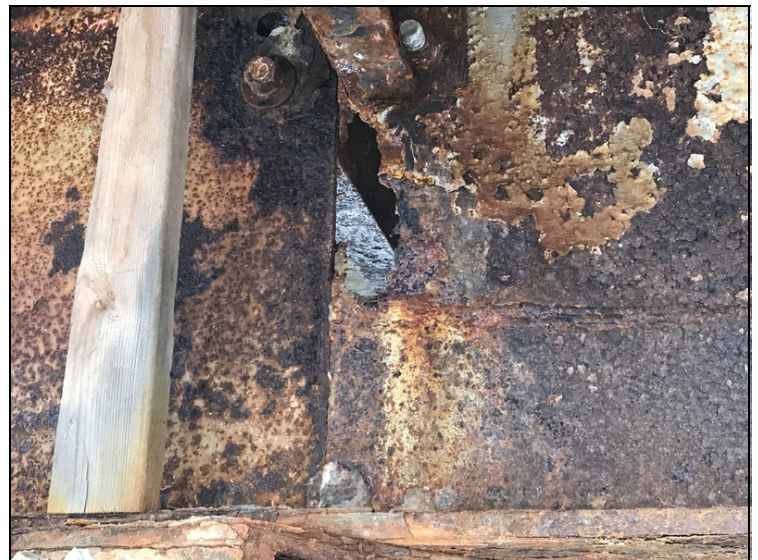
Span 7 girder 7

Ends of girders have rust and section loss along bottom of web, bottom flange, and at diaphragm connections.

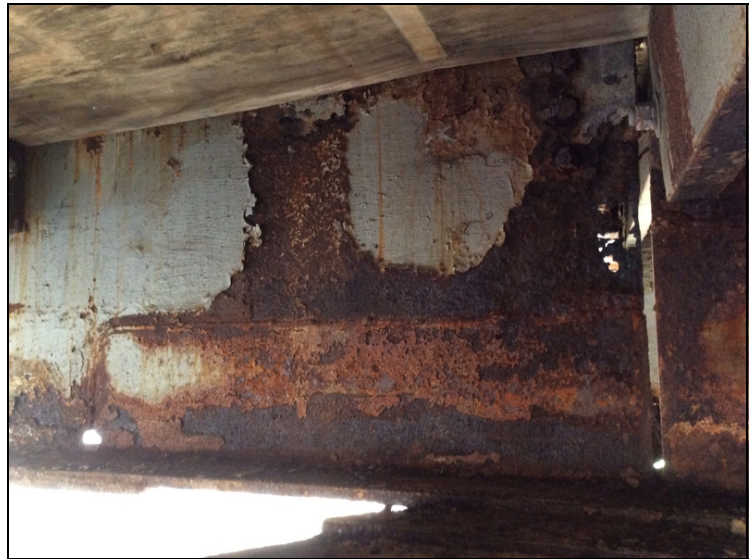
Span 3 girder 1 outside at Bent 4

Span 3 bent 3 girder 1 has heavy section loss along bottom of web and bottom flange.  
Span 3 bent 3 girder 4 was t spliced in the past. Web above splice has 1' of heavy section loss with pin holes rusted through.  
Span 3 bent 3 girder 6 has 2" x 1" hole in bottom of web 7" from end. Rt bottom flange is knife edged with a 5" x 1" hole rusted through.  
Span 3 bent 3 girder 7 was t spliced in the past. Top of web has a 4" x 1" hole at diaphragm connection.

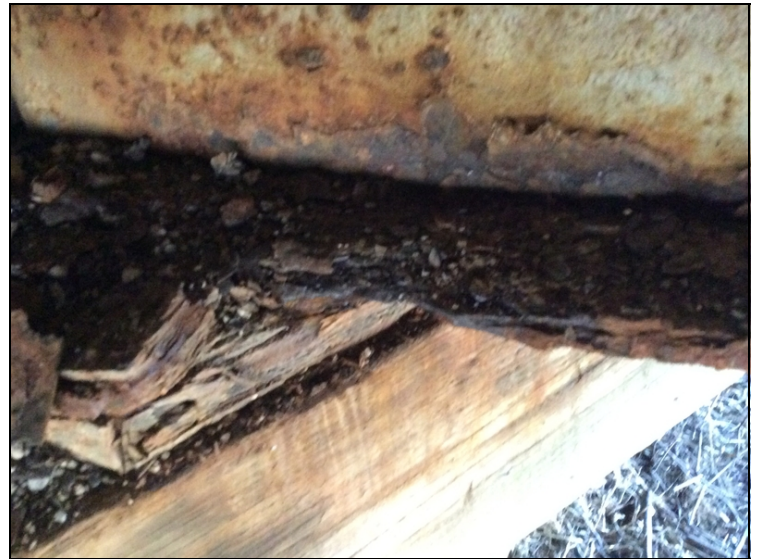
Span 7 girder 7 at bent 8.

Span 7 bent 7 girder 7 was t spliced in the past. End of web above splice has an 8" x 7" hole rusted through.

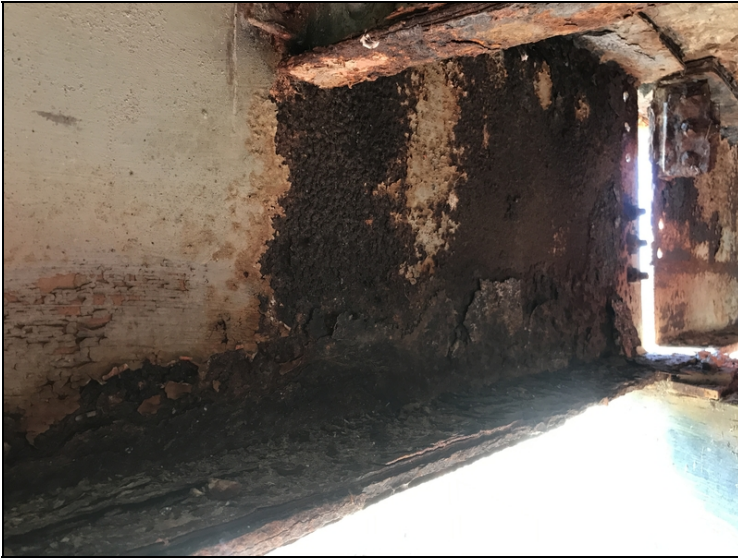
S1 b2 g1

Span 1 bent 1 girder 1 has 2' of heavy section loss. Rt bottom flange is knife edged.  
Span 1 bent 1 girder 5 has heavy section loss along bottom of web. Lt bottom flange is knife edged.  
Span 1 bent 1 girder 7 has an 8" x 3" area of heavy section loss with holes rusted through bottom of web starting 8" from end. Bottom flange is knife edged.  
Span 1 bent 1 girder 8 has heavy section loss at end with holes rusted through web near top flange 9" from end.

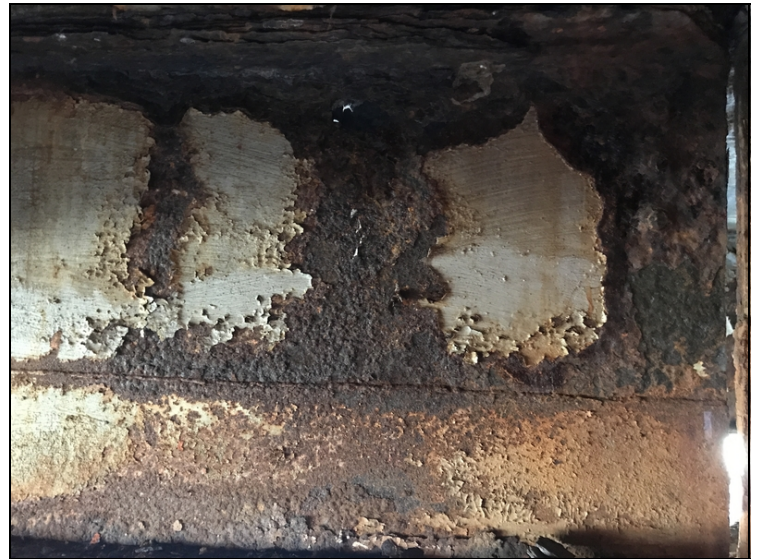
S2 b2 g6

Span 2 bent 2 girder 3 was t spliced in the past. Web above splice has a 2" diameter hole near old diaphragm connection.  
Span 2 bent 2 girder 4 has an 11" x 2" hole in bottom of web 21" from end. End of web is heavily pitted.  
Span 2 bent 2 girder 5 has 3' of heavy loss with holes rusted through at end of web, diaphragm connection, a 2" x 1" in bottom of web 8.5" from end. Lt bottom flange is knife edged with several holes rusted through.  
Span 2 bent 2 girder 6 has a 1" hole at end of web over T- splice. Top of web has 1" diameter hole 16" from end.  
Span 2 bent 2 girder 7 was t spliced in the past. Web above splice has a 7" x 2" hole at top of web.

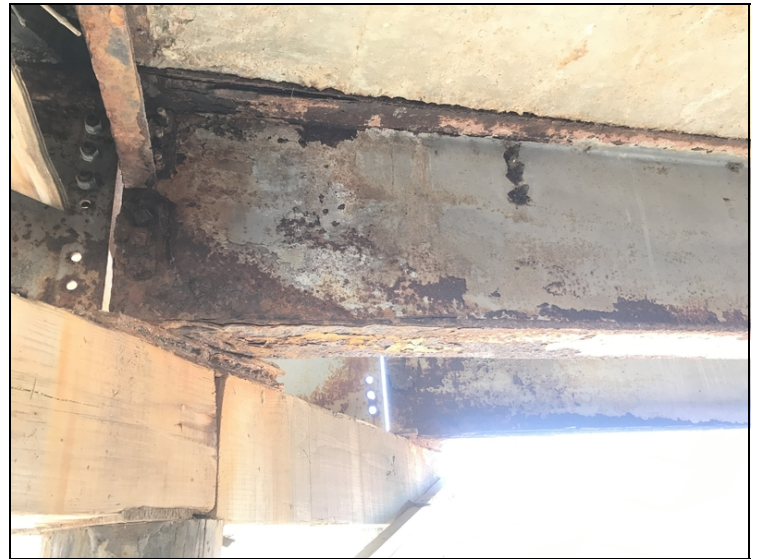
S6 b6 g1 & 2

Span 6 bent 6 girder 1 has heavy section loss along bottom of web and bottom flange. Rt bottom flange is knife edged.  
Span 6 bent 6 girder 3 has a 6" x 10" hole in web at old diaphragm connection 2" from end of girder. Bottom of web has a 2" x 1" hole 7" from end.  
Span 6 bent 6 girders 4 - 7 were t spliced in the past. Girder 6 has a 5" x 1" hole in top of web 6" from end.  
Span 6 bent 6 girder 8 has a 5' area of heavy section loss along bottom of web with a 7" x 1" hole 14" from and an 11" x 1" hole 37" from end. Bottom flange is knife edged with holes rusted through.

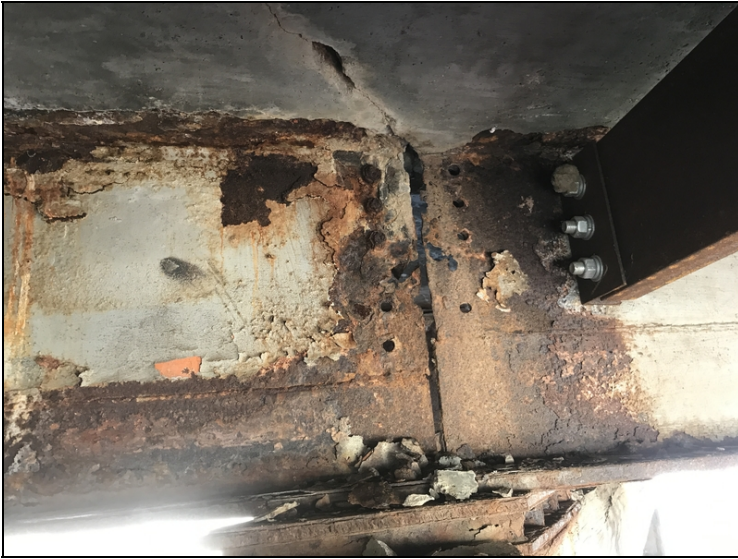
S7 b7 g6 & s6 b7 g6

Span 7 bent 7 girder 6 was t spliced in the past. End of web above splice has 6" area of section loss with holes rusted through.

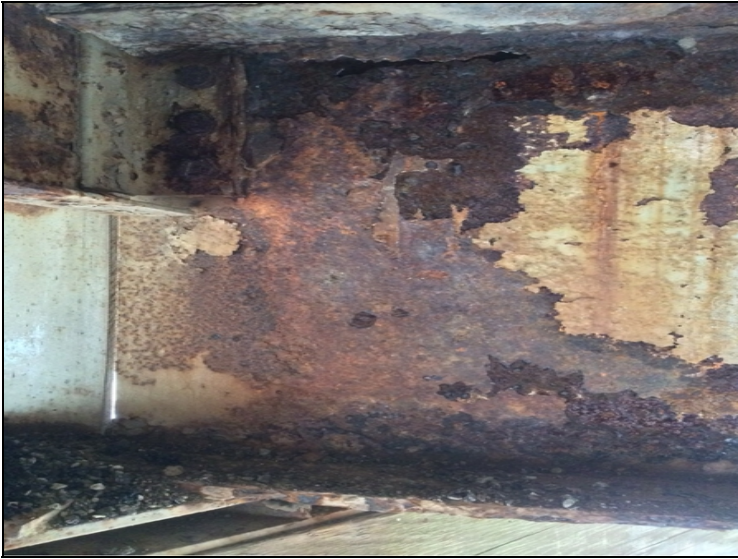
Span 5 girder 8.

Span 5 girders have been spliced & t- spliced. Girder 8 has been replaced. observed during inspection .01-24-2018

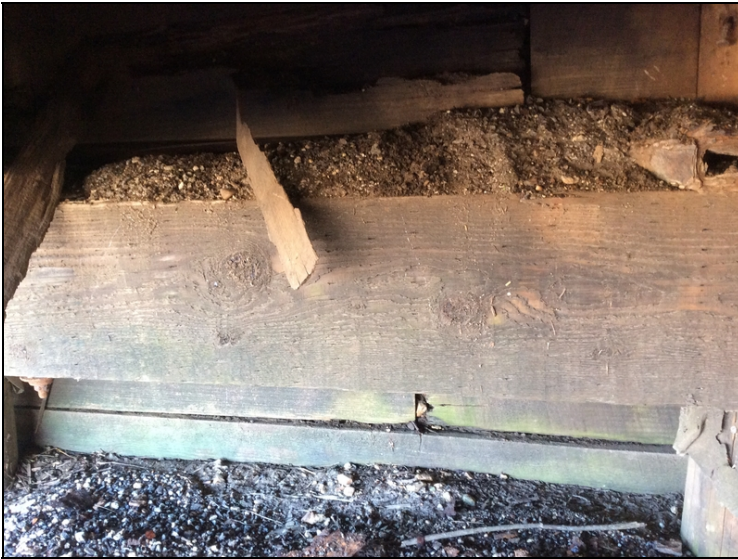
Bent 1 timber back wall is decayed with some section loss, beginning to lose embankment near piles 7 and 8.  
Bent 8 timber back wall is decayed and rotted & losing embankment.

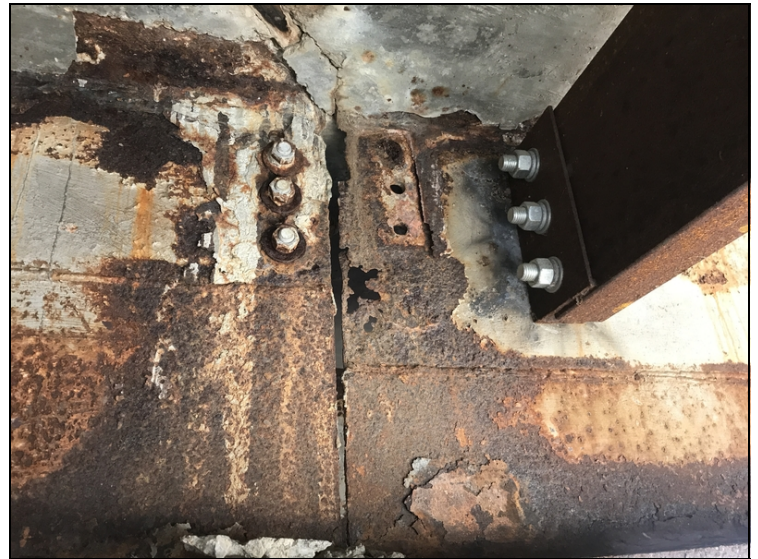
S6 b7 g4

Span 6 bent 7 girder 3 was t spliced in the past. Top of web has a 1" x 3" hole at end of girder.  
Span 6 bent 7 girder 4 was t spliced in the past. Web above splice has a 6" area of section loss with holes rusted through at end.  
Span 6 bent 7 girder 5 was t spliced in the past. Web above splice has a 6" area of section loss with holes rusted through at end.  
Span 6 bent 7 girder 6 was t spliced in the past. Web above splice has a 6" area of section loss with holes rusted through at end.  
Span 6 bent 7 girder 8 was t spliced in the past. Web above splice has a 6" area of section loss with a 6" x 7" hole rusted through at end.

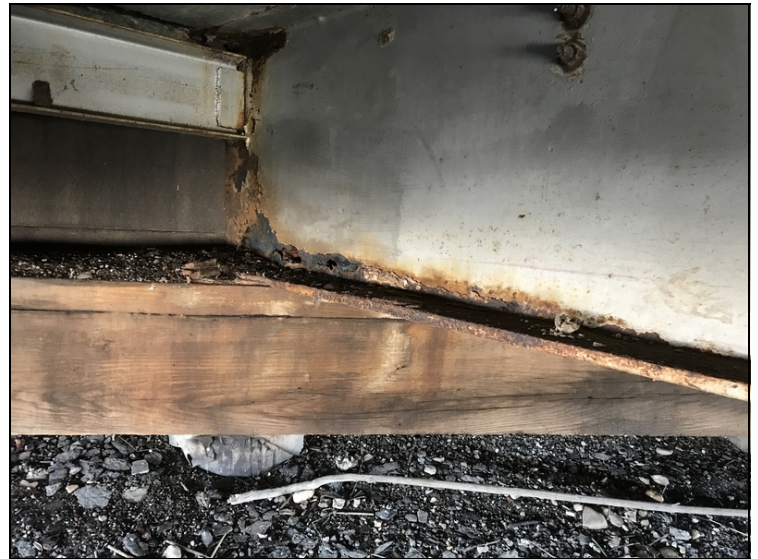
S7 b8 g5

Span 7 bent 8 girder 5 has a 15" x 2" hole in bottom of web 5" from end. Bottom flange is knife edged with some holes rusted through at edge.

This bridge scheduled for replacement with numerous others in this area in next year or so. Will keep monitoring as bridge repair schedule is overwhelmed. KAW 4/10/20  
Bridge is under contract 100955 to be replaced. RRJ

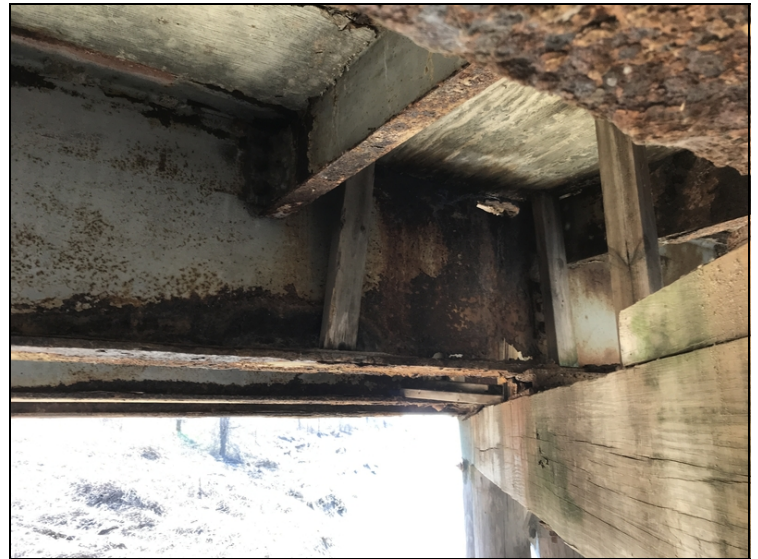
S3 b4 g3

Span 3 bent 4 girder 3 has a 19" x 3 1/2" hole in bottom of web 3" from end. Top of web has a 10" x 3" hole near diaphragm connection. Bottom flange is knife edged with holes rusted through. Girder is crushing over cap.

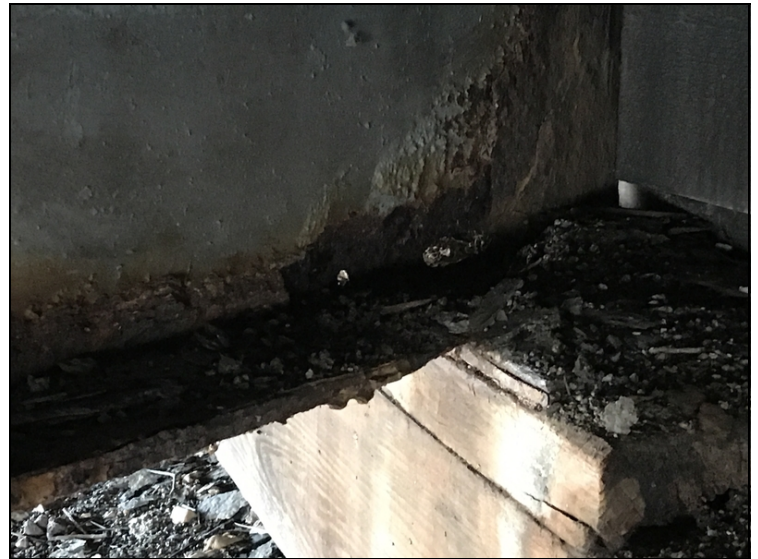
Span 7 girder 5 at bent 8

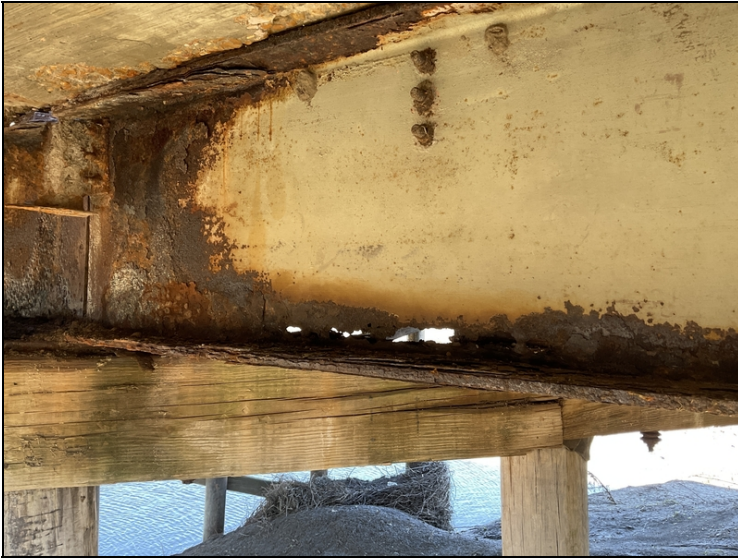
2022 - Span 3 bent 3 girder 2

Span 3 bent 3 girder 2 has 34" x up to 5" area of heavy section loss along bottom of web with several holes rusted through.

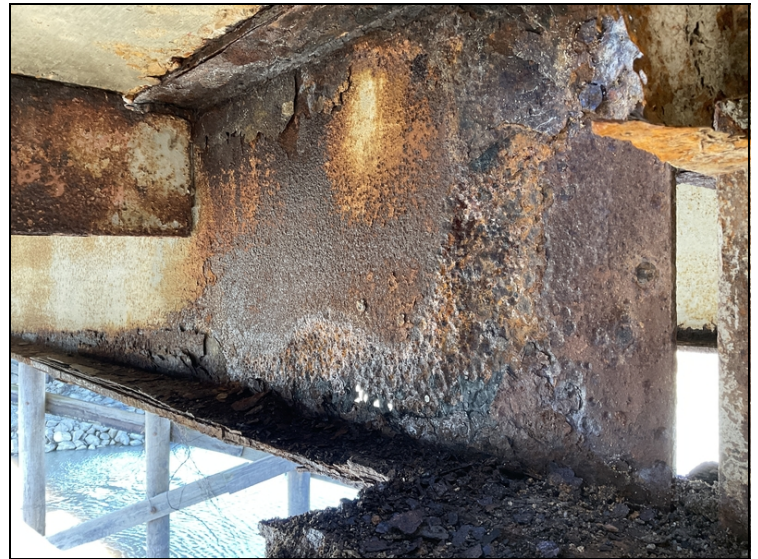
2022 - Span 2 bent 3 girder 8

Span 2 bent 3 girder 8 has an 8" x 1" hole in bottom of web 8" from end. Lt bottom flange is knife edged with holes rusted through.

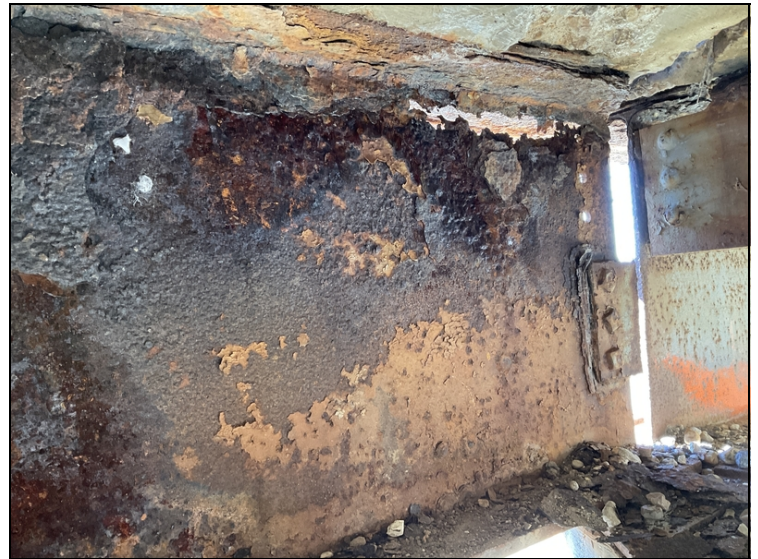
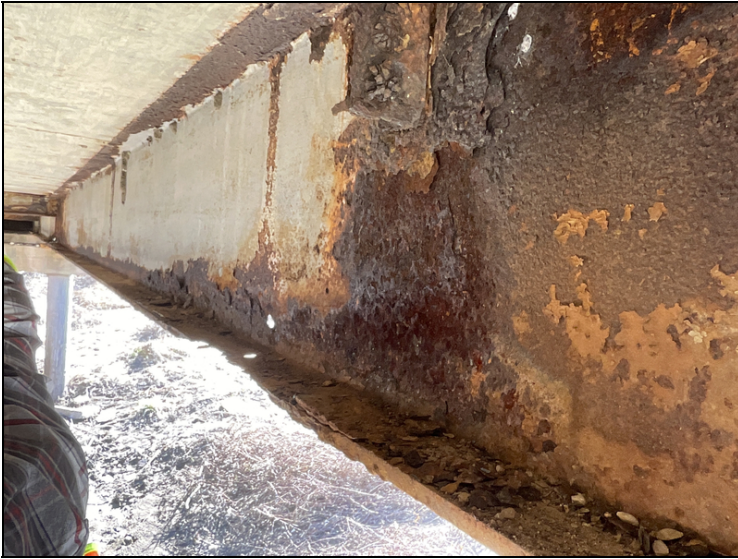
2022 - Span 3 bent 4 girder 1

Span 3 bent 4 girder 1 has a 16" x 2" hole in top of web 2" from end. Bottom of web and bottom flange has a 3' long area of heavy section loss with holes rusted through web and bottom flange starting 3' from end of girder.

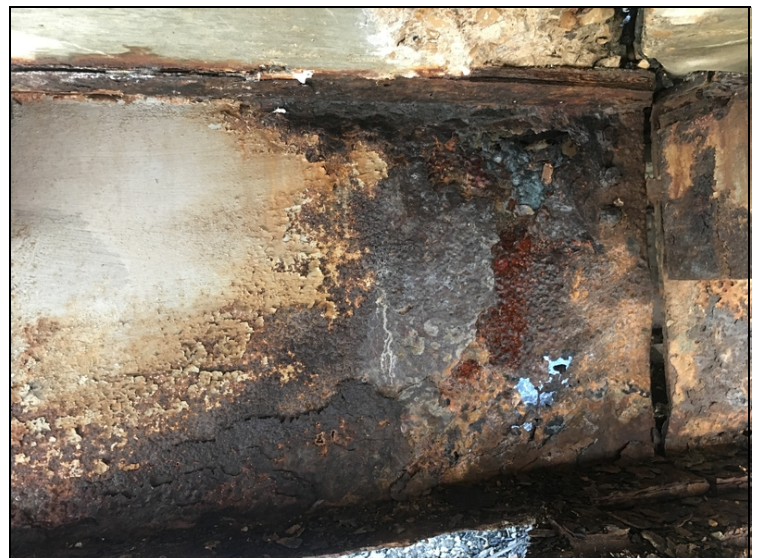
S1 g2

Span 1 bent 2 girder 2 has 3' of heavy section loss. Bottom of web has an 18" x up to 3" area of advanced section loss with holes rusted through and beginning to crush. Lt bottom flange has an 8" x 1.5" hole near cap.

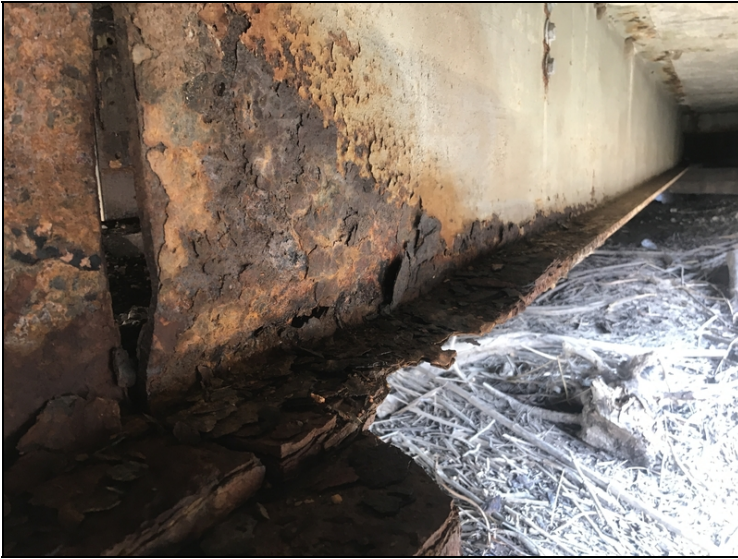
S2 b2 g2

Span 2 bent 2 girder 2 has a 21" x 5" area of holes, cracked, and crushing at end.

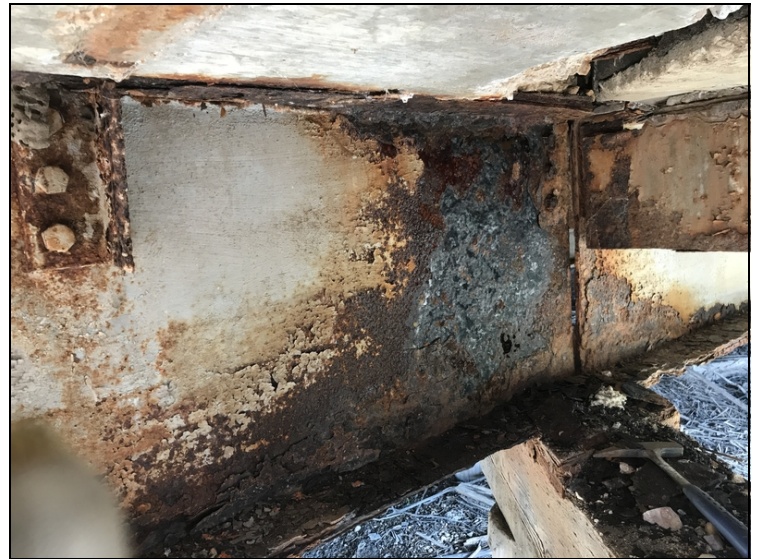
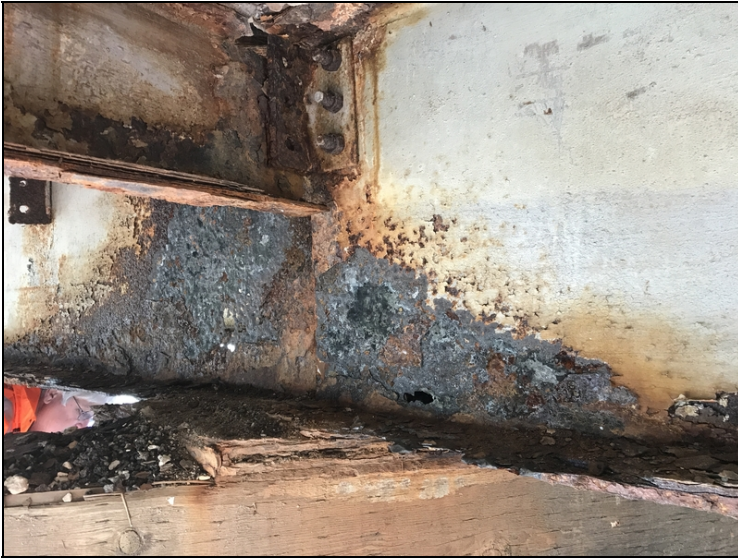
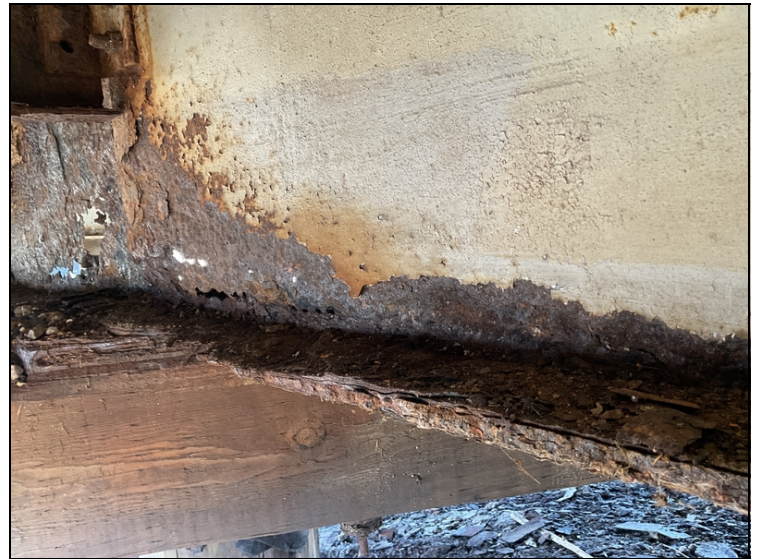
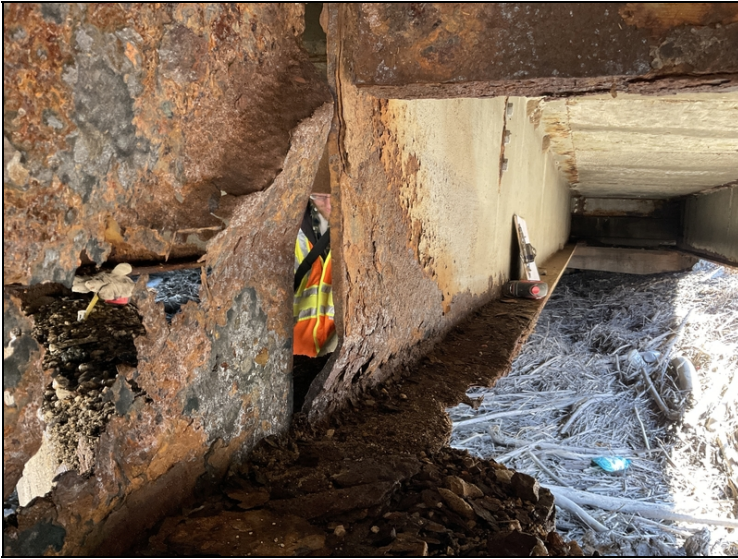
S1 b2 g2

Span 1 bent 2 girder 2 has 3' of heavy section loss. Bottom of web has an 18" x up to 3" area of advanced section loss with holes rusted through and beginning to crush. Lt bottom flange has an 8" x 1.5" hole near cap.  
Span 2 bent 2 girder 2 has a 21" x 5" area of holes, cracked, and crushing at end.

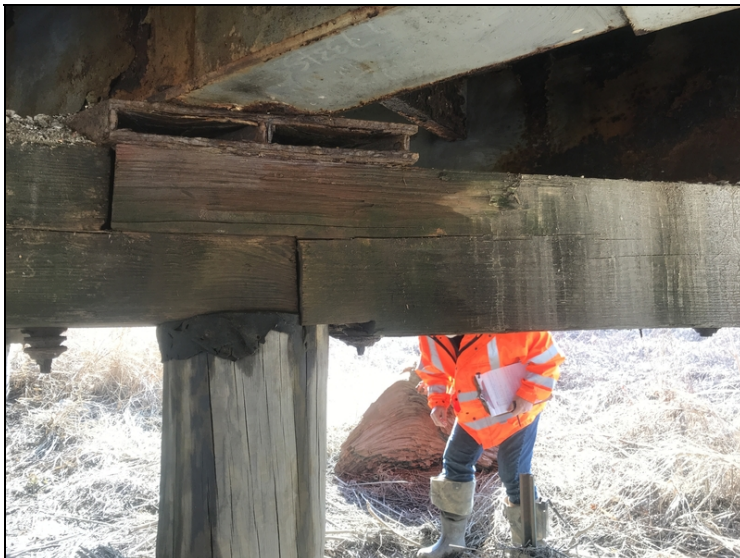
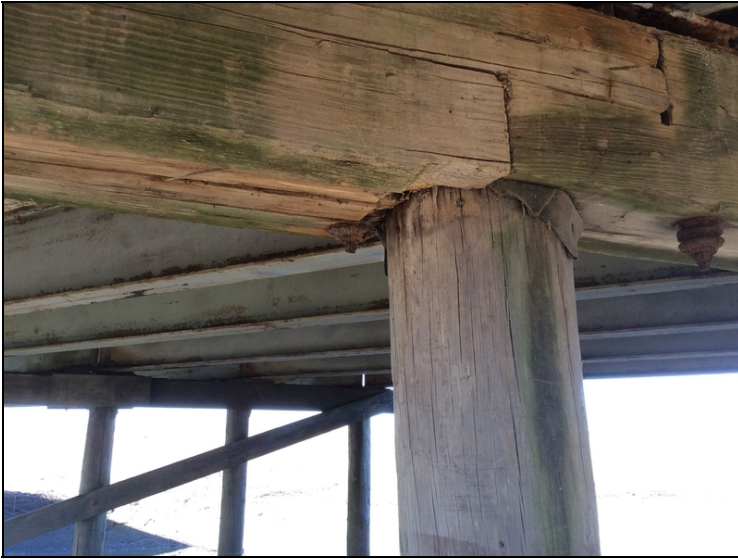
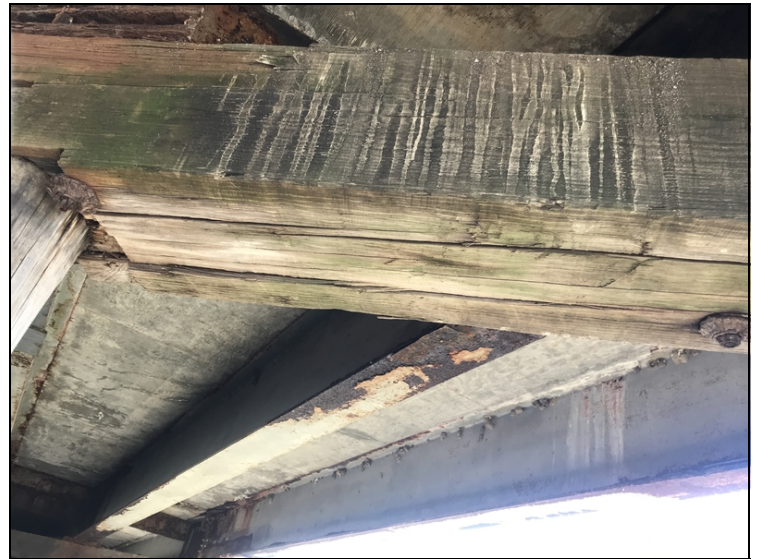
Left b3

Bent 2 cap is spliced over pile 6. Cap is decayed and hollow for 1' on each side of splice.  
Bent 3 cap is spliced over pile 3. Cap is decayed and hollow with some crushing for 6' on Lt side of splice.  
Bent 5 cap is spliced over pile 3. Cap has some crushing over piles 1, 2, and 3.  
Bent 6 is spliced over pile 2. Cap has some crushing over piles 1 and 2. Cap to the Rt of pile 2 has checks, 4" deep top decay, and areas of core decay. Cap is spliced over pile 6. Rt end has decay with 25% section loss for 3'.  
Bent 8 cap is spliced over pile 6. Cap is decayed and hollow with some section loss and minor crushing.

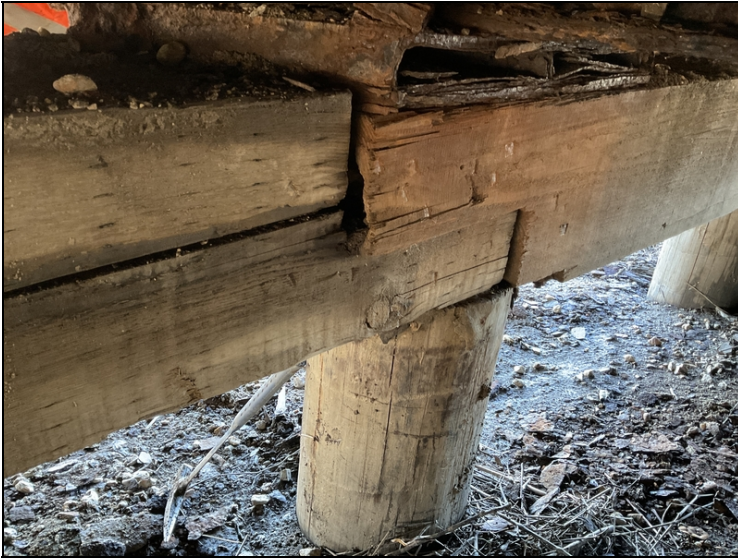
2022 - Bent 2 over pile 6

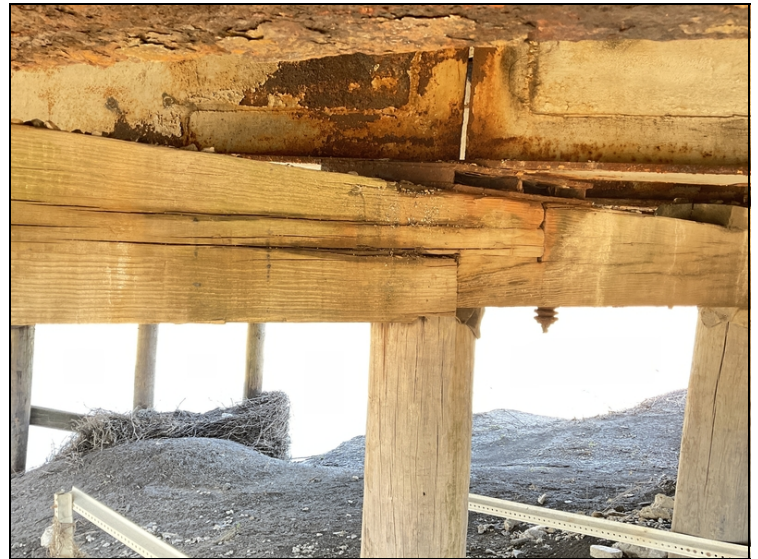
2022 - Bent 3 cap over pile 3

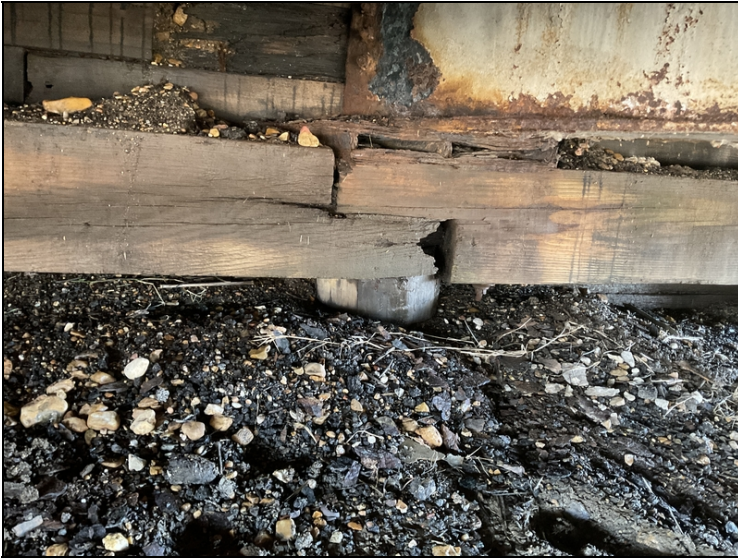
2022 - Bent 8 cap over pile 6
