**Bridge #M1653(Routine)**  
**SH 91-01- LM 3.55 over LINDSEYS CREEK**

**Location: 3.55 MI S JCT US412/91**

**Team Lead: Tim Myrick Inspection Date: November 03, 2021**

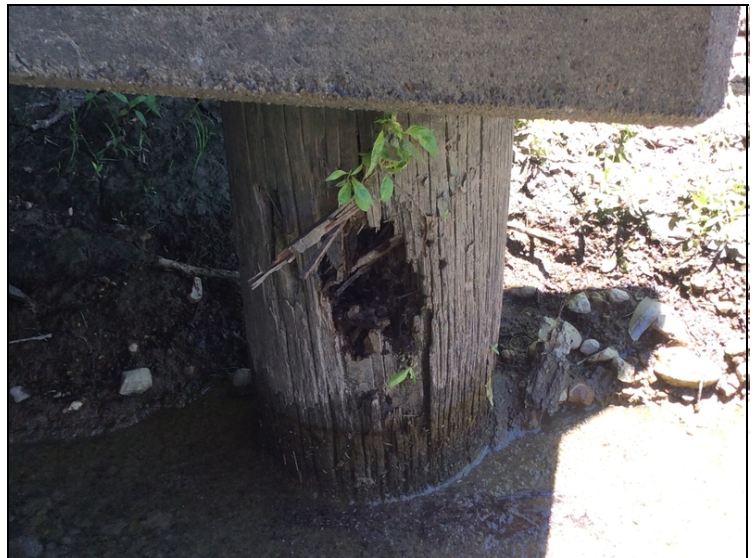
Majority of Piles have some decay with checks and shakes. Some Piles have 1 to 2in. outside decay with some section loss.

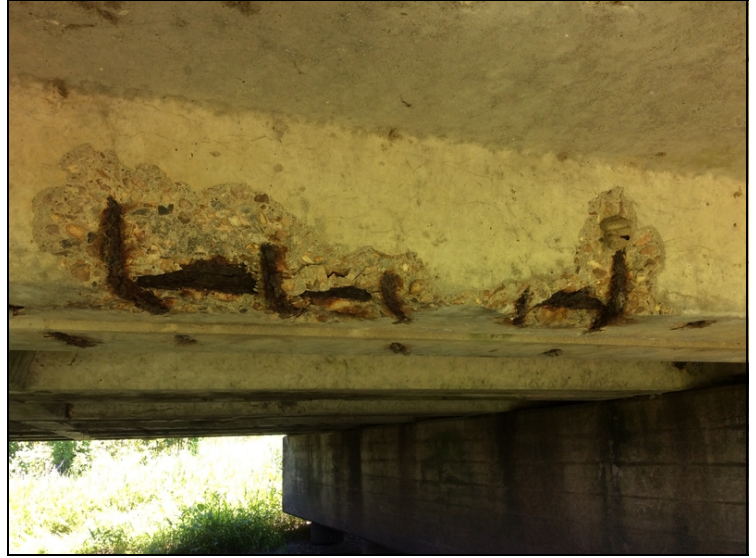
Girder portion of Deck Units have a few small shelled out areas with exposed rebar due to inadequate coverage from steel replacement.
