Asset #03180(Routine)

SH 181-00- LM 2.19 over I 55-SEC 12

Location: 2 MI E OF BASSETT

Team Lead: Richard Jones, Inspection Date: 08/18/2022

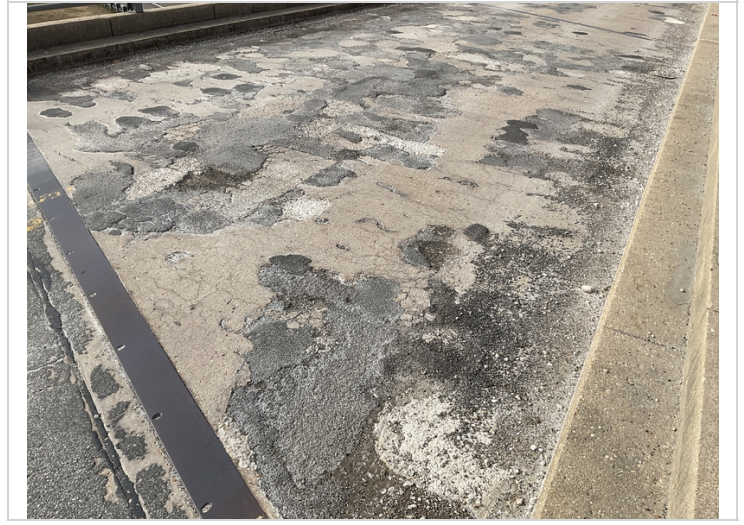
1/28/22 - Span 1

Majority of deck has been noted in the past as being spalled, delaminated, or patched. Patches were noted to be in mostly poor condition.

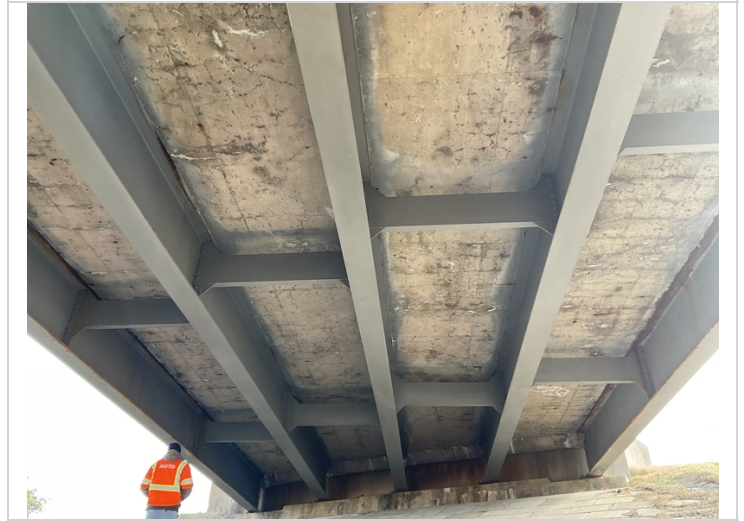
1/28/22 - Span 1

Soffit has several areas of map cracking. Some areas have efflorescence or rust stains.

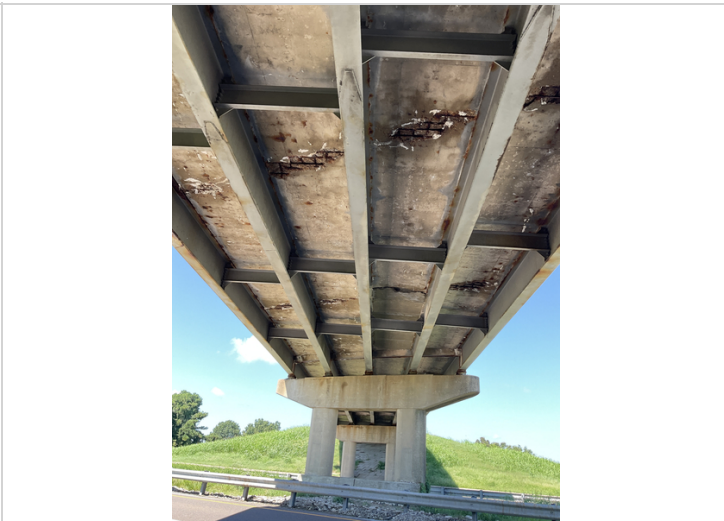
8/18/22 - Span 2

Soffit at spans 2 and 3 have 2 spalls with rebar exposed that run from exterior girder to exterior girder along the skew.

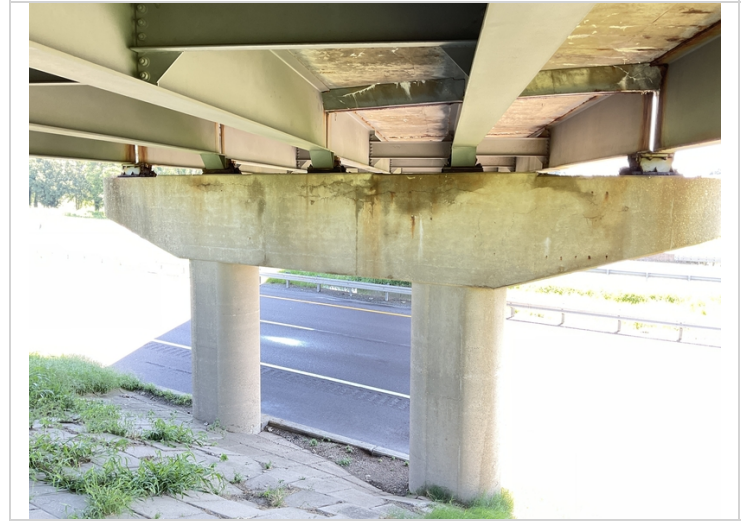
Bent 4

Span 3 bent 4 bearing 4 sole plate "ears" are bowed from pack rust at cap screw connection.

Span 3 bent 4 bearing 5 is missing a cap screw on Lt side.

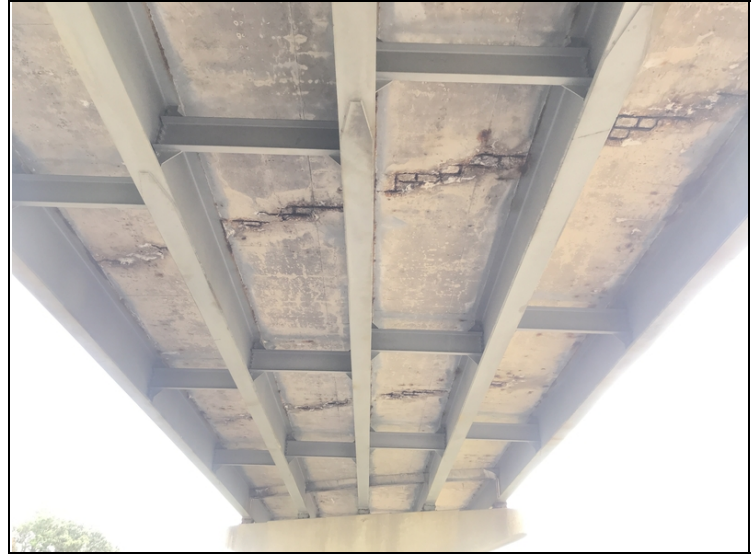
2021 - Span 3

Soffit has several areas of map cracking. Some areas have efflorescence or rust stains.
Soffit at spans 2 and 3 have 2 spalls with rebar exposed that run from exterior girder to exterior girder along the skew.
Spans 2 and 3 have considerable leakage with some efflorescent staining on under structure routes. North bound and South bound exterior lanes each have stains.

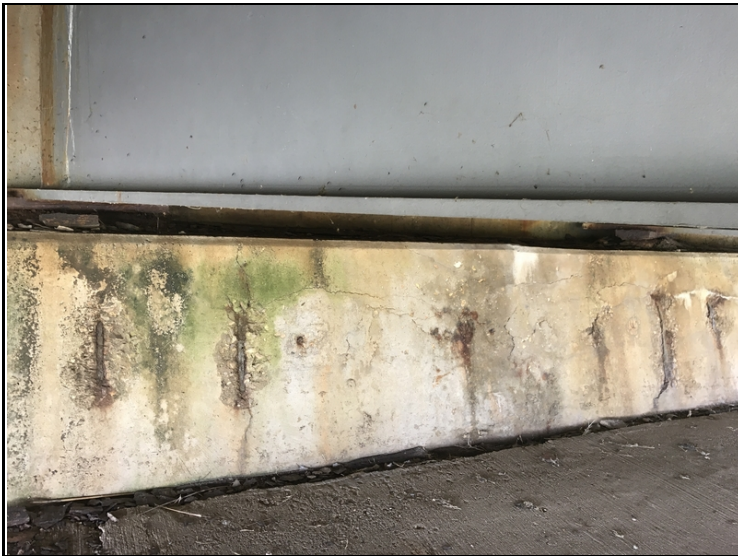
Bent 1 abutment has horizontal cracks with some efflorescence and rust stains along front face of cap. Front face has spalls with rebar exposed from lack of coverage.

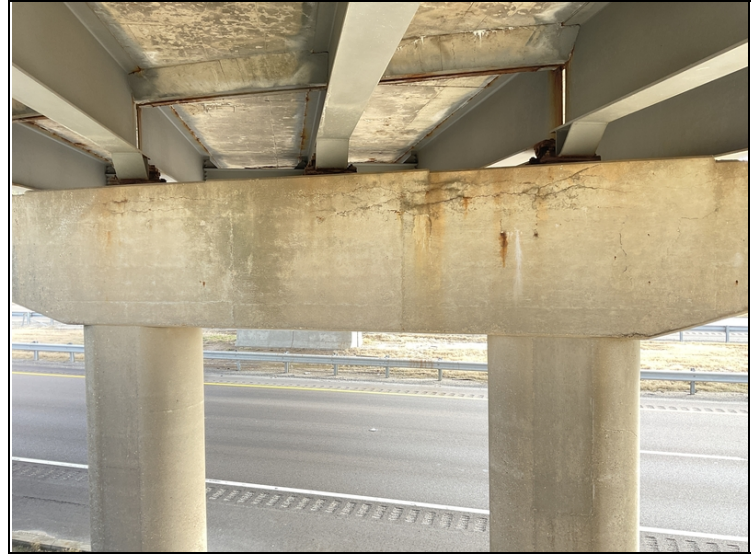
Bent 4

Interior bent caps have horizontal cracks with some rust stains and delaminated areas.
