Asset #00582(Routine)

SH 14-13- LM 13.53 over LANGUILLE RELIEF

Location: 4.2 MI W JCT SH 1

Team Lead: James Adams, Inspection Date: 01/16/2020

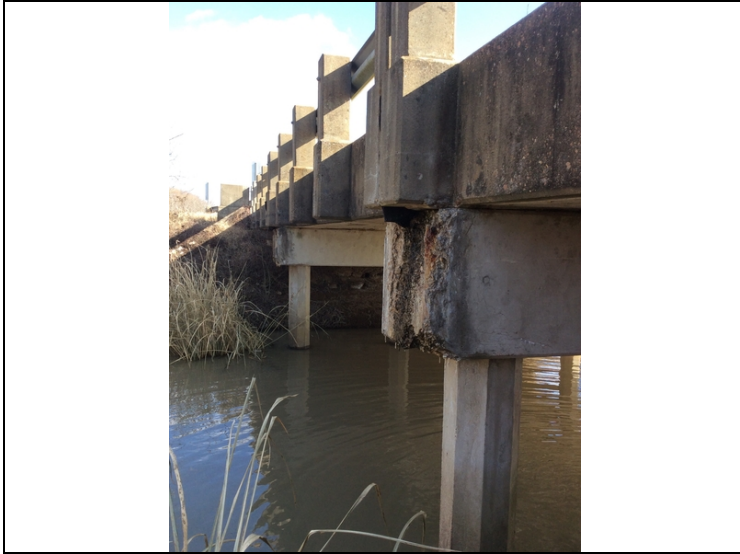
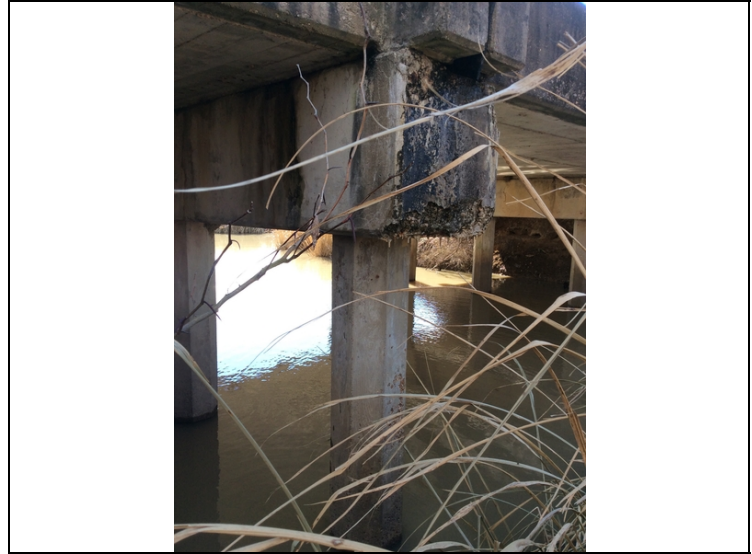
Bent 2 left side

Bents 2 and 3 caps have some deterioration on left end, and a few minor spalls with exposed rebar.  
Bent 2 cap span 2 side has 6 ft. of cracking & delamination on face of cap.  
Bent 3 cap span 3 side has 12 ft. of horizontal cracking 8 in. from top of cap. Cap has a 3 ft. area of cracking & delamination.  
Bent 3 pile 1 has 3 ft. cracked at the top of pile.  
Bent 3 pile 2 has a small spall with exposed rebar at top of pile.  
Bent 3 pile 5 has vertical cracks in top 3 ft. of pile.
