Asset #03084(Routine, Underwater type 2)
US 49-02- LM 8.71 over HURRICANE CREEK

Location: 8.09 N JCT US 412

Team Lead: Tim Myrick, Inspection Date: 11/03/2022

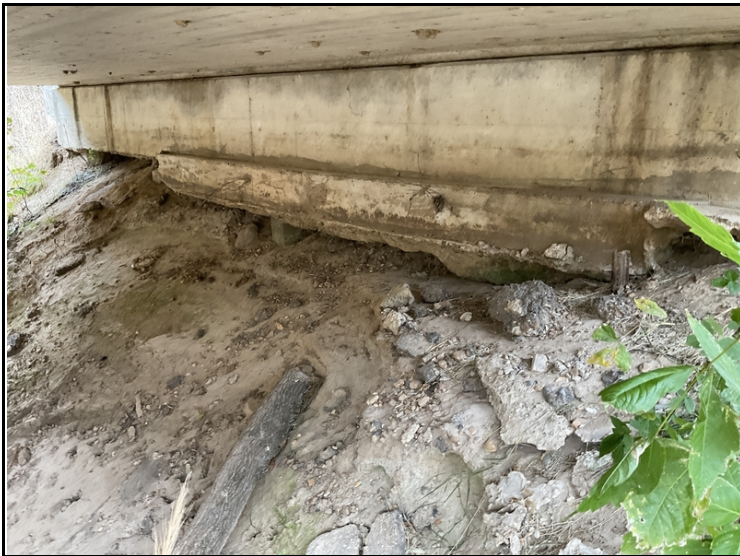
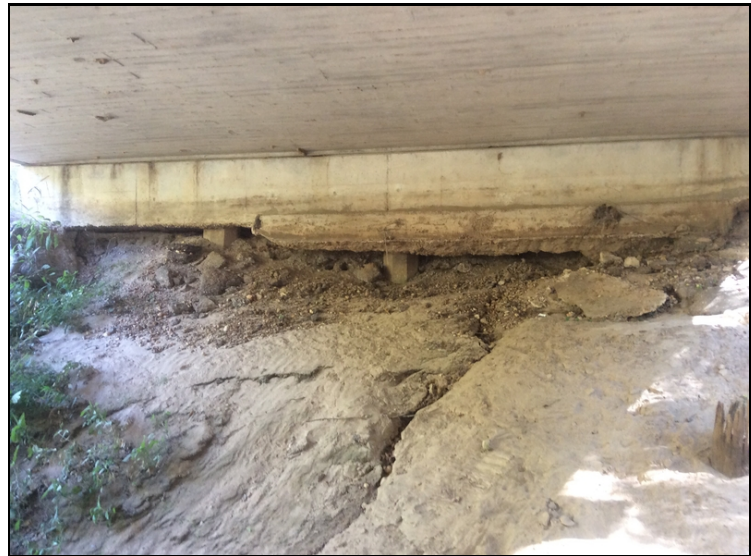
Bent 1 abutment is undermined up to 1.5' below and 2' back under. Bent 4 is undermined for 8' on each end up to 2' below and 3' back under abutment. Some repairs have been made in the past near centerline.

Bent 4 erosion

Date Reported: 01/03/2011
Priority: C - Important
Type of Work: Repair (General)
Status: Monitor
Component: Substructure
