Asset #03825(Routine)

SH 181-02- LM 3.76 over DRAINAGE DITCH NUMBER 31

Location: 3.76 MI N SH 140

Team Lead: Richard Jones, Inspection Date: 05/24/2022

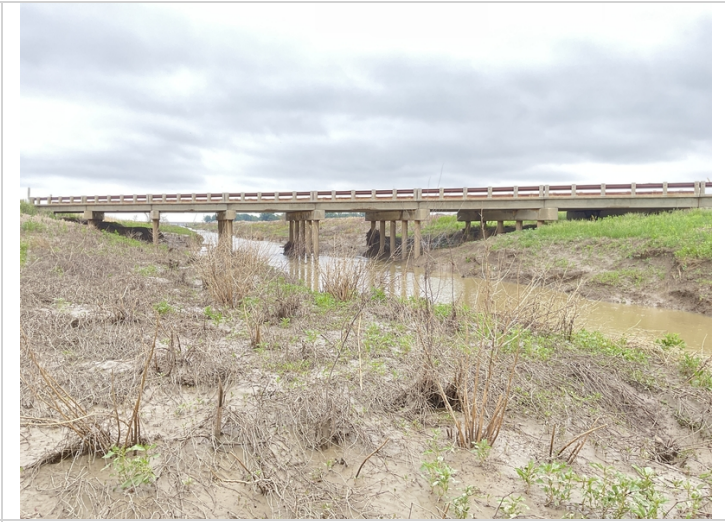
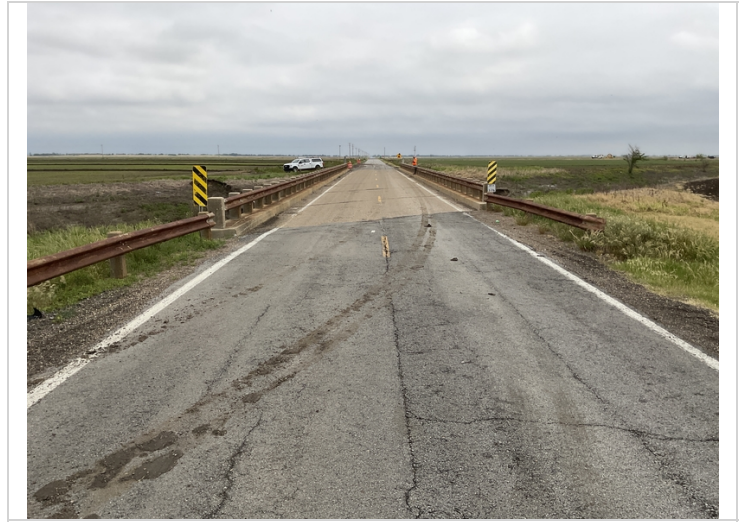
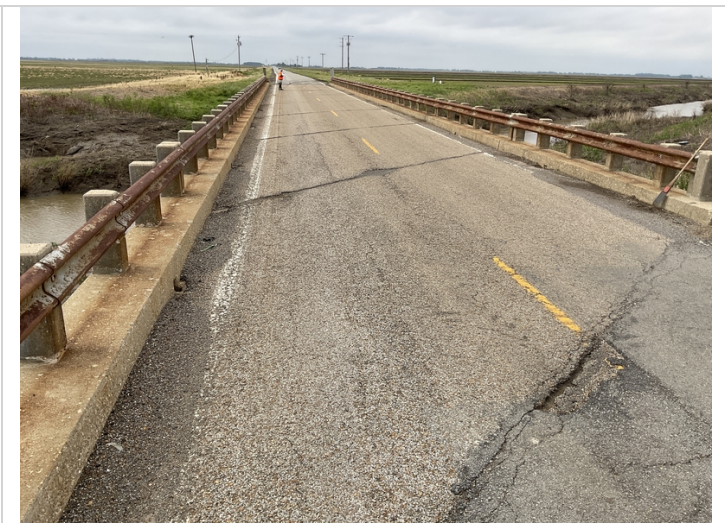
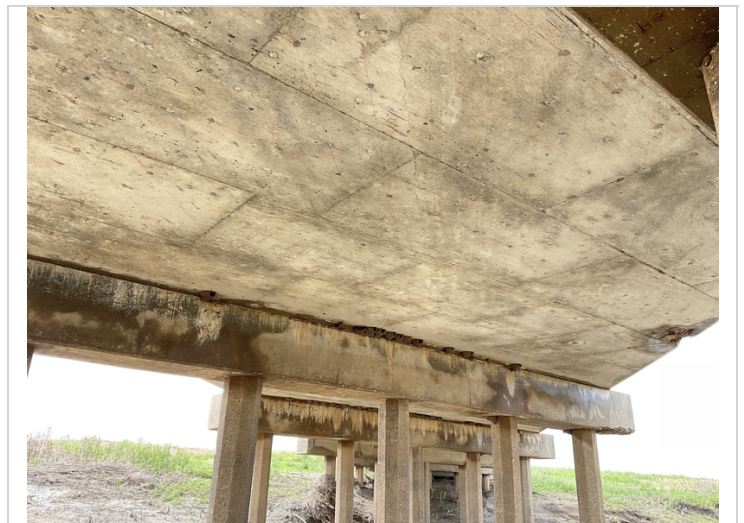
Wearing surface

Asphalt wearing surface has a few longitudinal cracks. Asphalt is cracked and delaminated over joints.
