Asset #M2232(Routine)

SH 181-02- LM 0.49 over DITCH 44

Location: 0.5 MI N JCT SH 140

Team Lead: Richard Jones, Inspection Date: 10/19/2022

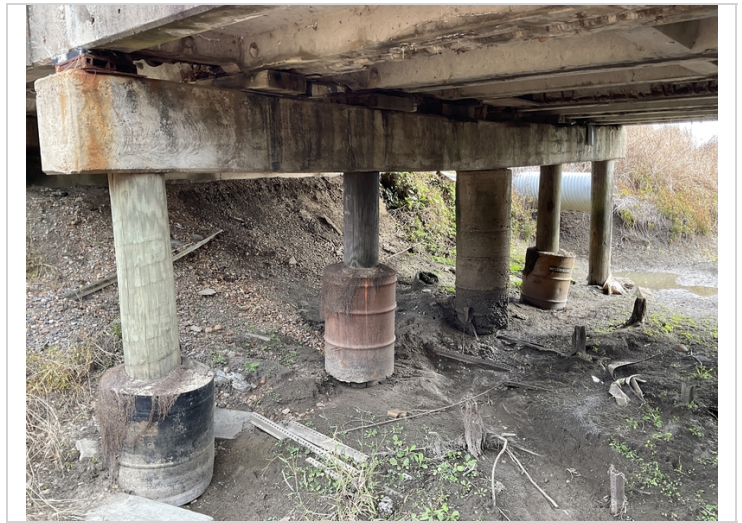
Bent 3 cap has a 2.5" bow and settlement cracks from piles 2 -4. Lt end of cap is approximately 6.25" lower than Rt end.

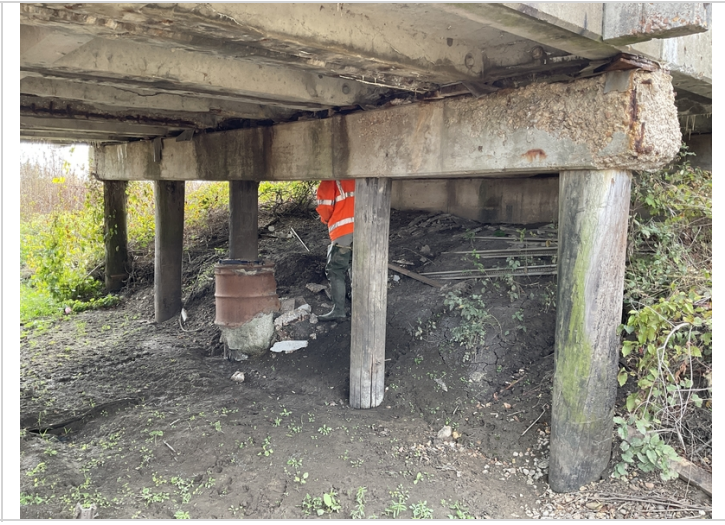
Bent 2 cap has 5' of concrete disintegration on Lt end. Top of cap is spalled up to 3.5" deep with exposed rebar and some loss of bearing area under unit 1.

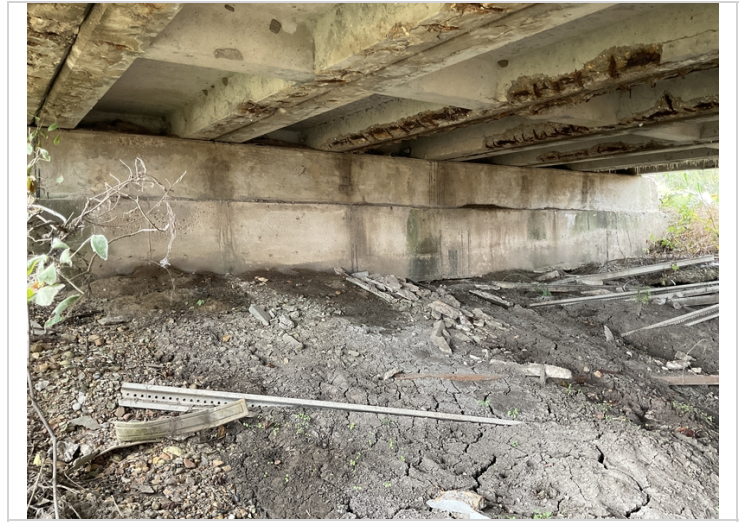
Bent 1

Bents 1 and 4 have concrete scour repairs below caps. Piles not visible for inspection.

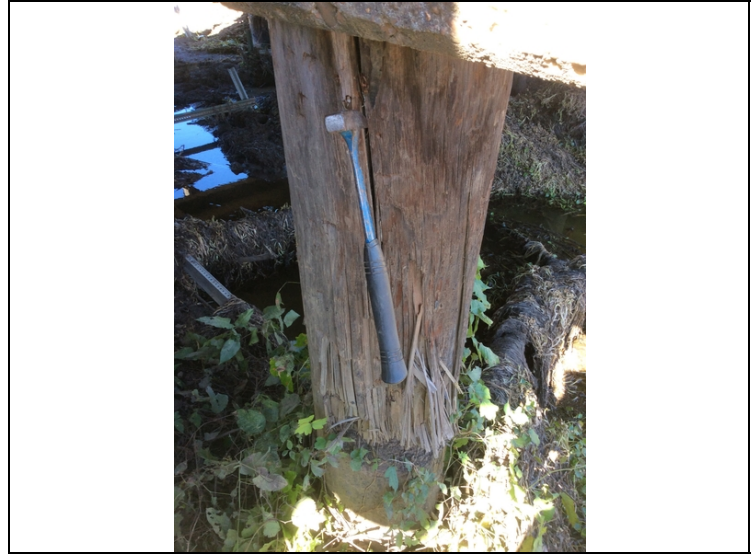
Bent 2 pile 5 has a 4" deep damaged area on Rt side. Possibly hit by bush hog.

Bent 2 pile 5.

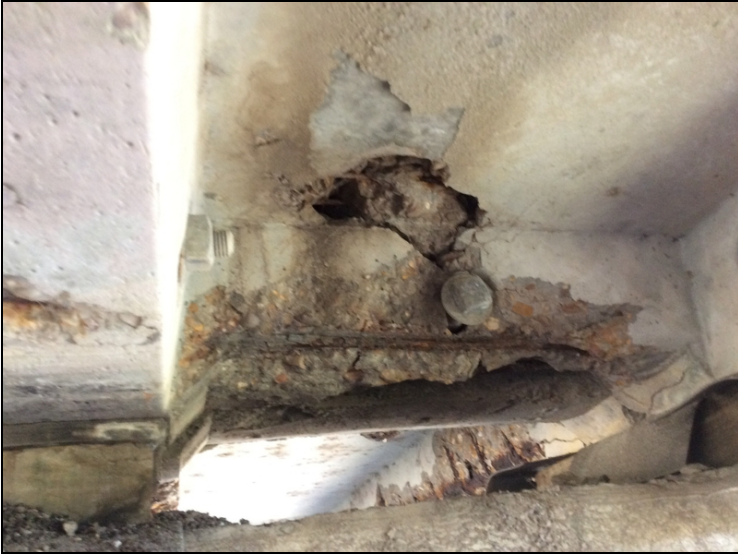
2021 - Span 2 bent 3 unit 4

\*\*Span 3 bent 3 unit 4 has a full depth patch. Patch was poured even with bottom of girders. Forms are still in place. - RRJ 10/27/21

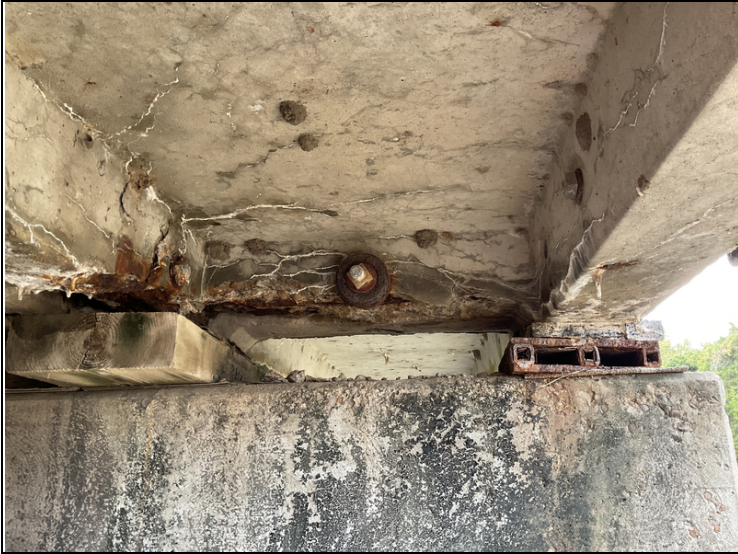
2021 - Span 3 bent 3 unit 1

Span 3 unit 1 has 5' of rebar exposed. Rt leg at bent 3 end has a possible shear crack at transverse bolt connection. Crack has efflorescent buildup, and runs into soffit portion of unit.
