Arnold Road ID:61x34x2xA, Arnold Log mile:1.933

District 10, 121 - Randolph County

Asset #06531(Routine, Underwater type 2)
SH 34-02- LM 1.94 over BEAVER DAM DITCH
Location: S W LIMITS OF O'KEAN ARK
Team Lead: Richard Jones Inspection Date: 04/13/2023

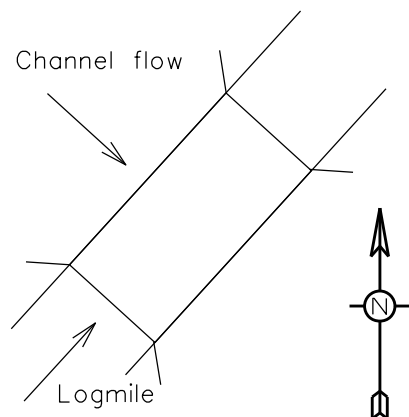
Bridge No. 06531	Dist. 10	Co. Randolph - 61
Logmile 1.94	Rt. 00034	Sect/Zone - 02
Date Drawn 4/1/19	Insp. / Assist. RRJ / BDS

Sub is in overall good condition, but pile encasements are undermined, partially exposing piles 4 and 5 at bent 2.

(225) Bent 2 pile encasements are undermined at piles 4 and 5, partially exposing steel shells. Exposed portion has flaking rust.							
234	Reinforced Concrete Pier Cap	LF	67	61	4	2	0
1080	Delamination/Spall/Patched Area	LF	1	0	1	0	0
1120	Efflorescence/Rust Staining	LF	2	0	0	2	0
1130	Cracking (RC and Other)	LF	3	0	3	0	0

Green soundings taken on 4/1/2019

Orange soundings taken on 4/13/2023

Type of Work: Substructure Repair
