Asset #05266(Routine)

US 412-09- LM 0.83 over EIGHT MILE CREEK

Location: 1.8 Mi E Jct US 49

Team Lead: Richard Jones Inspection Date: 09/13/2023

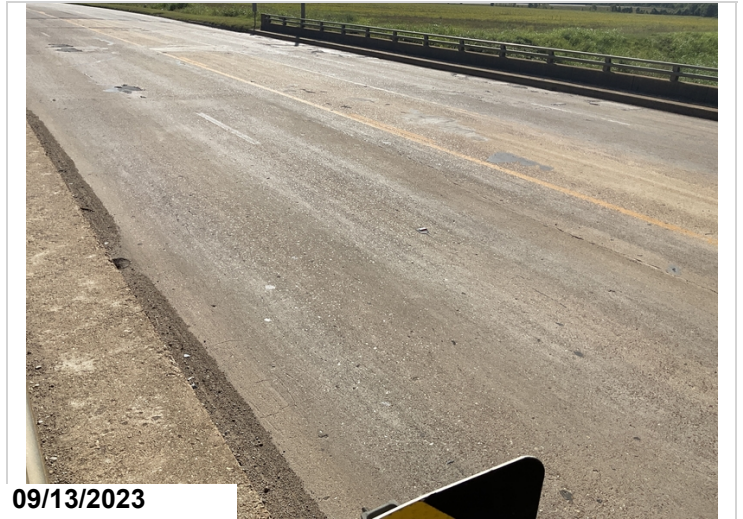
Top of slab

(38) Bridge slabs have areas of moderate size map cracking. Some were sealed in the past. Slabs have several patched areas. Patches are in fair to poor condition. Slabs have a few spalls or delaminated areas. Span 3 has some rebar exposed. Slab soffits have longitudinal cracks with some efflorescence or rust stains. Slabs have a few spalls or delaminated areas along cracks. Slabs have cracked or delaminated areas near drain openings.							
215	Reinforced Concrete Abutment	LF	163	160	2	1	0
1120	Efflorescence/Rust Staining	LF	1	0	0	1	0
1130	Cracking (RC and Other)	LF	2	0	2	0	0

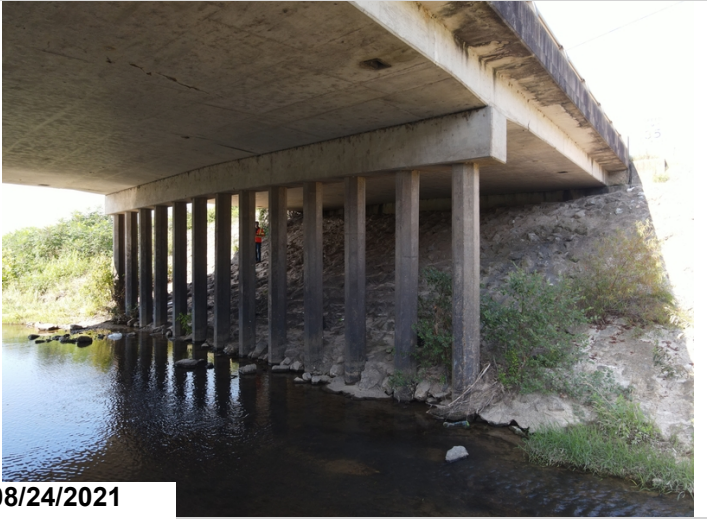
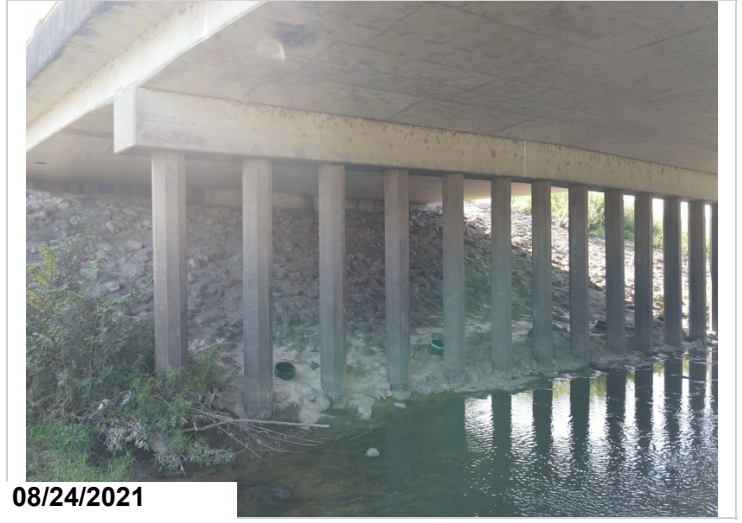
Span 1 cracks

Slab soffits have longitudinal cracks with some efflorescence or rust stains. Slabs have a few spalls or delaminated areas along cracks. Slabs have cracked or delaminated areas near drain openings.
