Asset #M3982(Other Special Recurring)

SH 358-01- LM 4.39 over VILLAGE CREEK

Team Lead: Richard Jones Inspection Date: 05/08/2024

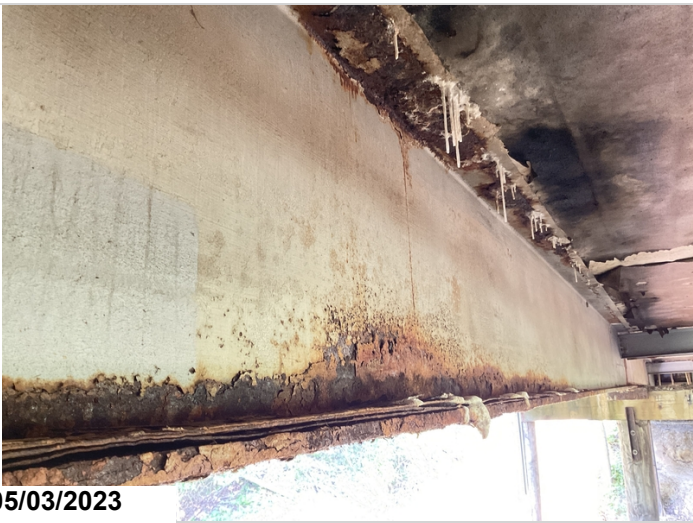
Span 1 girder 2 near 1/4 point

1000	Corrosion	LF	174	0	139	35	0
515	Steel Protective Coating	SF	4601	1654	1793	924	230
3440	Effectiveness (Steel Protective Coatings)	LF	2947	0	1793	924	230
<p>(107) Girders have scattered areas of surface rust. Most girder ends were t-spliced in 2019.  Exterior girders on span 2 have some section loss to the web and bottom flange under drains.</p> <p>Span 1 bent 1 girder 1 was t-spliced sometime in the past. Splice is painted but has some existing pitting/section loss.  Span 1 bent 1 girder 2 was t-spliced in 2019.  Span 1 bent 1 girder 8 was t-spliced in 2019.</p> <p>Span 1 bent 2 girder 1 was t-spliced sometime in the past  Span 1 bent 2 girder 2 was t-spliced sometime in the past  Span 1 bent 2 girder 3 has plates welded over holes in bottom of web.  Span 1 bent 2 girder 4 was t-spliced sometime in the past.  Span 1 bent 2 girder 7 was t-spliced sometime in the past.  Span 1 bent 2 girder 8 was t-spliced sometime in the past.</p> <p>Span 2 bent 2 girder 1 was cleaned and painted in 2019.  Span 2 bent 2 girder 2 was cleaned and painted in 2019.  Span 2 bent 2 girder 3 was repaired with a bolted plate at bottom of web.  Span 2 bent 2 girder 4 was t-spliced sometime in the past  Span 2 bent 2 girder 5 has 30" x 3.75" plates welded over holes in bottom of web 4.5" from end of girder.  Span 2 bent 2 girder 7 was t-spliced sometime in the past.  Span 2 bent 2 girder 8 was t-spliced sometime in the past.</p> <p>Span 2 bent 3 girder 1 was repaired with a 3' bolted plate on bottom of web.  Span 2 bent 3 girder 2 was t-spliced sometime in the past  Span 2 bent 3 girders 4 and 5 was t-spliced sometime in the past.  Span 2 bent 3 girder 6 was t-spliced sometime in the past.  Span 2 bent 3 girder 7 was cleaned and painted in 2019.</p>

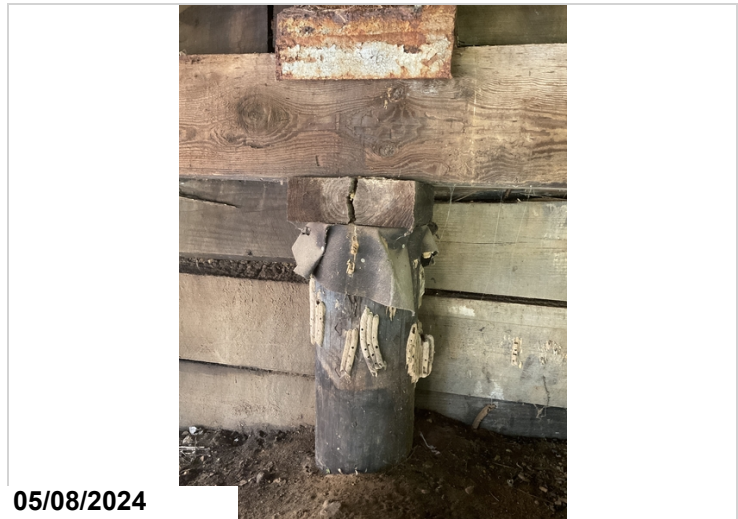
Bent 1 pile 6

(228) Piles have checks and some outside decay near ground level. Bent 1 pile spacer blocks have splits and some crushing. Bent 2 pile 1 was spliced in 2019. Concrete collar is cracked/broken on back side. Bent 2 piles 2 and 3 have a concrete mass pressed against them on back side. Piles have delaminated areas on ahead side and are bowed. Pile 3 is possibly broken. Bent 2 pile 8 is decayed and hollow at ground line. Pile appears to be swelling or broken on ahead side.							
235	Timber Pier Cap	LF	123	61	46	4	12
1140	Decay/Section Loss	LF	32	0	16	4	12
1150	Check/Shake	LF	30	0	30	0	0
