Arnold Road ID:61x328x1xA, Arnold Log mile:8.808

District 10, 121 - Randolph County

Asset #05734(Routine, Underwater type 2)
SH 328-01-LM 8.83 over CURRENT RIVER RELIEF
Location: 8.83 MI E MAYNARD
Team Lead: James Adams Inspection Date: 02/15/2023

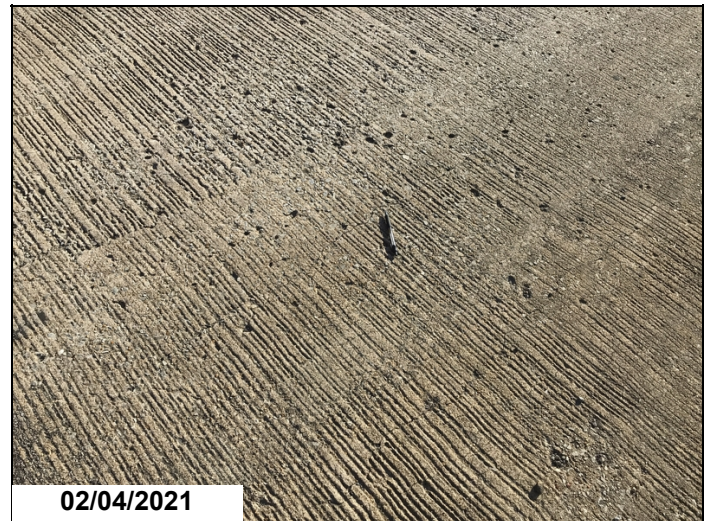
Top of slabs have several areas of abrasion and a few small pop outs. Slabs have areas of map cracking, especially in wheel paths. Slabs have a few unsealed moderate width cracks.

Polymer deck observed repair by statewide crews 2-28-2023

Map cracks in wheel path
