Asset #05735(Routine)

SH 328-01- LM 9.07 over CURRENT RIVER

Location: 9.07 MI E MAYNARD

Team Lead: Brandon Sutton Inspection Date: 05/08/2023

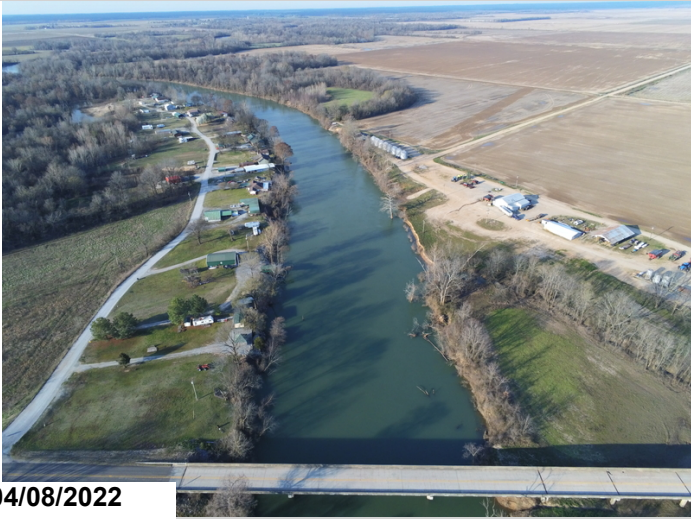
VIEW OF DOWNSTREAM CHANNEL, FROM ABOVE BRIDGE

Overall, the channel is in good condition. The upstream channel is well aligned with the substructure units. There is minor timber debris on the upstream nose of Bent 8, however it is not adversely affecting flow through the channel. The banks upstream and downstream of the bridge are stable and well vegetated. The east bank under the bridge is stable and protected with rip rap. The west bank under the bridge is partially vegetated with an areas of runoff erosion.

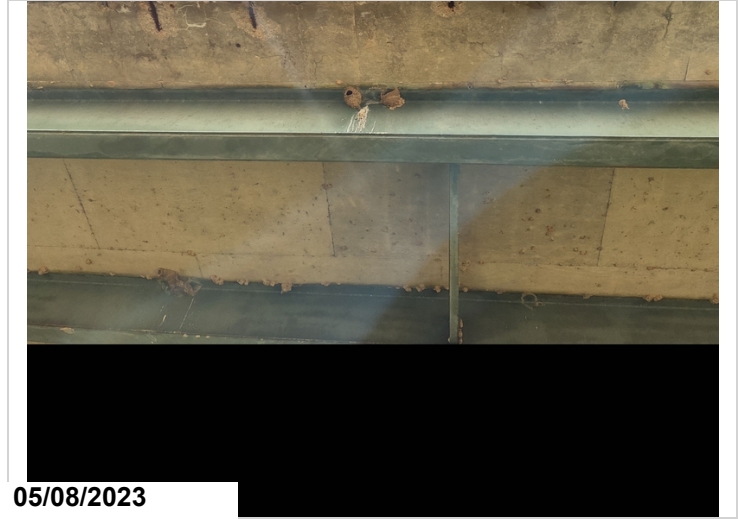
Span 5 It overhang

(1090-12) Lt over hang							
107	Steel Open Girder/Beam	LF	2888	2520	364	4	0
1000	Corrosion	LF	345	0	345	0	0
1020	Connection	LF	23	0	19	4	0
515	Steel Protective Coating	SF	29308	26938	0	1152	1218
3440	Effectiveness (Steel Protective Coatings)	LF	2370	0	0	1152	1218
