Route:328 Section:01 Log:9.3

Arnold Road ID:61x328x1xA, Arnold Log mile:9.272

Asset #05736(Routine, Underwater type 2)
SH 328-01-LM 9.30 over CURRENT RIVER RELIEF
Location: 9.3 MI E MAYNARD
Team Lead: James Adams Inspection Date: 02/15/2023

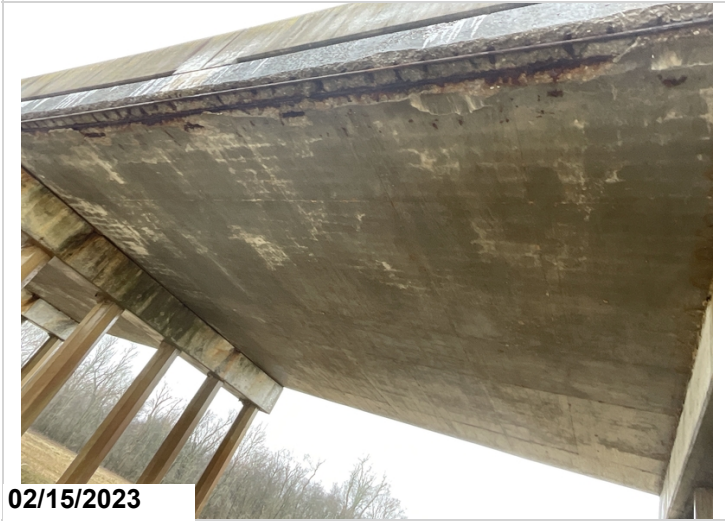
Soffit

Concrete soffit, left edge all spans have areas spalled with exposed rebar, rebar has section loss, some areas are up to 3.0 ft. wide.

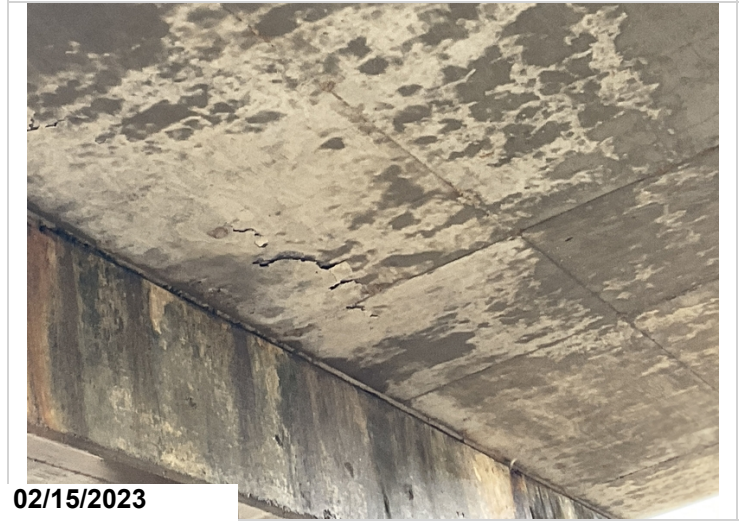
Span 6 centerline

Slab portion of Spans 2, 3, 4,5, 6, 7, 9,10 and 11 have areas along left edge where concrete has spalled completely away from 1 longitudinal bar.

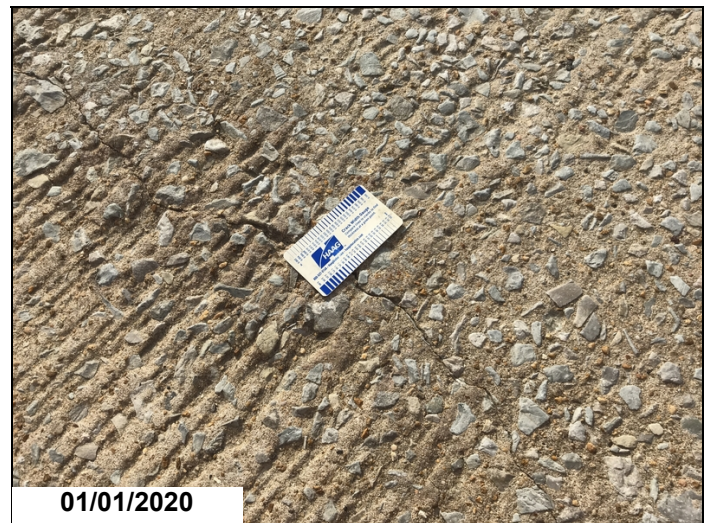
cracks, spalls, abrasion

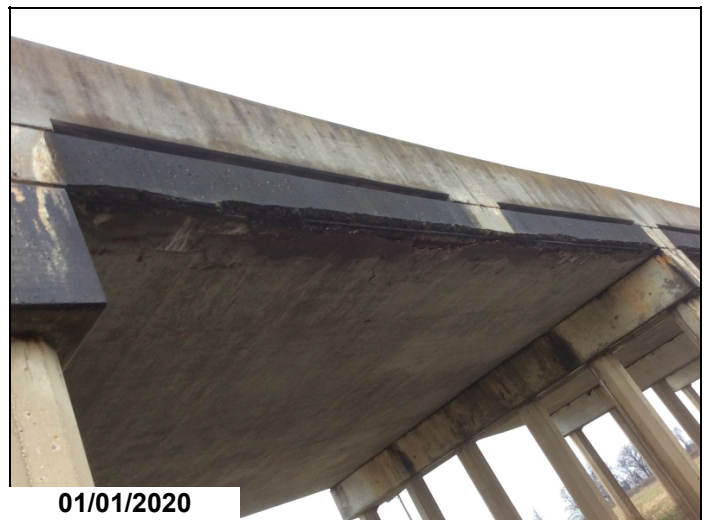
Span 1 left

Left edge of slabs are cracked, delaminated, and have spalls with exposed rebar.

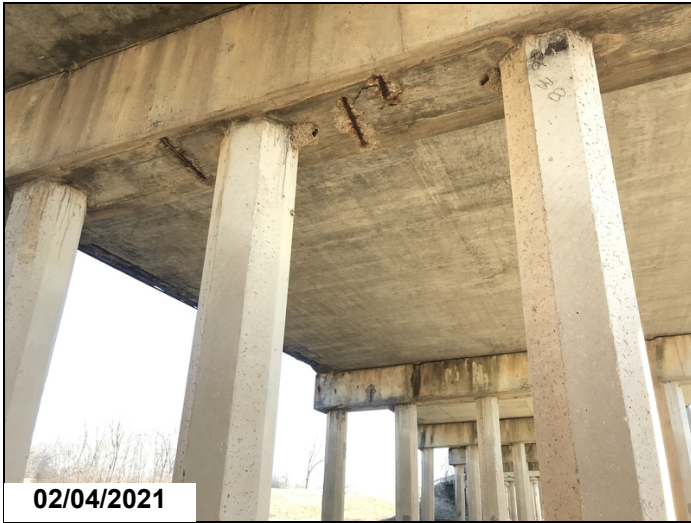
Caps have several minor cracks, spalls, and delaminated areas. Some spalls have exposed rebar. A few piles have minor honeycombed areas.

Bent 14 delam
