Bridge 02858 Inspection Report

Asset #02858(Routine)

US 62- 20- LM 8.72 over DITCH NO. 19

Team Lead: Cory Shaw Inspection Date: 11/15/2024

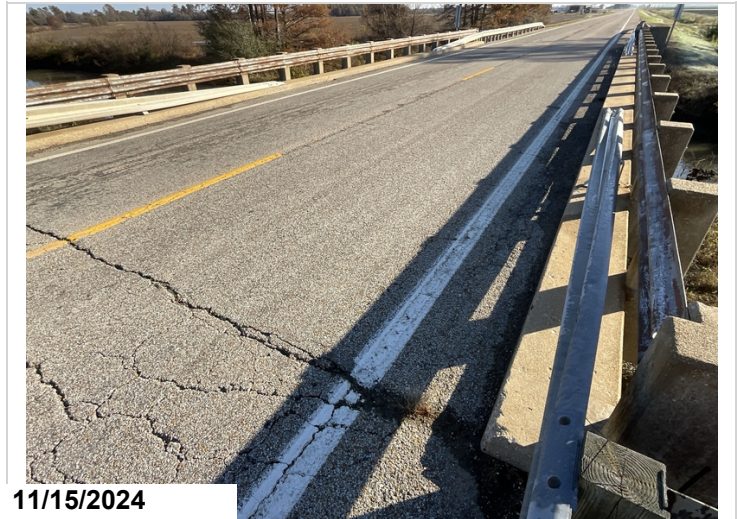
Deck

(38) Undersurface has longitudinal and transverse cracks with some efflorescence along construction joints. Efflorescence 6' CS2, Cracking 20' CS2 & 65' CS3							
Undersurface has delaminated areas or spalls with rebar exposed near drains.							
Span 2 undersurface at Bent 2 has a spall with rebar. Rebar 2' CS3							
(510-38) Asphalt has several cracks. 597' CS3							
215	Reinforced Concrete Abutment	LF	77	71	6	0	0
1130	Cracking (RC and Other)	LF	6	0	6	0	0
