Asset #05854(Routine)

Sh-1/Sec-6/L-1.24 over White River Relief

Location: 1.63 Mi E Of White River

Team Lead: Drew Melton, Inspection Date: 09/06/2022

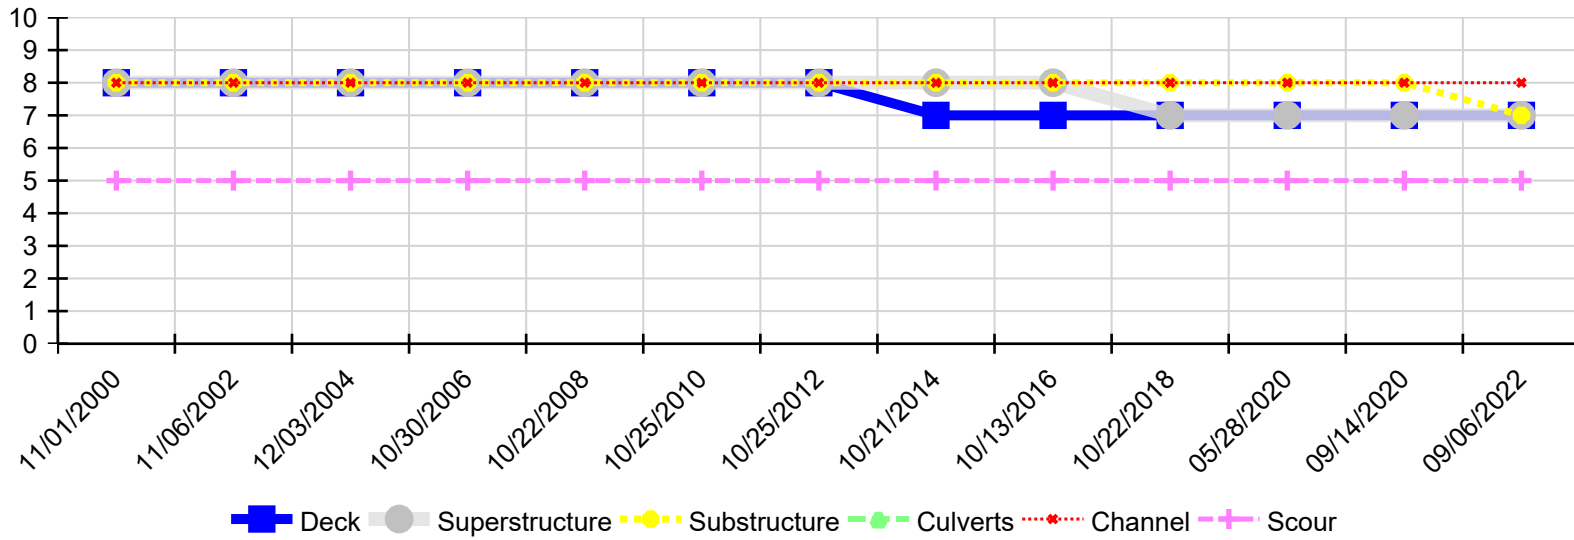
Condition History

Inspection Date	Deck	Superstructure	Substructure	Culverts	Channel	Scour
09/06/2022	7	7	7	N	8	5
09/14/2020	7	7	8	N	8	5
05/28/2020	7	7	8	N	8	5
10/22/2018	7	7	8	N	8	5
10/13/2016	7	8	8	N	8	5
10/21/2014	7	8	8	N	8	5
10/25/2012	8	8	8	N	8	5
10/25/2010	8	8	8	N	8	5
10/22/2008	8	8	8	N	8	5
10/30/2006	8	8	8	N	8	5
12/03/2004	8	8	8	N	8	5
11/06/2002	8	8	8	N	8	5
11/01/2000	8	8	8	N	8	5
