Asset #05135(Routine, Underwater type 2)

Sh-147/Sec1/L13.85 over Ditch Number 50

Location: 1.6 Miles South Jct Us 70

Team Lead: Drew Melton Inspection Date: 01/08/2024

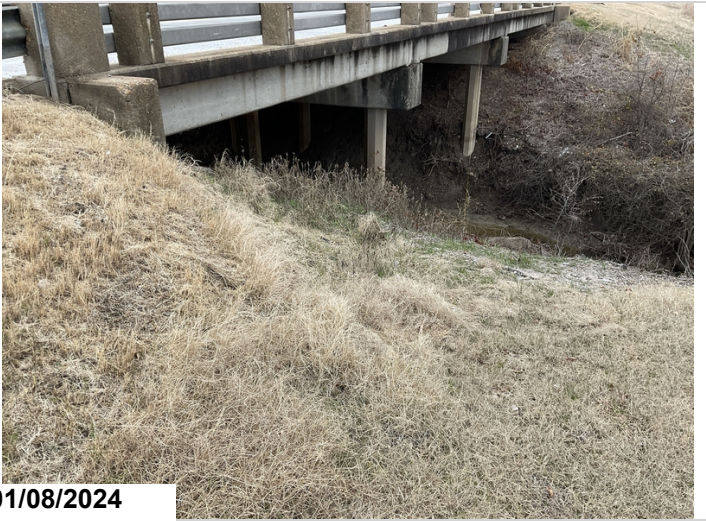
Side view-elevation

Superstructure is a slab so deck and superstructure is rated the same. Superstructure is in satisfactory condition with cracks in the sides of the slab.

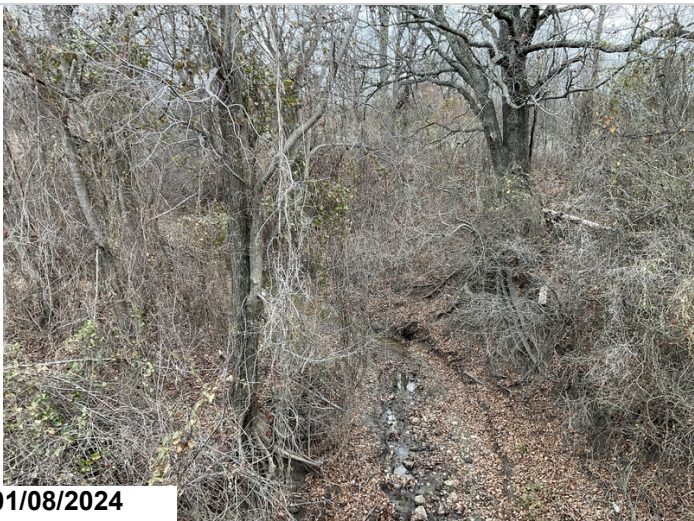
Channel left side

61 - Channel/Channel Protection (5 - Bank protection is being eroded. River control devices and/or embankment have major damage. Trees and brush restrict the channel.)

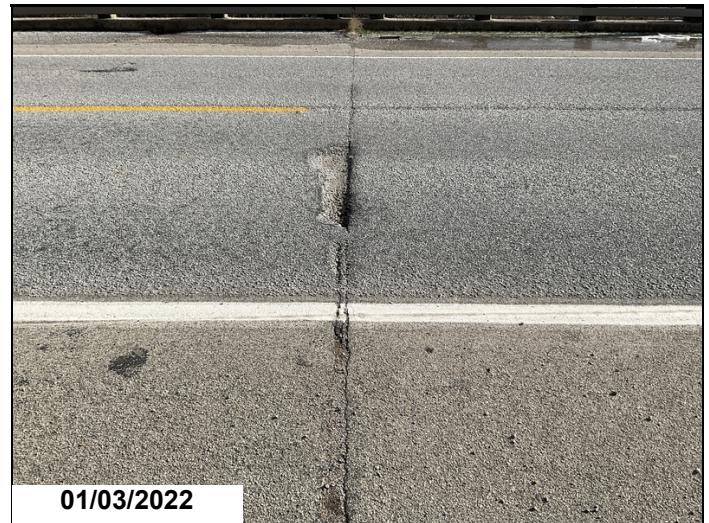
Bent #2 joint

Joint material has failed allowing non-compressibles to enter.

Joints have been replaced since last inspection.
