Asset #07173(Routine, Underwater type 2)

Sh147/Sec-1/L11.84 over 10 Mile Bayou Cutoff Di

Location: 11.84 Miles Ne Jct Sh 131

Team Lead: Drew Melton Inspection Date: 06/15/2023

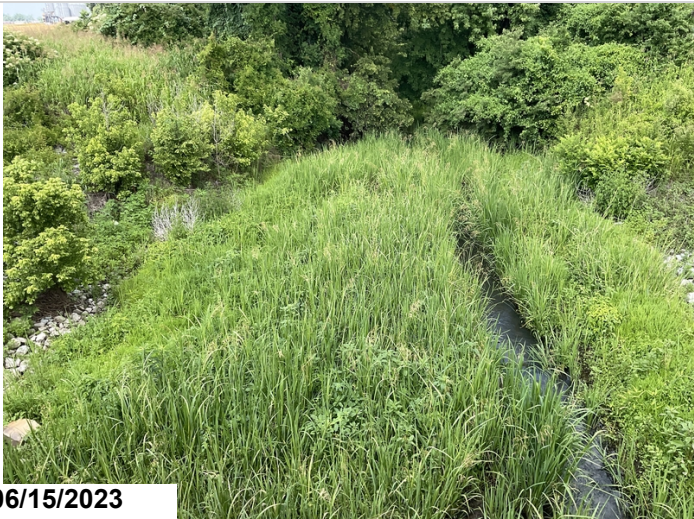
Channel left side

61 - Channel/Channel Protection (5 - Bank protection is being eroded. River control devices and/or embankment have major damage. Trees and brush restrict the channel.)

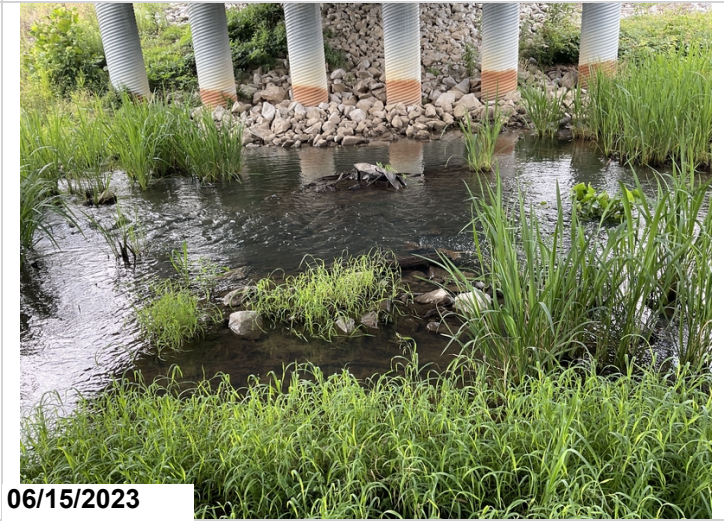
Channel under bridge

06/15/2023 Under water type 2 inspection was performed. No substructure was in water at time of inspection. This was a visual around substructure at low water conditions. Little to no scour at this time. Channel profile was made on both sides of bridge measurements taken and recorded into MicroStation drawing at each bent and center point of span from top of rail down.

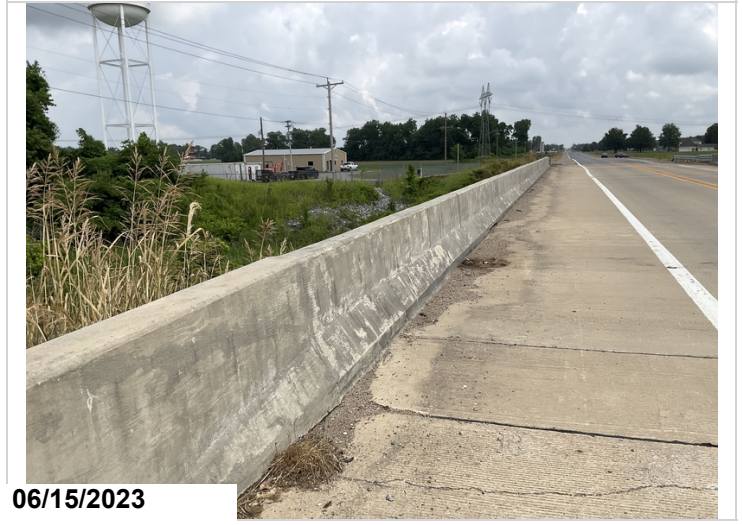
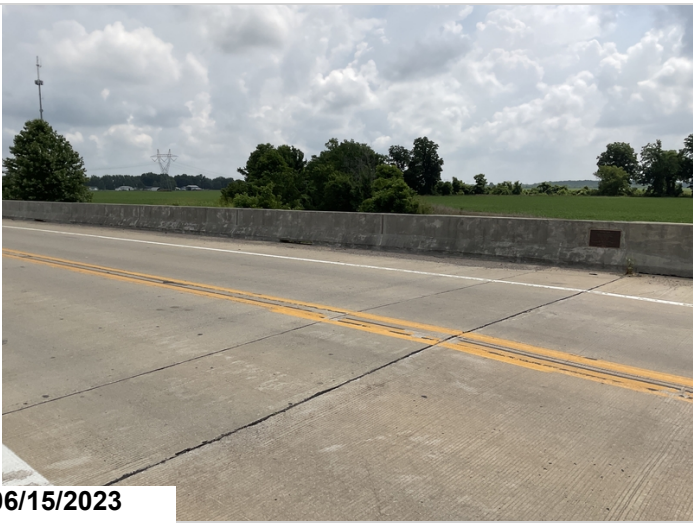
(331) -Bridge rails have vertical cracks spaced every 4' some with light efflorescence.

Left bridge rail

Right bridge rail

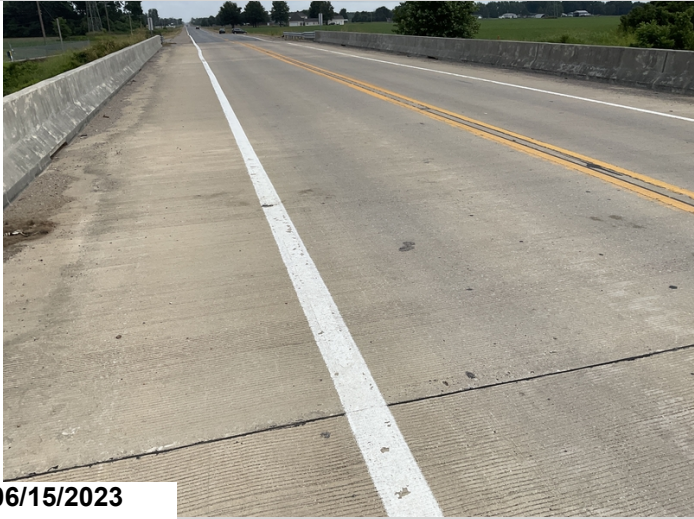
Typical deck

Deck is in good condition with hairline to cs2 cracks in deck with hairline cracks in the soffit/undersurface as well.

Deck has unsealed transverse and longitudinal cracks each span.

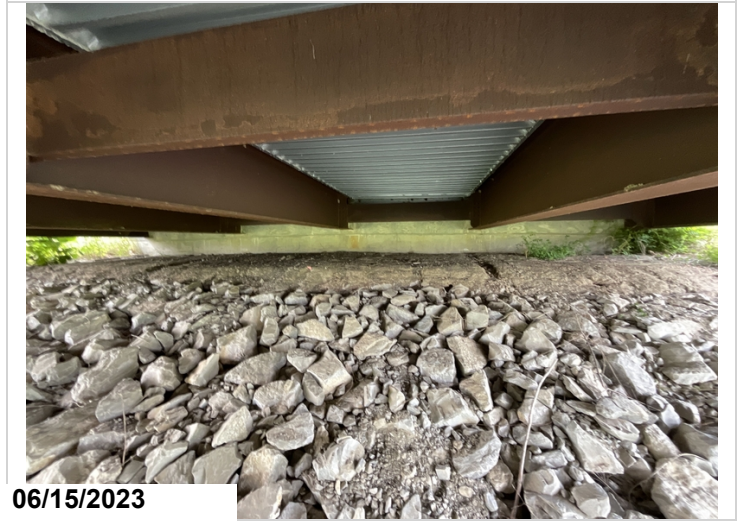
Abutment #1

(107) -Steel protective coating has granular texture.							
215	Reinforced Concrete Abutment	LF	90	90	0	0	0
(215) -Both abutment backwalls have vertical hairline cracks.							
225	Steel Pile	EA	12	12	0	0	0
515	Steel Protective Coating	SF	258	223	35	0	0
3430	Oxide Film Degradation Color/Texture Adherence(Steel Protective Coatings)	EA	35	0	35	0	0
