Asset #01791(Other Special Recurring)

Sh-42/Sec-2/L-5.63 over Gum Slough

Location: 4.5 Miles East Jct Us 49

Team Lead: Myron Futrell, Inspection Date: 11/30/2022

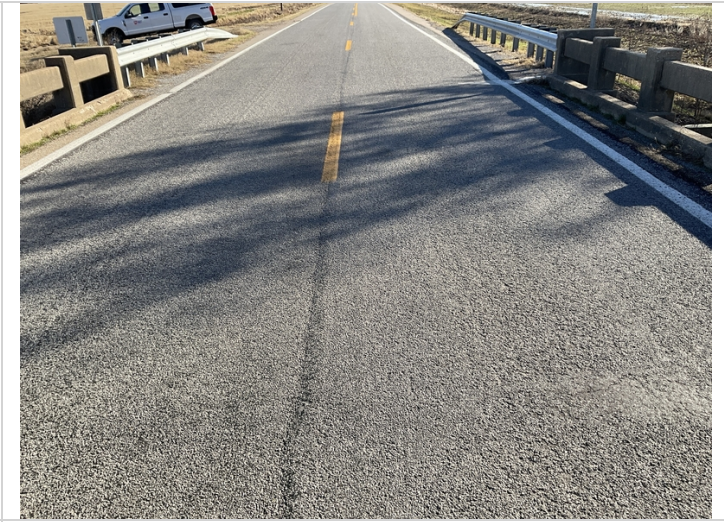
Typical deck

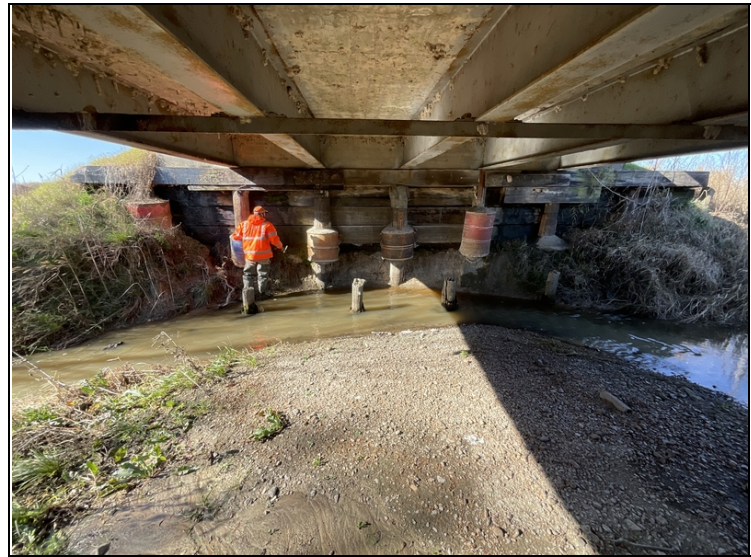
Abutment #1

(216) Small void behind abutment #2 back wall by pile #5 causing hole in abutment #2 approach roadway right side at bridge end. Void developing behind timber abutment at abutment #1 between piles #2,4 and abutment #2 between piles #4,5.							
228	Timber Pile	EA	16	0	0	15	1
1140	Decay/Section Loss	EA	16	0	0	15	1

Small void behind abutment #2 back wall by pile #5 causing hole in abutment #2 approach roadway right side at bridge end.

Date Reported: 12/10/2021
Priority: A - Safety deficiency; requires prompt action
Type of Work: Repair (General)
Status: RepairDocumented
Component: Approach

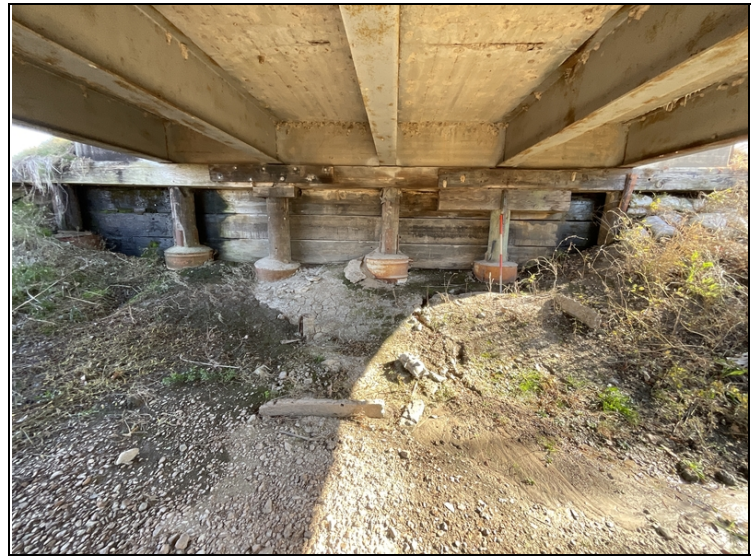
Abutment #2.

(235) Abutment #1 caps are decayed on top cord on each side of bridge with up to 15% section loss. Abutment #2 cap left section is decayed with up to 30% section loss, for 18'. Abutment #2 cap right section has been replaced.

Abutment #2 cap left side

Date Reported: 12/15/2021
Priority: B - Pressing
Type of Work: Replace (General)
Status: Forward State
Component: Element
