Asset #06978(Routine, Underwater type 2)

Us-79/Sec-15/L4.29 over Walnut Lake / Big Creek

Team Lead: Myron Futrell, Inspection Date: 11/08/2021

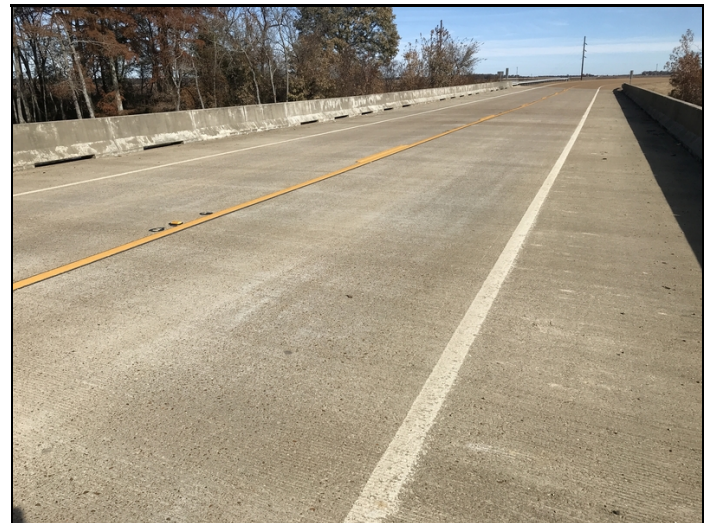
Typical deck

(12) Deck has open transverse and longitudinal cracks spaced three to four feet apart. Soffit overhang has transverse cracks with light to moderate efflorescence spaced four to five feet apart. Span #3 left side shoulder near bridge rail four feet back from bent #4 the deck has a one foot wide by three foot long area of light scaling.							
107	Steel Open Girder/Beam	LF	1525	1515	10	0	0
1000	Corrosion	LF	10	0	10	0	0
515	Steel Protective Coating	SF	12532	0	12532	0	0
3430	Oxide Film Degradation Color/Texture Adherence(Steel Protective Coatings)	LF	12532	0	12532	0	0
