**Asset #M2516**(Routine, Underwater type 2)

**Sh-242/Sec-1/L9.30 over Creek**

**Location: 0.7 Miles East Of Sh 1**

**Team Lead: Myron Futrell, Inspection Date: 11/29/2022**

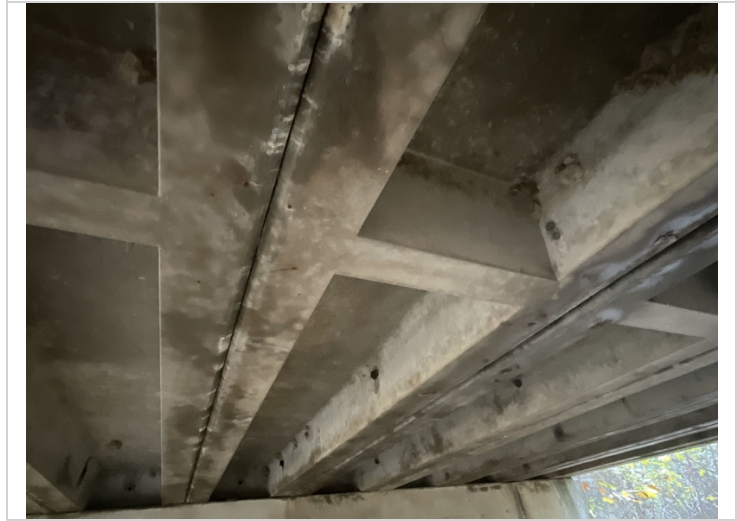
Soffit / underside of deck

Superstructure has a few pieces of rebar exposed in channel beam stems due to poor concrete coverage. Stems have a few small shallow spalls with no exposed rebar. Connection bolts are corroded with section loss. Overall condition of superstructure is good with no major problems visible. Several bridge rail posts have collision damage and are not connected to bridge rail, bridge rail left side at abutment #1 has approximately four feet missing both rails have areas of damage.

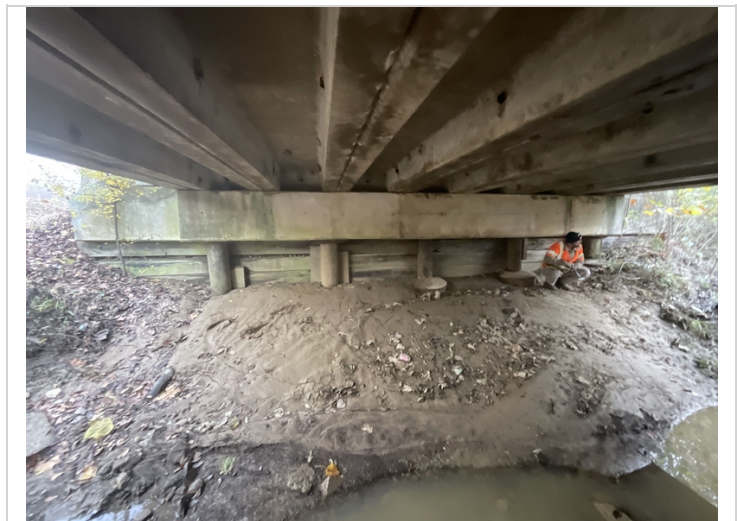
(216) Abutment #1 timber abutment is decayed behind piles #3,5 for eight feet in length.							
228	Timber Pile	EA	5	1	0	4	0
1140	Decay/Section Loss	EA	4	0	0	4	0

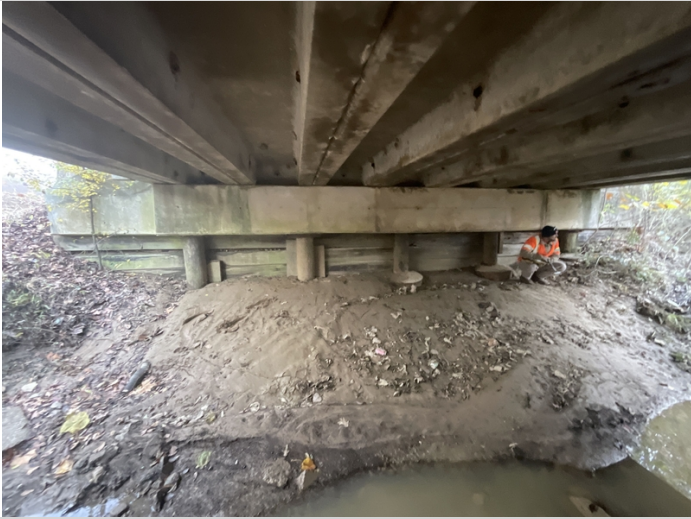
Abutment #1

(228) Bent # 1 piles 1,2,3&4 have been spliced and encased in concrete. Piles have minor weathering and shallow splits.							
234	Reinforced Concrete Pier Cap	LF	52	48	4	0	0
1080	Delamination/Spall/Patched Area	LF	1	0	1	0	0
1120	Efflorescence/Rust Staining	LF	3	0	3	0	0

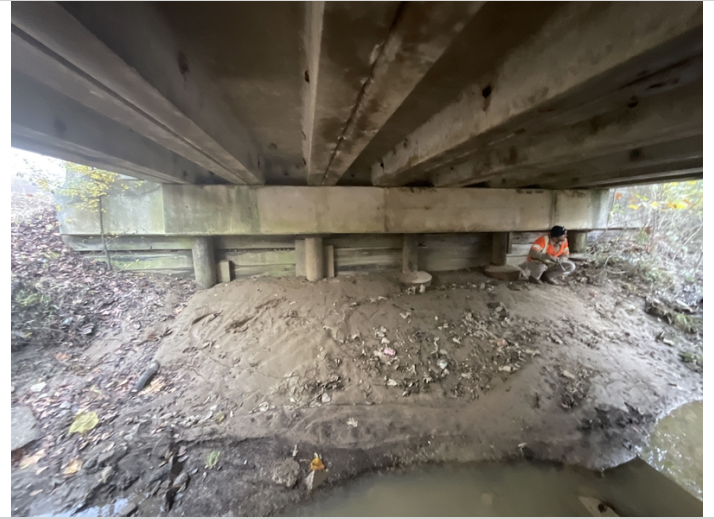
(215) Abutment #1 left wing has one foot of scaling with light efflorescence.							
216	Timber Abutment	LF	35	21	14	0	0
1140	Decay/Section Loss	LF	14	0	14	0	0

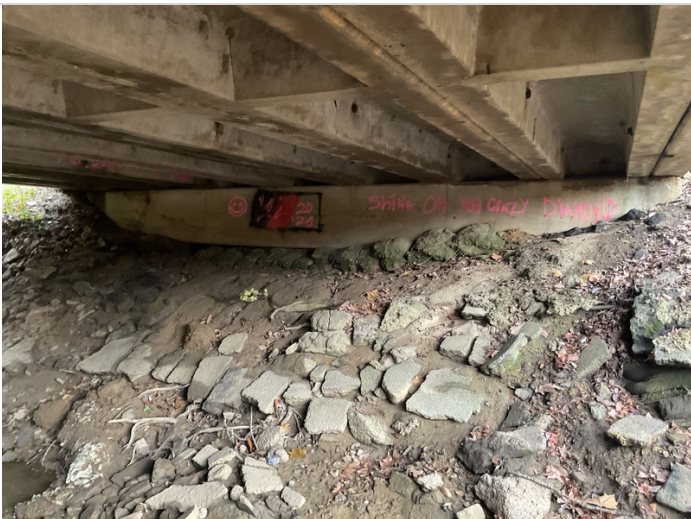
(234) Several small areas of steel exposed on faces of cap where snap ties were broken off. Abutment #1 cap has a few cracks with light efflorescence. Abutment #2 cap back face right side has six inch shallow spall with no exposed rebar.							
330	Metal Bridge Railing	LF	62	14	37	5	6
1000	Corrosion	LF	31	0	31	0	0
1020	Connection	LF	5	0	0	5	0
7000	Damage	LF	12	0	6	0	6
515	Steel Protective Coating	SF	186	70	111	0	5

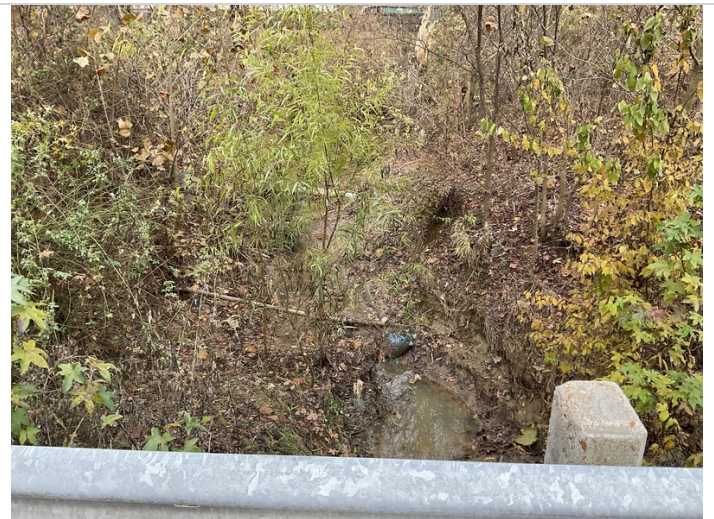
Channel left side

Comment: 11/29/2022-Lowered channel and channel protection from 8 to 7 due to minor erosion at abutment #2 requiring sand bags. Channel has fairly steep slopes that are well vegetated. Channel right side of bridge has recently been cleared of brush, left side has small trees and vegetation growing.

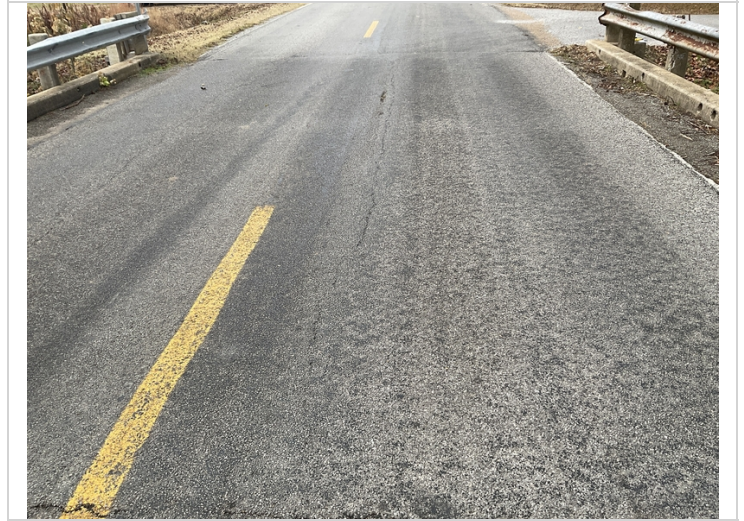
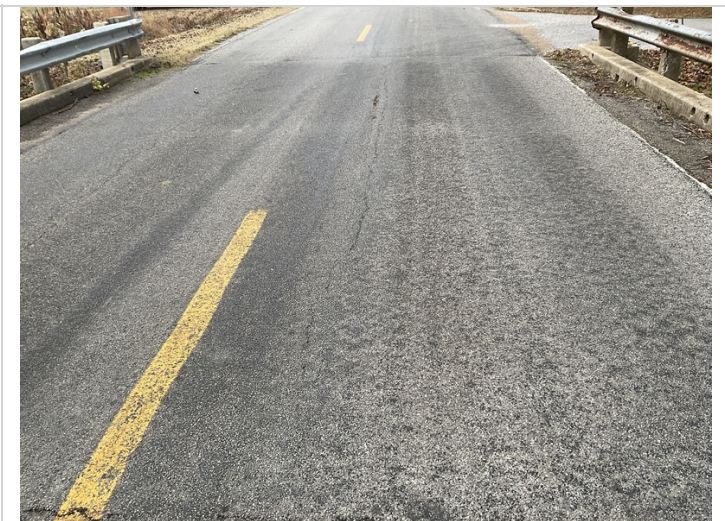
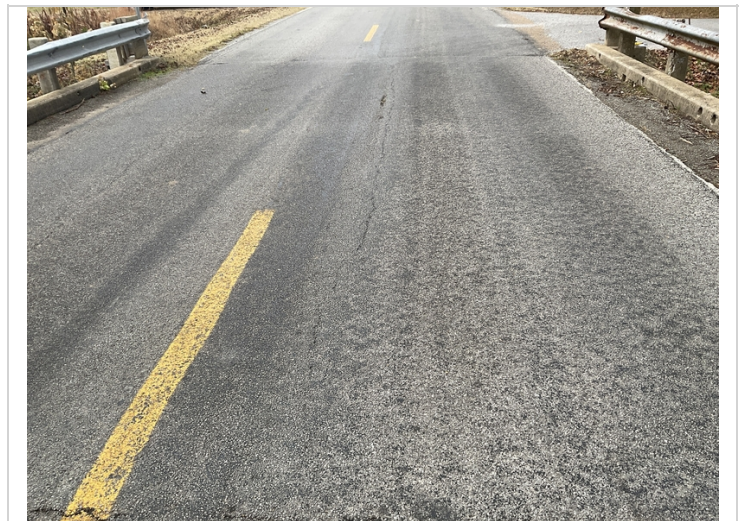
Typical deck

Deck has three inches of achm overlay except in gutters. No problems are visible in the deck, achm has a few cracks.

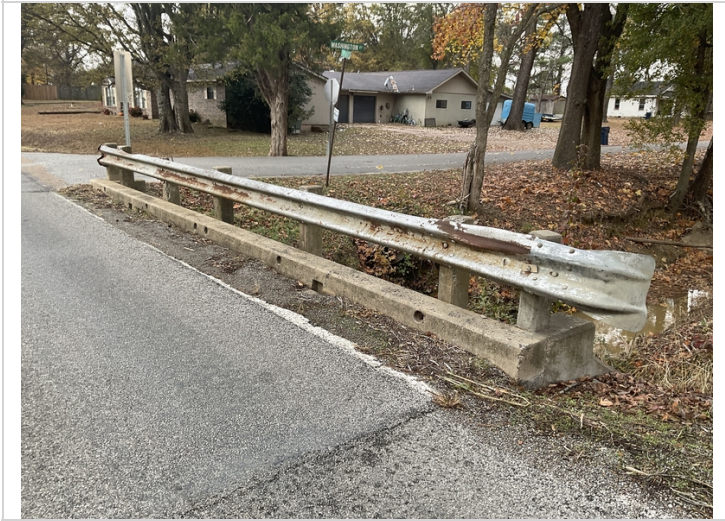
Bridge rail right side

ELEMENTS	DESCRIPTION	UNITS	TOTAL	CS1	CS2	CS3	CS4
3440	Effectiveness (Steel Protective Coatings)	LF	116	0	111	0	5
(330) 6" SPALL WITH EXPOSED REBAR ON RAIL POST RIGHT SIDE NEAR ABUTMENT #2. Right rail has some spots of rust. Second rail post on left side broken with exposed rebar. Fifth rail post on right side broken with exposed rebar. Abutment #1 and 2 left side first and last posts have been repaired, forms left in place. Left side first, third, forth, sixth and seventh rail posts not connected. Left rail, abutment #1 has several feet missing and four feet of minor damage mid span. Abutment #1 right rail first post broken, second post cracked and spalled with no exposed rebar, fifth post broken with exposed rebar sixth post has minor spall at top with no exposed rebar, last post not connected. Right rail has collision damage both ends.
