Asset #06293(Routine, Underwater type 2)

Sh-38/Sec-2/L-1.55 over Cache River

Location: 1.55 Miles East Jct Sh 33

Team Lead: Drew Melton, Inspection Date: 12/20/2022

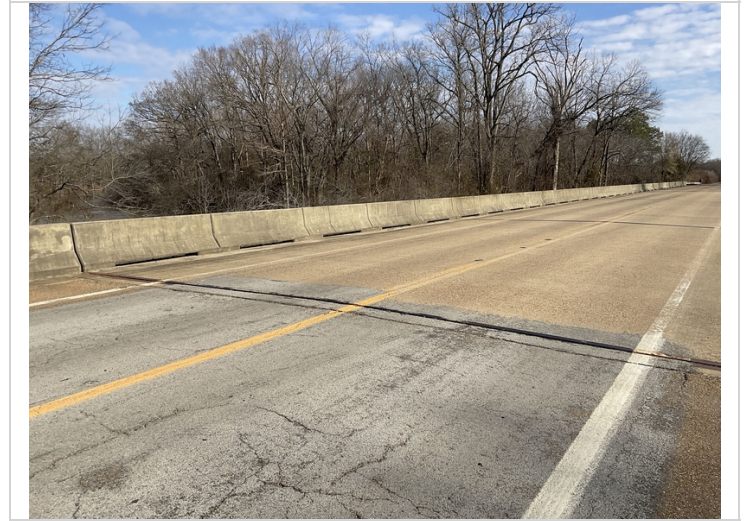
Left bridge rail

ELEMENTS	DESCRIPTION	UNITS	TOTAL	CS1	CS2	CS3	CS4
	(331) Rails have vertical hair line cracks spaced four feet apart.

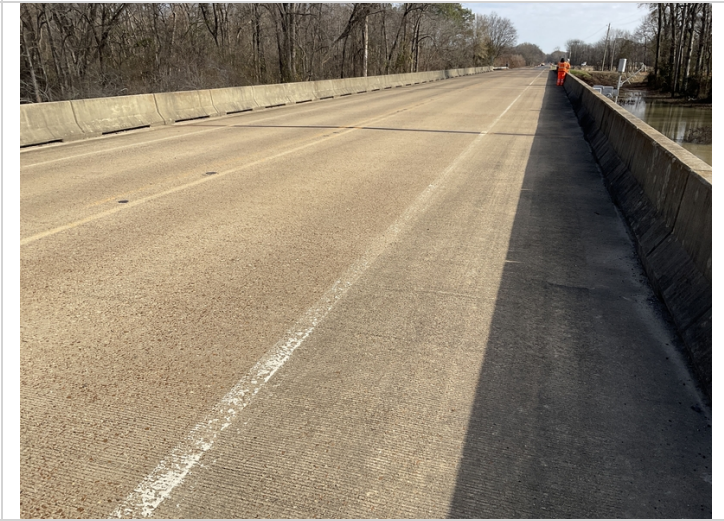
Typical deck

Deck is cast in place concrete. Deck has some open cracks.

(12) All spans have transverse and longitudinal cracks. Soffit-under surface overhangs have transverse cracks some with light efflorescence.							
107	Steel Open Girder/Beam	LF	2250	2166	84	0	0
1000	Corrosion	LF	84	0	84	0	0
515	Steel Protective Coating	SF	16532	16462	70	0	0
3430	Oxide Film Degradation Color/Texture Adherence(Steel Protective Coatings)	LF	70	0	70	0	0
