Asset #M3330(Routine, Underwater type 2)

Sh-50/Sec-1/L11.08 over Ten Mile Bayou

Location: about 4 Mi East Sh 38 S

Team Lead: Austin Janes Inspection Date: 10/02/2024

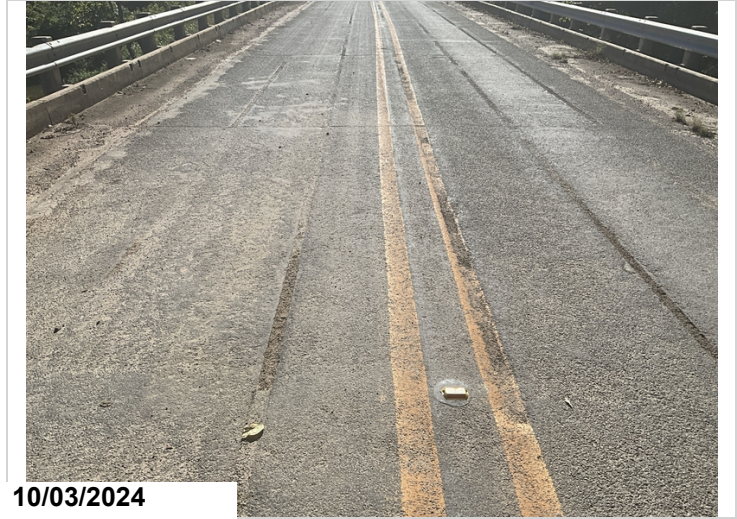
Typical deck.

Overall the Deck is in Satisfactory condition with grout joints beginning to spall and several units having hairline cracking in underside of top flange with light efflorescence.

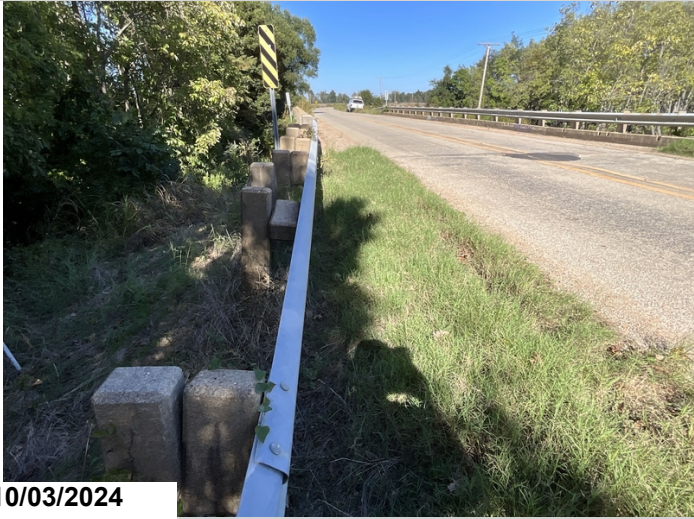
Bent 1, Left, Transition:

Overall the bridge railing transitions are in good condition with minor damage and some blocks have rotated.

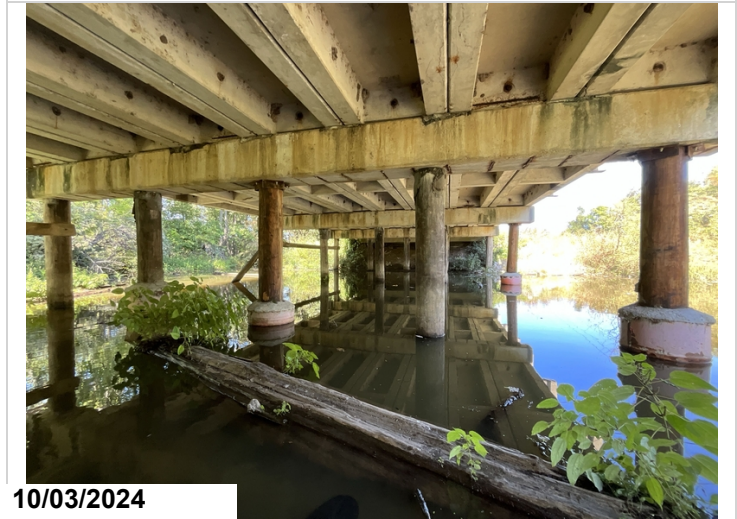
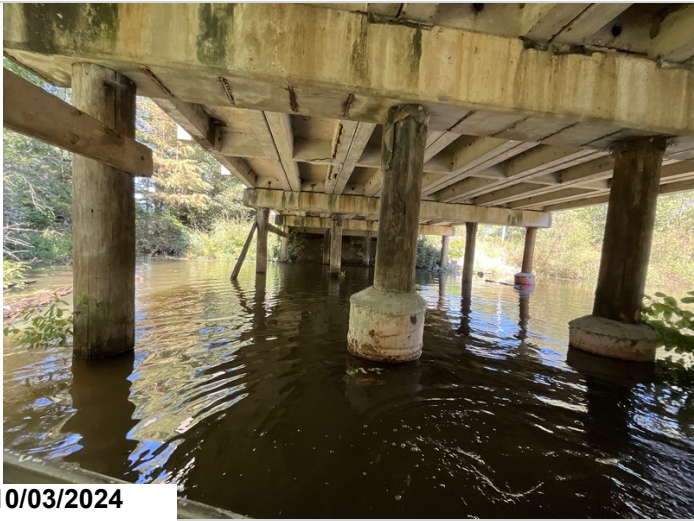
Bent 4 piles.

Bent #4 pile #2 has outer shell decay with moderate section loss, damage now encased concrete, structural integrity unknown.

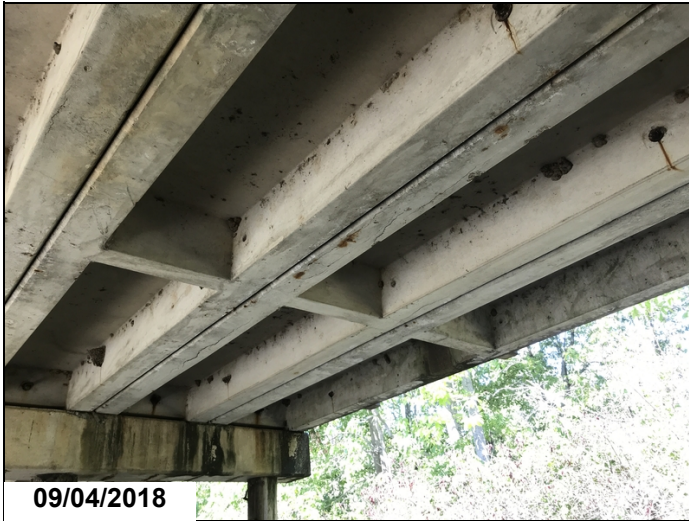
Typical soffit

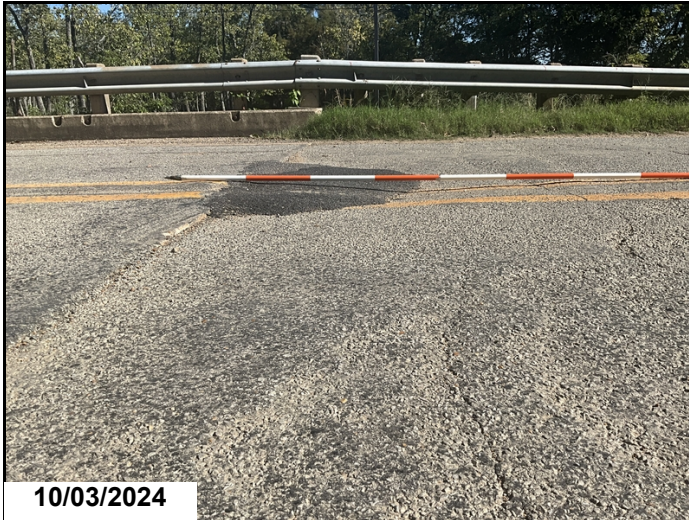
Approach Roadways at Bents 1 & 7: Settlement in the approach roadways along both ends of the bridge.

Bent 1, Approach: roadway settlement.
