Bridge M3986 Inspection Report

Asset #M3986(Routine, Underwater type 2)

Us-49/Sec-7/L-1.10 over Creek

Team Lead: Myron Futrell Inspection Date: 06/12/2024

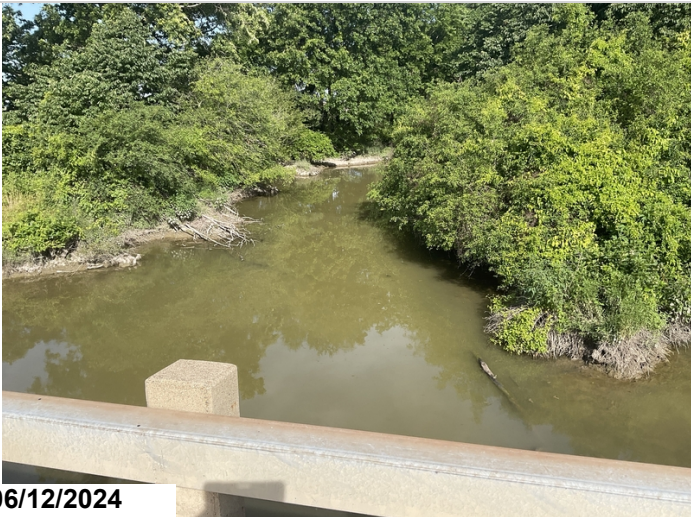
Channel, right side

Channel is in overall good condition. Channel alignment is good, slopes are well vegetated and there is a minor amount of debris in channel.
