Bridge #M3076(Routine)
SH 138-03 LM 7.59 over Lower Cut-Off Creek

Location: 7.59 Mi N US278-Pine Hill

Team Lead: Sharon Hooks Inspection Date: August 02, 2021

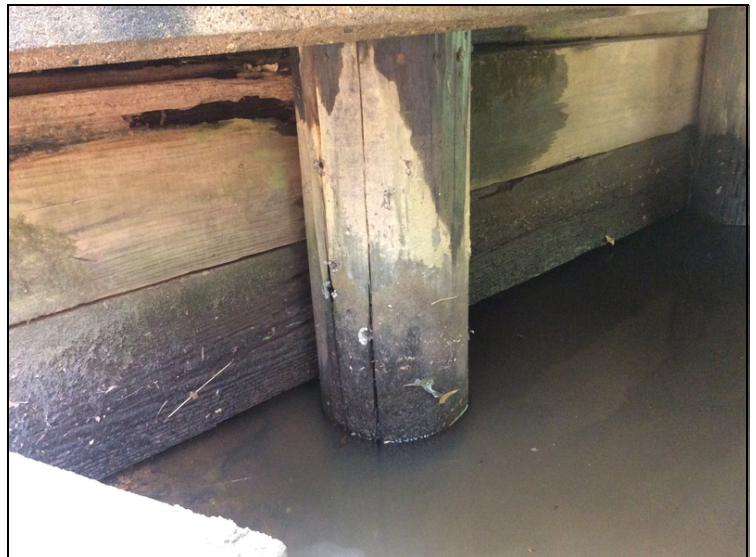
(228)							
Pile: 5 per bent / Bents 1 & 2. Bent 1 pile 4 has outer shell decay and spongy at water line. Bent 1 pile 5 large checks with a hollow area near cap. Bent 2 Pile 1: Moderate- to large-sized checking with some decay and hollow on left side. Bent 2 pile 2 very heavy decay from cap down 3'. Bent 2 pile 3 light hollow sound near cap. Bent 2 pile 4 outer shell decay. Remaining piles have minor-sized checking with some decay to the exterior around waterline.							
234	Reinforced Concrete Pier Cap	LF	52	52	0	0	0

Bent 1 pile 4 has outer shell decay and spongy at water line.
Bent 1 pile 5 large checks with a hollow area near cap.
Bent 2 Pile 1: Moderate- to large-sized checking with some decay and hollow on left side.
Bent 2 pile 2 very heavy decay from cap down 3'.
Bent 2 pile 3 light hollow sound near cap.
Bent 2 pile 4 outer shell decay.
Remaining piles have minor-sized checking with some decay to the exterior around waterline.
Changed priority from "G" to "C" SDH 2019.
Changed priority from "C" to "B" SDH 2021.

Bent 2 pile 1 has large checks.
