Asset #02962(Routine)

SH 8-15 LM 4.67 over Fleshman Bayou

Location: 4.68 Mi E US 165-Parkdale

Team Lead: Sharon Hooks, Inspection Date: 10/03/2022

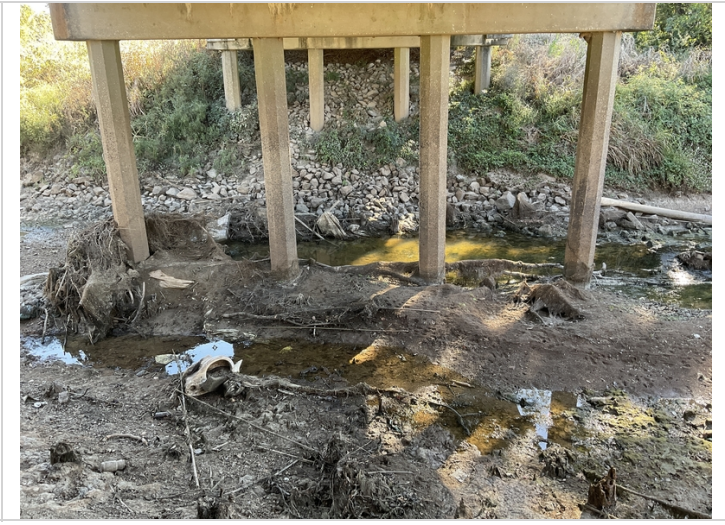
| ELEMENTS | DESCRIPTION | UNITS | TOTAL | CS1 | CS2 | CS3 | CS4 |
|---|---|---|---|---|---|---|---|
| Bent 4 Pile 2 left: Vertical crack 8-10' down from cap. | | | | | | | |
| Bent 4 Piles 1-4: Some abrasive wear from stream flow - CS2 abrasive wear x 3. | | | | | | | |
| Bents 4-5: Spalling with some rebar exposed - 5'. | | | | | | | |

Bent 4 substructure view.

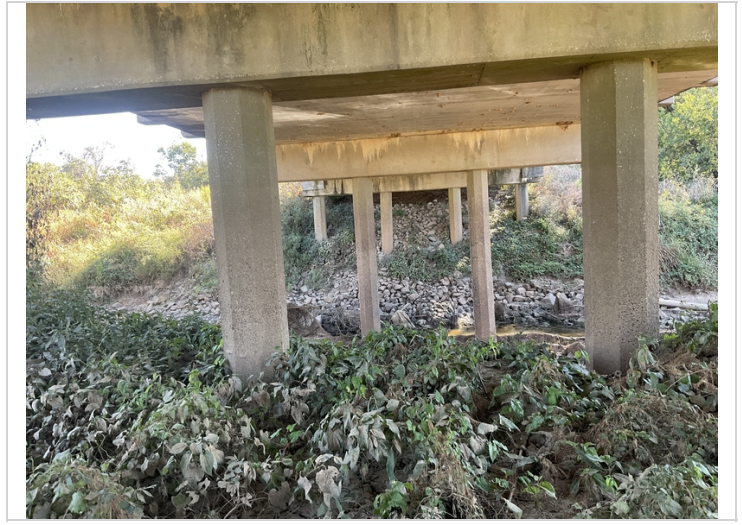
Under view.

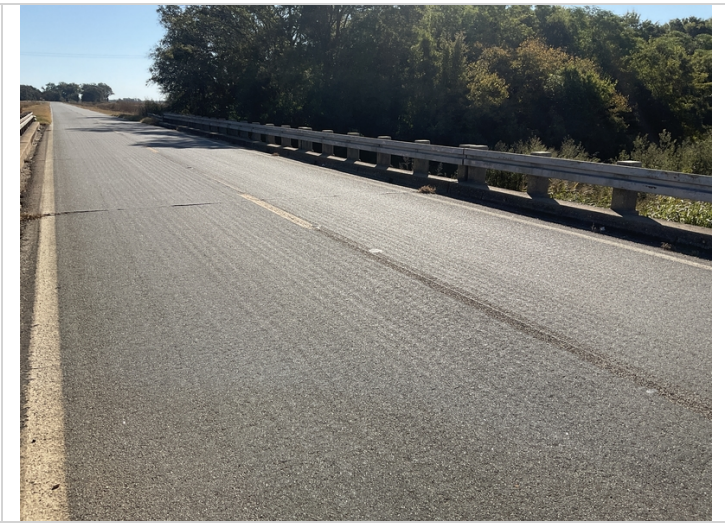
| ELEMENTS | DESCRIPTION | UNITS | TOTAL | CS1 | CS2 | CS3 | CS4 |
|---|---|---|---|---|---|---|---|
| (38) Deck: 26'-6" wide x 140' long = 3710 sqft.<br>Wearing surface (asphalt overlay): 22' wide x 140' long = 3080 sqft.<br>New chip overlay 1/2" added in 2018.<br>Transverse cracking @ Bents, | | | | | | | |

Deck over view.

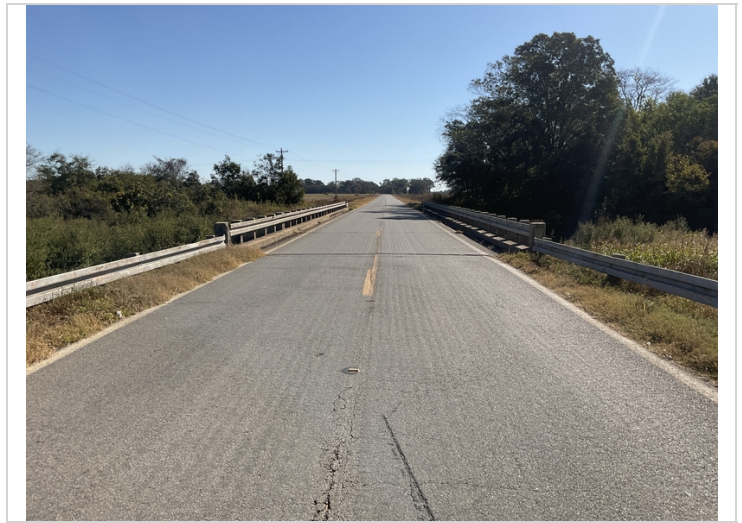
Approach.
