Asset #M1497(Routine)

US 425-06 LM 4.43 over Flat Creek

Location: 4.43 Mi N SH 11-Star City

Team Lead: Sharon Hooks, Inspection Date: 08/08/2022

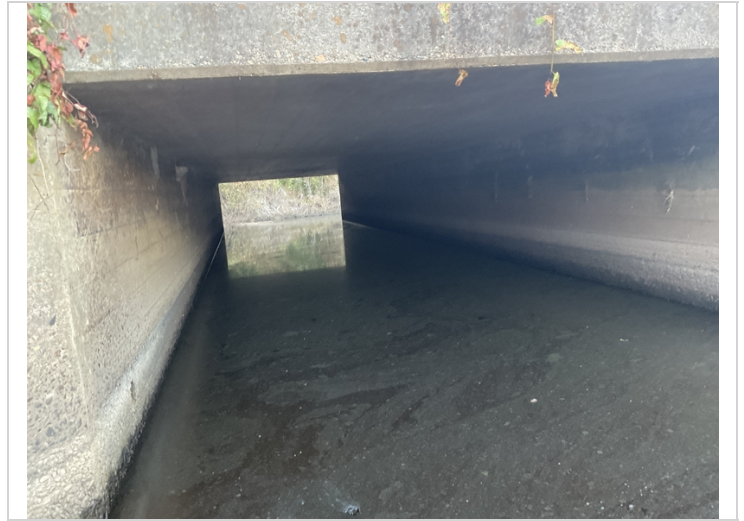
ELEMENTS	DESCRIPTION	UNITS	TOTAL	CS1	CS2	CS3	CS4
241	Reinforced Concrete Culvert	LF	132	62	69	1	0
1130	Cracking (RC and Other)	LF	4	0	4	0	0
1190	Abrasion/Wear (PSC/RC)	LF	66	0	65	1	0
(241) Box culvert: 44' each / Barrels 1-3. Barrels 1-3: Abrasive wear on bottom 24" of walls - heaviest from center to right side. Hairline vertical cracks at corners of box walls and wing walls. Channel - Barrels 1 & 3: Some minor erosion at end of bottom slab.

Barrel 3 view.
