Bridge 03552 Inspection Report

Route:425 Section:02 Log:6.67

District 02, 3 - Ashley County

Asset #03552(Routine, Underwater type 2)
US 425-02 LM 6.67 over S Fork Fountain Creek
Location: 6.67 Mi N US 82-Hamburg
Team Lead: Sharon Hooks Inspection Date: 04/28/2025

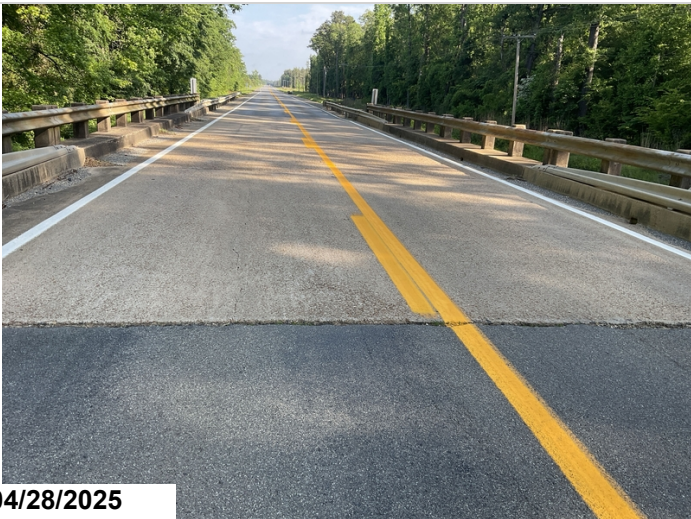
Deck is in satisfactory condition with cracking/ scaling on top and large delaminations to undersurface.

Deck - all spans: Several unsealed, minor- to large-sized longitudinal cracks with reflective cracking, efflorescence, and rust staining on undersurface, especially along centerline and heaviest on Spans 3 & 4 - Several unsealed, minor- to moderate-sized transverse cracks, heaviest on Spans 3 & 4 on right side.

Deck Overview

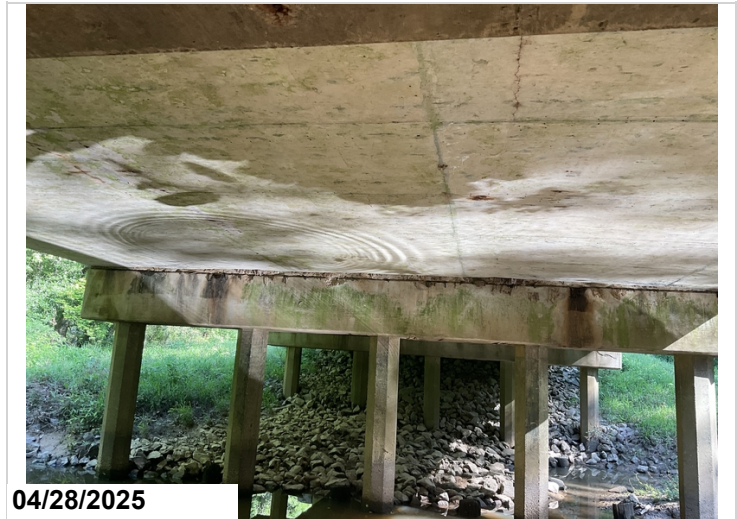
Superstructure-Undersurface of slab has large delaminations with rust staining due to leakage from top side of slab.
Voided Slab.

Undersurface view.
