Bridge 03553 Inspection Report

Asset #03553(Routine, Underwater type 2)

US 425-02 LM 8.03 over NForkFountainCr/AshCo

Team Lead: Sharon Hooks Inspection Date: 04/28/2025

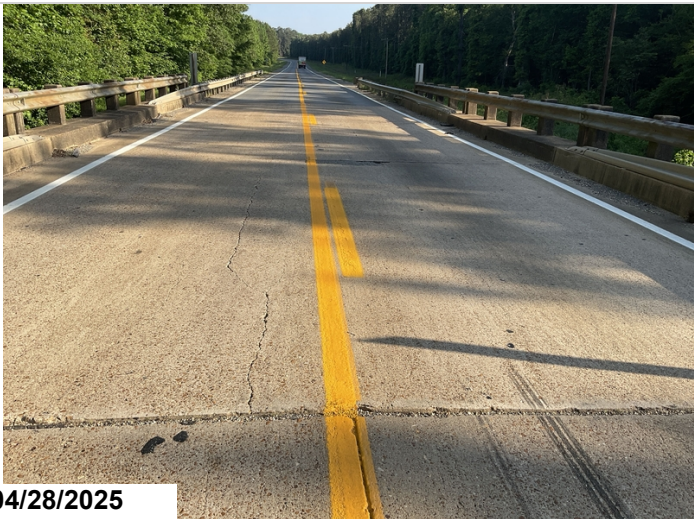
Deck Overview

Deck- Slab is in satisfactory condition with cracking/scaling on top and large delaminations/staining to undersurface.
Voided Slab

Deck - all spans: Unsealed, moderate to Large sized longitudinal cracks with reflective cracking, efflorescence, and rust staining to undersurface.

Travel lanes have abrasion with loss of mortar on surface with large unsealed cracks.

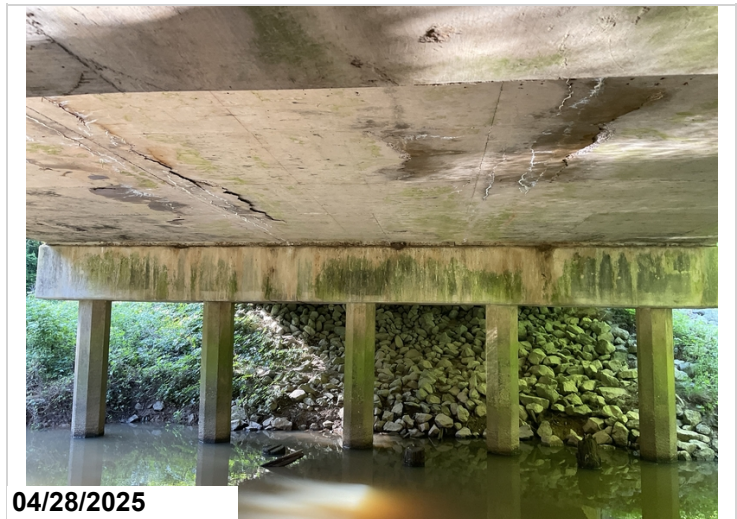
Undersurface view.

Superstructure-Undersurface of slab has large delaminations with rust staining due to leakage from top side of slab.
Voided Slab.
