## Bridge 03930 Inspection Report

Asset #03930(Routine)

US 425-03 LM 1.40 over South Fork Panther Creek

Team Lead: Sharon Hooks Inspection Date: 07/25/2023

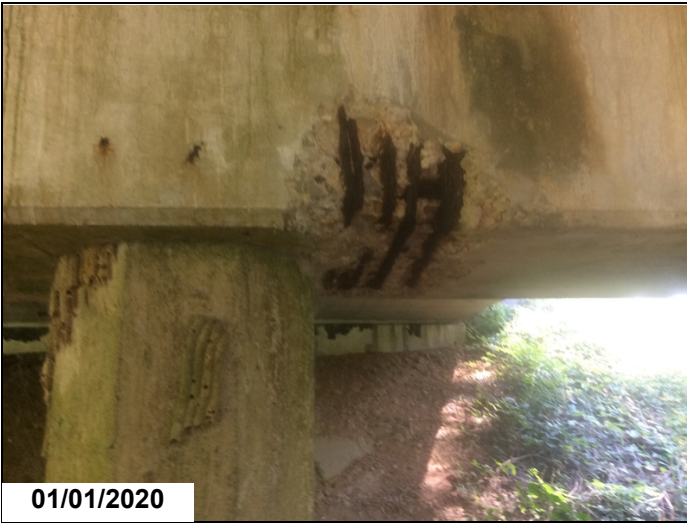
(234) Caps: 30.66' = 31' each / Bents 2-3. Bents 2 : Spalling with exposed rebar (heavy corrosion) on bottom face of cap right of Pile 4. Bent 3: Spalling with exposed rebar on back face near pile 4.							
301	Pourable Joint Seal	LF	132	0	0	122	10
2320	Seal Adhesion	LF	66	0	0	66	0
2330	Seal Damage	LF	10	0	0	0	10
2350	Debris Impaction	LF	56	0	0	56	0

Bent 3 right of pile 4 spall with reposed rebar.
