District 03, 57 - Hempstead County

Asset #06419(Routine, Underwater type 2)
SH 27- 03- 2.40 over N. FORK OZAN CREEK
Location: 2.4 NE HOWARD CO LINE

Team Lead: Charlie Rogers, Inspection Date: 01/11/2022

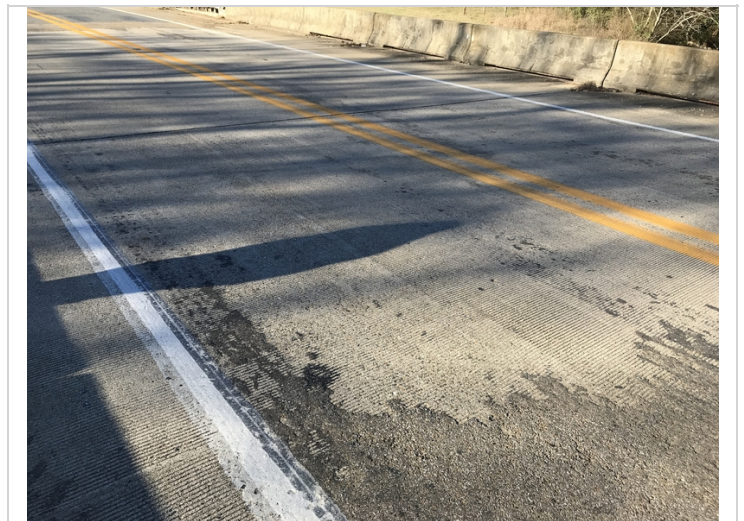
Deck

(12) CONCRETE DECK WITH COATED REBAR 60 LF OF EFFLORESCENCE SPAN 1 10 LF OF EFFLORESCENCE SPAN 2 50 LF OF EFFLORESCENCE SPAN 3 SEALED DECK CRACKS ON TOP OF DECK							
110	Reinforced Concrete Open Girder/Beam	LF	375	375	0	0	0
215	Reinforced Concrete Abutment	LF	126	122	0	4	0
1080	Delamination/Spall/Patched Area	LF	4	0	0	4	0
225	Steel Pile	EA	15	15	0	0	0
515	Steel Protective Coating	SF	466	0	466	0	0
3430	Oxide Film Degradation Color/Texture Adherence(Steel Protective Coatings)	EA	466	0	466	0	0
234	Reinforced Concrete Pier Cap	LF	86	78	8	0	0
1010	Cracking	LF	4	0	4	0	0
1120	Efflorescence/Rust Staining	LF	4	0	4	0	0
301	Pourable Joint Seal	LF	80	80	0	0	0
331	Reinforced Concrete Bridge Railing	LF	150	100	50	0	0
1130	Cracking (RC and Other)	LF	50	0	50	0	0
