Asset #03674(Routine)

US 71 SEC.04-18.35 over LITTLE RIVER

Location: 2.50 MI N OF WILTON

Team Lead: John King, Inspection Date: 03/21/2022

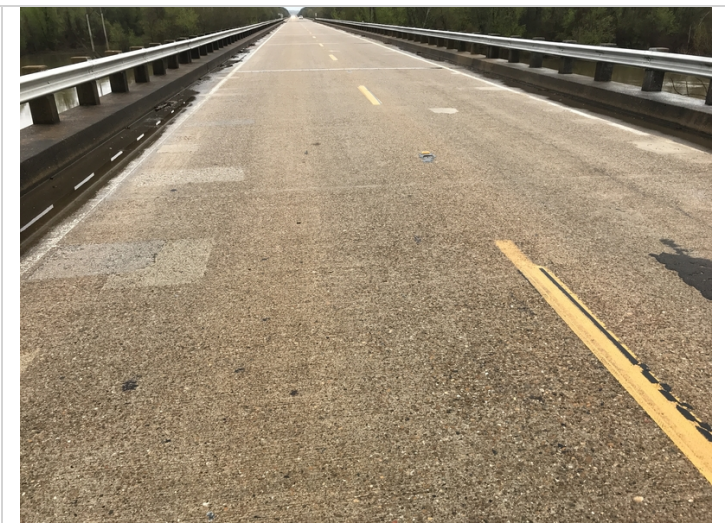
58 - Deck (4 - POOR CONDITION - advanced section loss, deterioration, spalling or scour)

Curbs: SOME MINOR DAMAGE Wearing Surface: DECK PATCHES 29.33% patched...3/27/2017.. AL,CH,SS,DECK PHOTO TAKEN SPECIAL INSPECTION WITH LITTLE TO NO CHANGE IN DECK3/20/2018 AL,CH,SS,DECK PHOTOS TAKEN PER THIS INSPECTION...3/21/2019...Special recurring on deck. AL, SS, Deck photos taken. Patch quantities updated per this inspection... 03/2022... Deck photos taken. Patching quantities updated per this inspection... End of bridge Lt side approach is cracking and spalling.

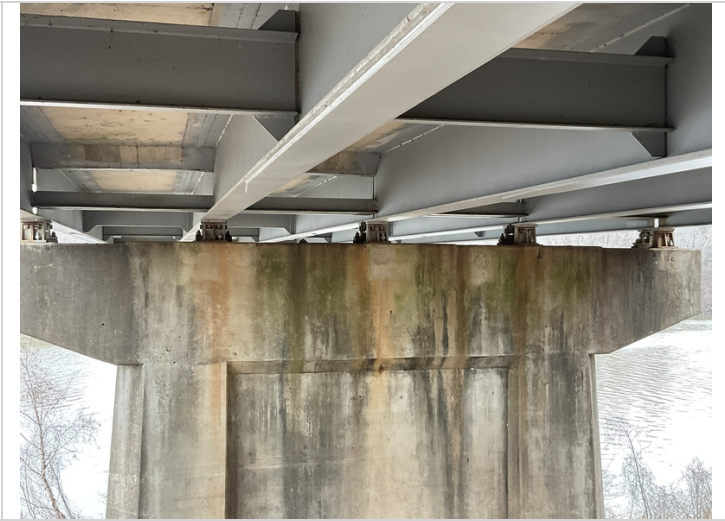
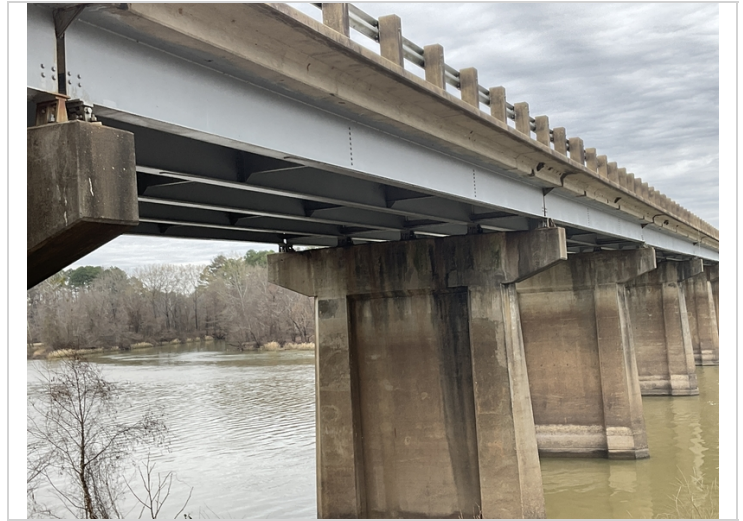
(107) PAINTED IN 2011 (1000-107) 3/26/2020...Rust in various locations on outside beams...							
205	Reinforced Concrete Column	EA	16	11	0	5	0
1080	Delamination/Spall/Patched Area	EA	5	0	0	5	0

03/2022... steel beams typical all spans

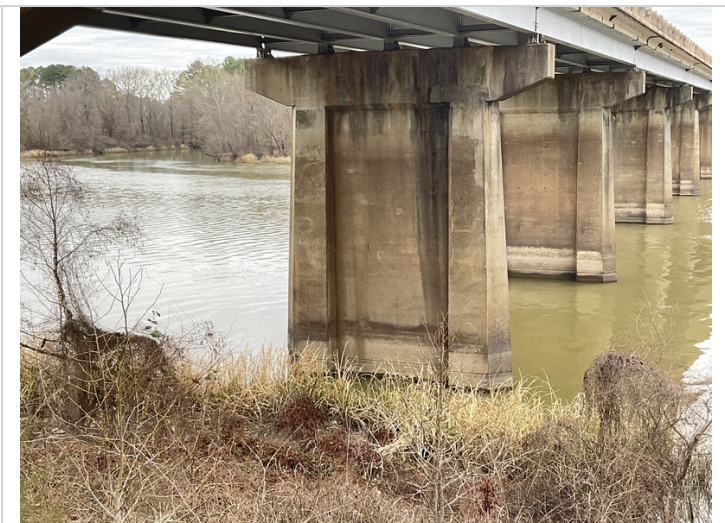
(205) SPALLS ON COLUMN #1 AND #2 BENT 3, COLUMN #1 BENT 4, COLUMN #2 BENT 5 AND COLUMN #2 BENT 6.							
215	Reinforced Concrete Abutment	LF	56	56	0	0	0
234	Reinforced Concrete Pier Cap	LF	232	212	0	20	0
1080	Delamination/Spall/Patched Area	LF	10	0	0	10	0
1130	Cracking (RC and Other)	LF	10	0	0	10	0

(234) SPALLS AND CRACKS ON CAPS AT BENTS 2, 3, 4, 5, 6, 7, AND 8.							
305	Assembly Joint without Seal	LF	280	280	0	0	0
311	Movable Bearing	EA	45	21	24	0	0
1000	Corrosion	EA	22	0	22	0	0
2210	Movement	EA	2	0	2	0	0

03/2022... Typical bent

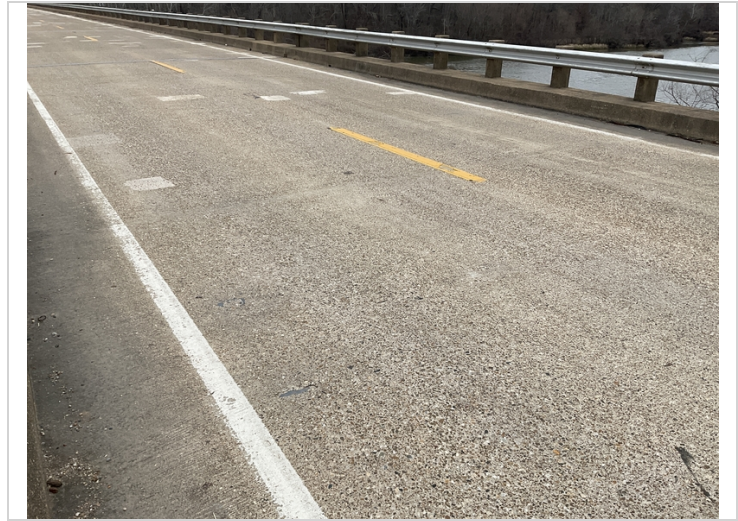
(12) 5709 sqft of deck is patched. 2019 updated patched areas to 5715 sq ft (1090-12) 03/2022... spalls on underside of deck at various locations.							
107	Steel Open Girder/Beam	LF	3010	2967	43	0	0
1000	Corrosion	LF	43	0	43	0	0
515	Steel Protective Coating	SF	24080	24037	0	0	43
3440	Effectiveness (Steel Protective Coatings)	LF	43	0	0	0	43

03/2022... typical photo of deck all spans
