Asset #01869(Routine, Underwater type 2)

US 71 SEC.05-11.27 over LITTLE BELLVILLE CREEK

Location: 1.4 M S OF LOCKESBURG

Team Lead: Charlie Rogers, Inspection Date: 02/16/2022

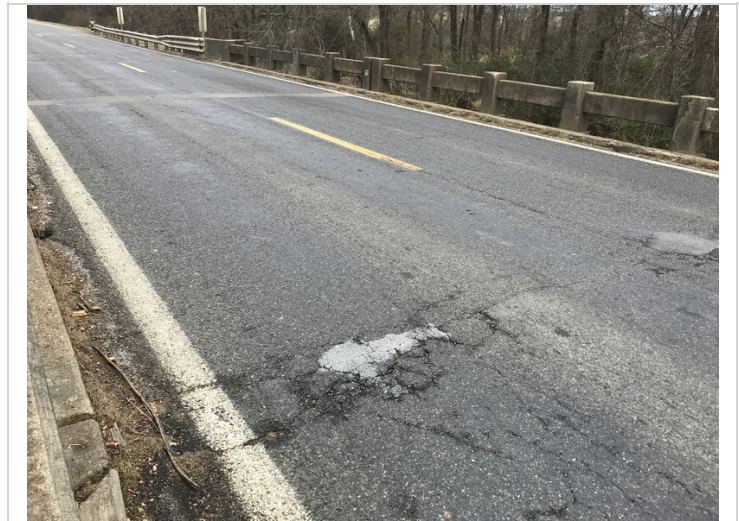
Deck 2/2022

02/20/2018...AL, SS, DECK PHOTOS TAKEN. LITTLE OR NO CHANGE IN CONDITION...2/16/2022...Deck has large cracking, efflorescence with rust staining, and efflorescence on bottom side of deck. Exposed rebar near bent 3 abutment in bottom of deck. Dropped deck to a 5...

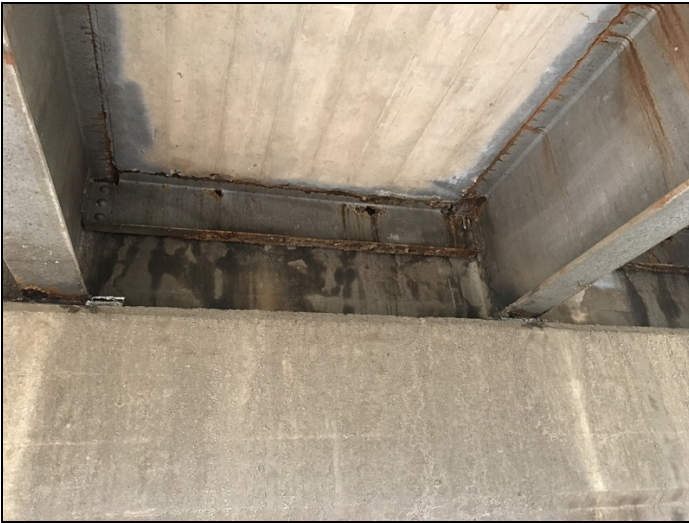
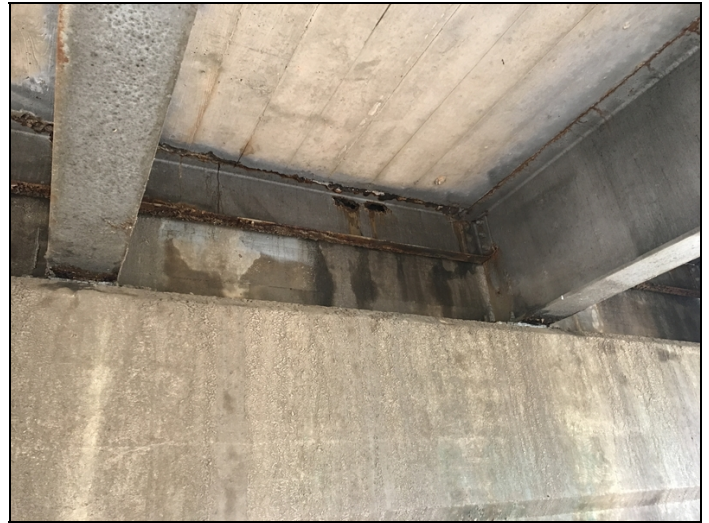
Raised super to a 5 fair due to repairs made to beams; see drawings -----2/16/2022... Corrosion with section loss on various beam ends. Corrosion in various locations of beams. All bearings have corrosion with heavy section loss. Various diaphragms at bents 1 and 2 have section loss holes...

Bent 2 bay 1 diaphragm
