Asset #02928(Routine)

SH 355 - 01-1.37 over BRUSHY CREEK

Location: 1.3 MI SE MINERAL SPRINGS

Team Lead: John King, Inspection Date: 04/07/2022

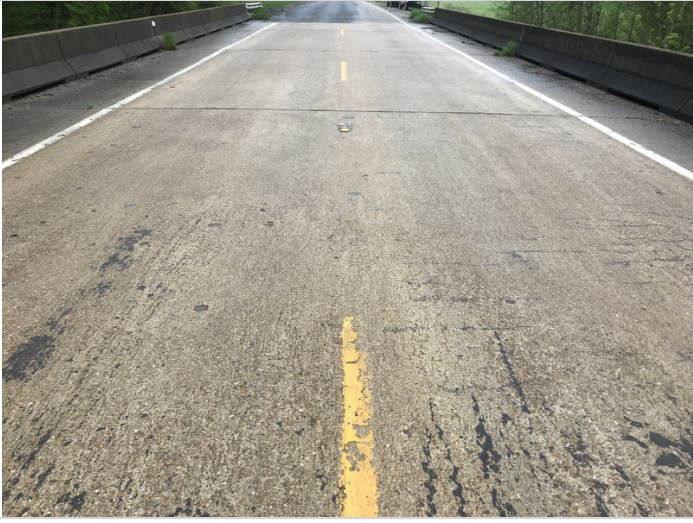
Deck

Underside of Deck: SLAB CONSTRUCTION JOINTS WHERE DECK WAS WIDENED LONGITUDINAL CRACKS WITH EFFLORESCENCE LEAKAGE AT CONSTRUCTION JOINTS.....4/7/2020...Dropped deck to a 6 due to cracking, efflorescence, delams on top and bottom of deck....04/2022... little to no change in condition per this inspection

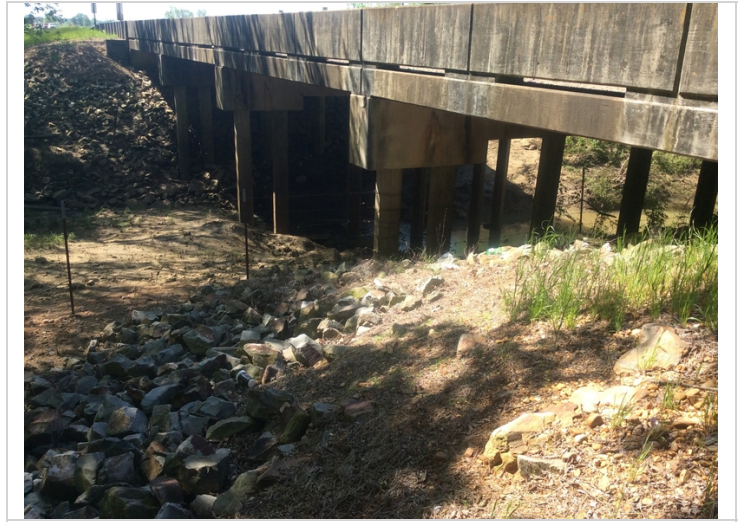
SS

Girders/Beams: SLAB BRIDGE.....4/7/2020...Dropped super to a 6 to match deck rating... 04/2022. Little to no change in condition per this inspection.
