Asset #05877(Routine)

SH 19-SEC 5 - 8.39 over BRUSHEY CREEK

Location: 8.83 MI NO JCT US 67

Team Lead: John King Inspection Date: 06/06/2023

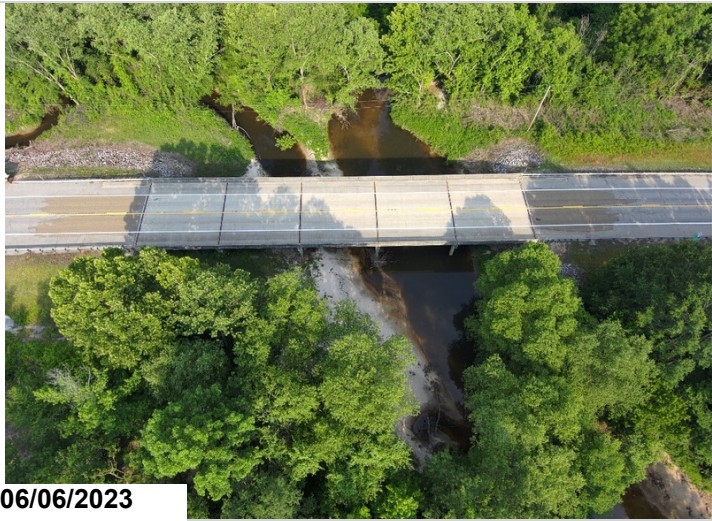
Chennal\_05877\_20230606Drone photo

6/23 channel in good condition may need minor repair

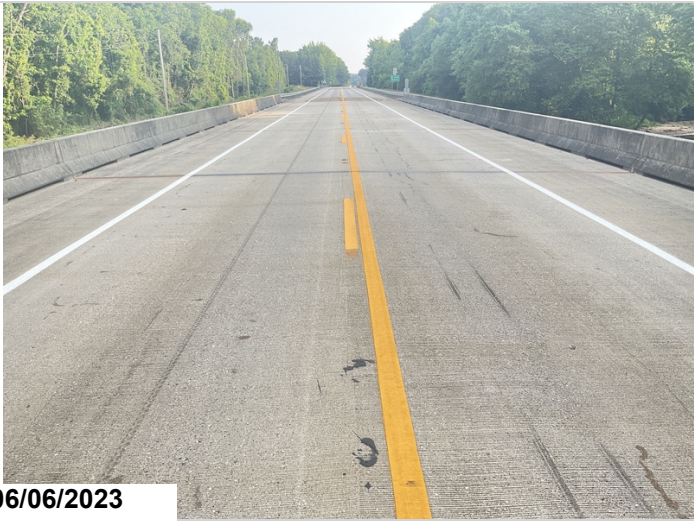
6/2023 deck in good condition. Some small cracking in top of deck, some were sealed in past.  
Joints were repaired around 2021.

6/2023 typical deck photo
