Asset #05061(Routine)

US 371 SEC 4 -3.00 over I 30- SEC-13- 43.95

Location: JCT HWY 371 & I-30

Team Lead: John King, Inspection Date: 06/19/2023

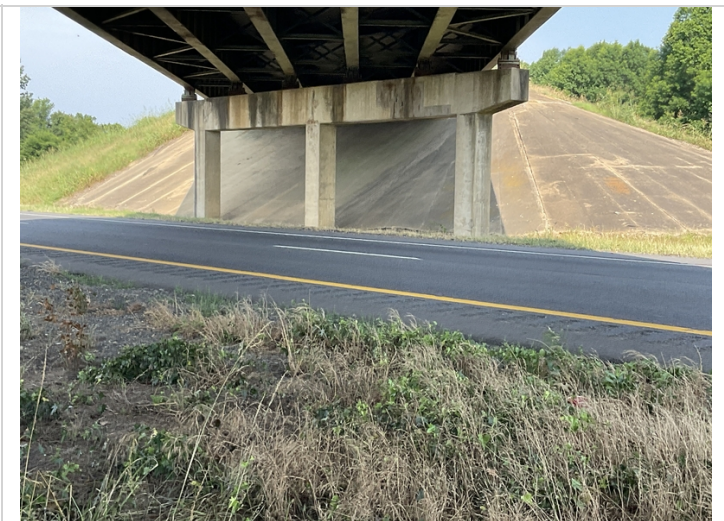
Typical substructure

Substructure rated a 6 due to:
large amounts of cracking, spalling, and old patchwork " in some places failing" on caps and columns

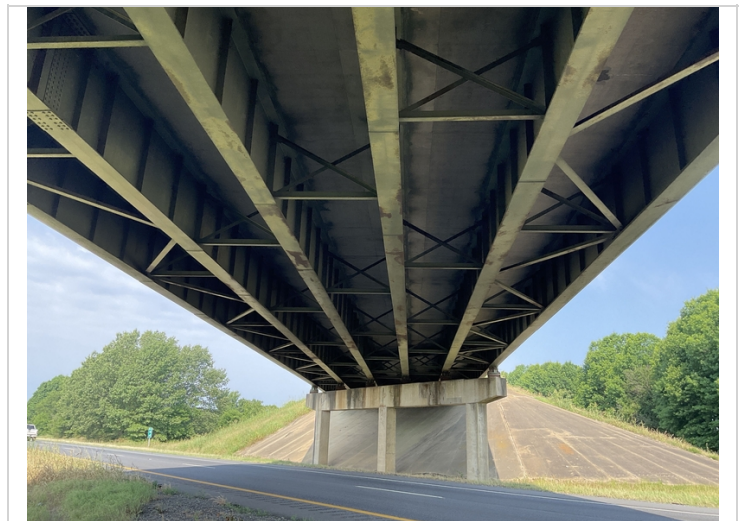
Typical superstructure

Superstructure rated a 7 due to:
Chalking of paint in various locations on beams
all bearings showing signs of corrosion.

Bridge was raised in 2001 by state forces.
Bearings are rusting with some section loss. all beams will need to be painted soon.

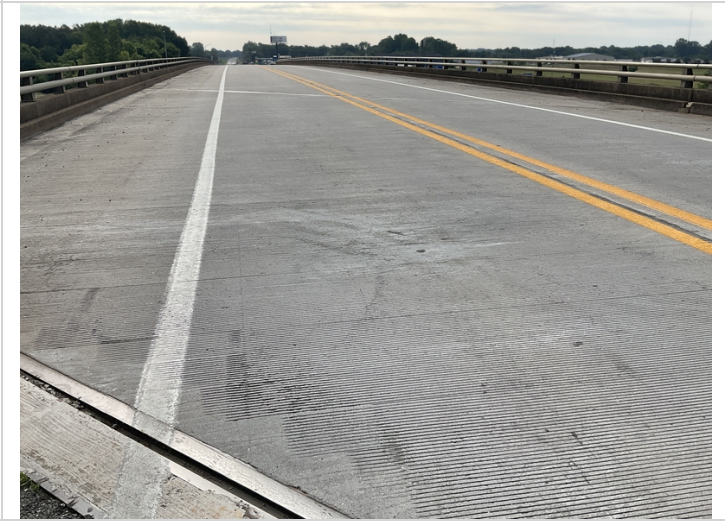
Typical deck

6/20/2019..1 1/2" thick hydro polymer overlay...
deck was lowered to 7 good due to light cracking in Hydro. top side and bottom side has
some spalls and efflorescence..
