Bridge M3801 Inspection Report

Inspection Notes

US 278 - 06 - 3.54 over BODCAU CREEK

Team Lead: John King Inspection Date: 09/05/2024

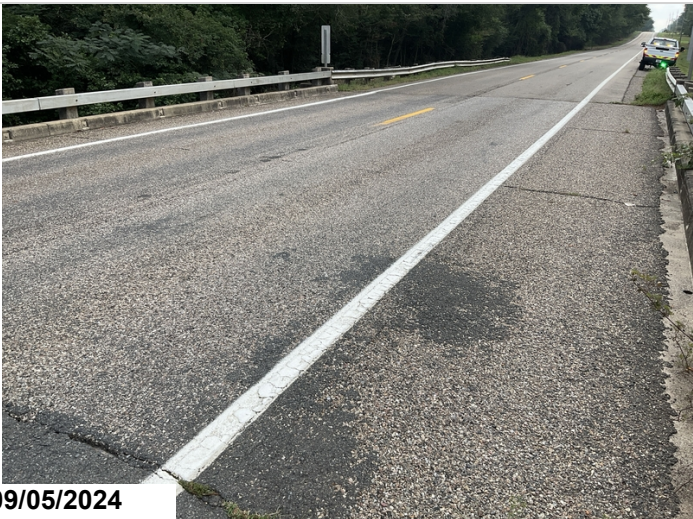
Deck photo, Driving surface

Asphalt overlay and chip seal has cracking throughout entire deck, all joints are impacted by asphalt.

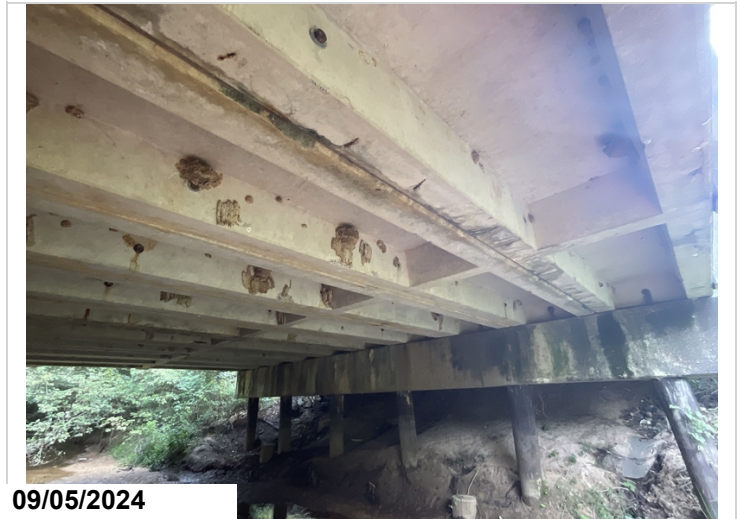
Precast units

In both spans 1 & 2 there are minor areas of spalling found to the bottom stems in various locations.

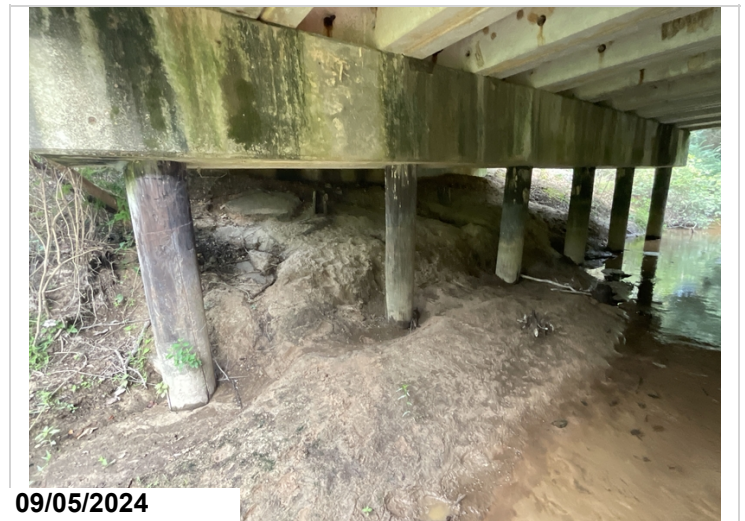
Bent 2

There is minor cracking to the intermediate bents 2 & 3 caps in various locations.

Pile 5 at bent 2 shows approximately 1" of outer shell decay and is located 1.5' above the ground level at the time of this inspection.

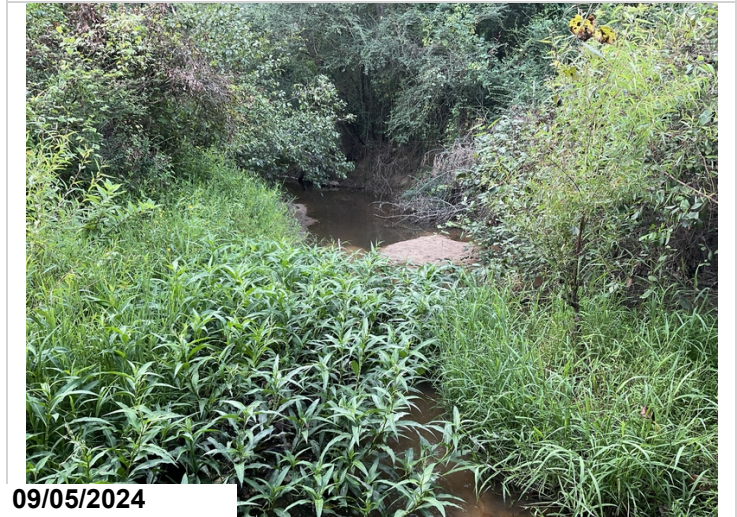
Downstream

61 - Channel/Channel Protection (6 - Bank is beginning to slump. River control devices and embankment protection have widespread minor damage. There is minor stream bed movement evident. Debris is restricting the channel slightly.) The channel has been rated a 6 for this inspection, owing to extensive streambank damage observed at multiple points on both the upstream and downstream sides of the bridge. Additionally, minor vegetation in the downstream channel is causing a slight restriction in the flow.

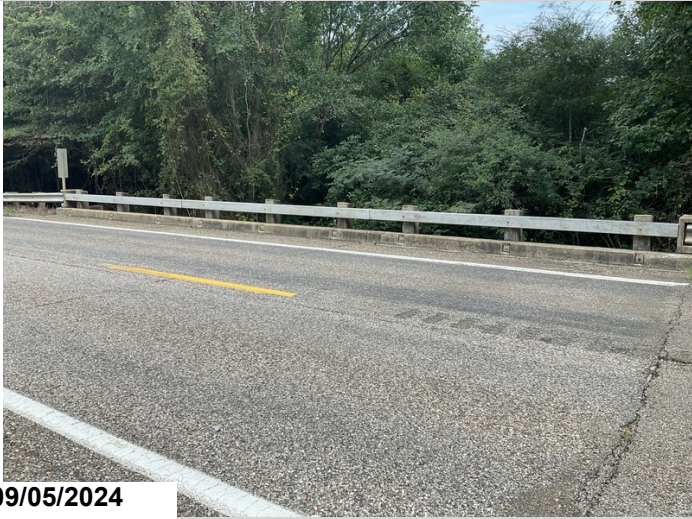
Bridge railing

Both sides of concrete bridge railing have spalling in various locations.

ELEMENTS	DESCRIPTION	UNITS	TOTAL	CS1	CS2	CS3	CS4
	(331) Concrete bridge railing, Both right and left sides, Spalling, CS2
