Asset #02450(Routine, Underwater type 2)

SH 29 - 01- 7.98 over DOOLEY CREEK

Location: 2.0 MI N OF BRADLEY

Team Lead: Jared Kegley Inspection Date: 09/09/2024

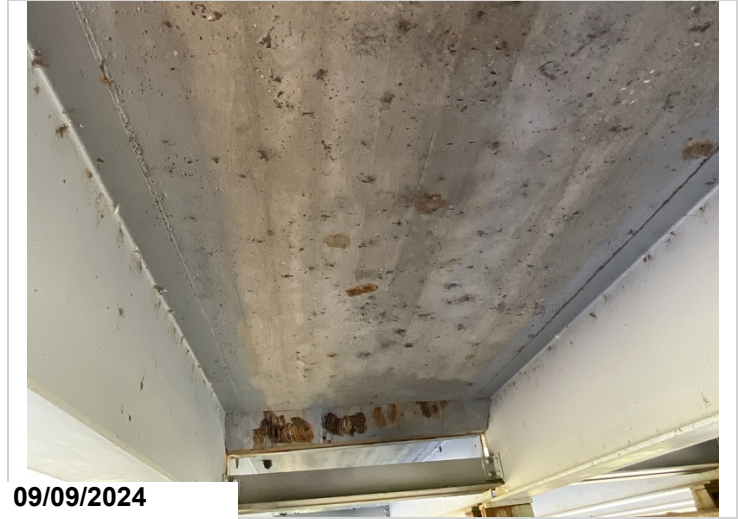
Deck is rated a 6 this inspection due to cracking with efflorescence on bottom side of deck in various locations. Note: Top side of deck has an asphalt overlay.

Typical photo of the under surface.

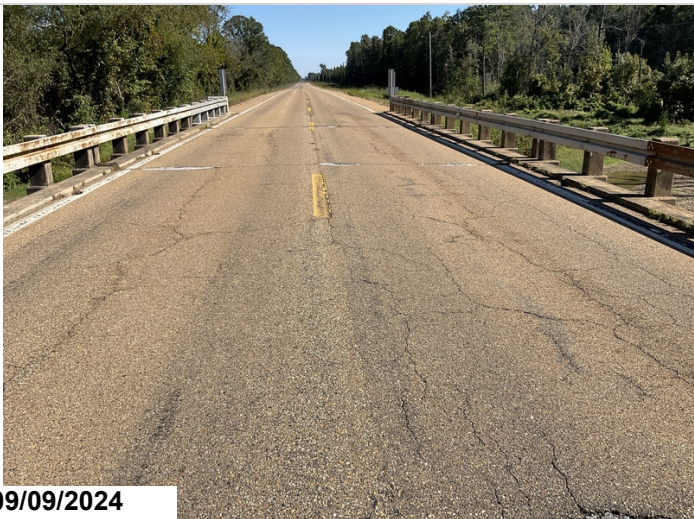
Typical photo of the topside of the deck.

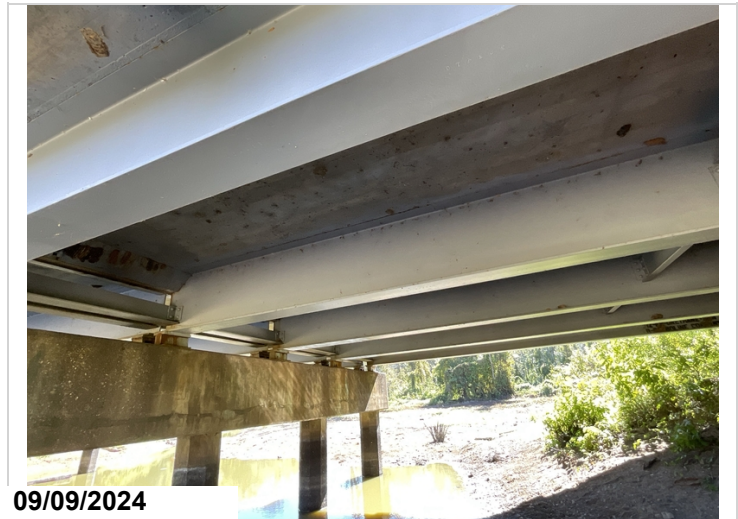
The superstructure is rated a 6 this inspection due to minor and moderate corrosion with minor section loss in various locations of the beam ends.

Typical photo of the superstructure.

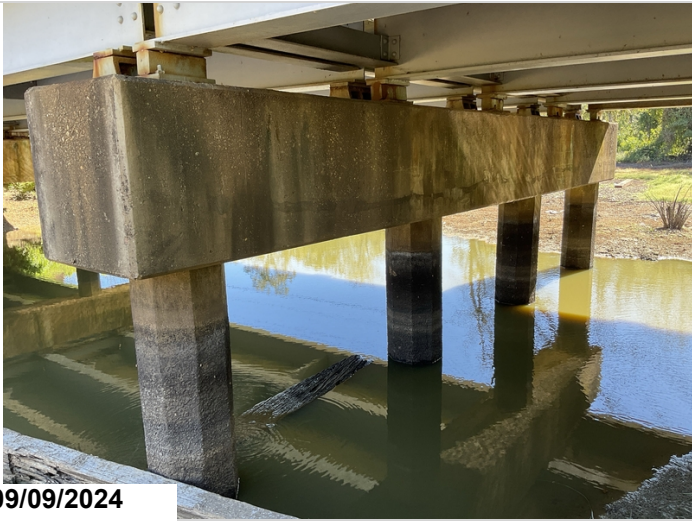
Typical photo of the substructure.

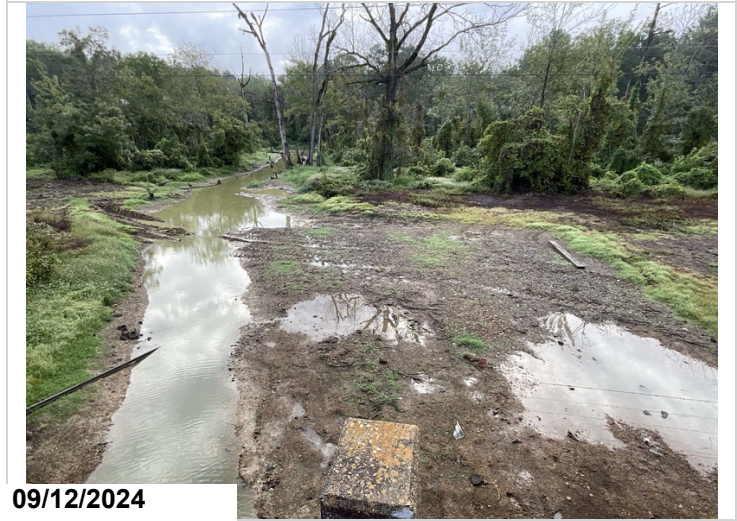
Upstream channel

Channel is rated a 7 this inspection due to banks being well vegetated with minor streambank damage. Soundings were taken this inspection and linked to the report and asset files.

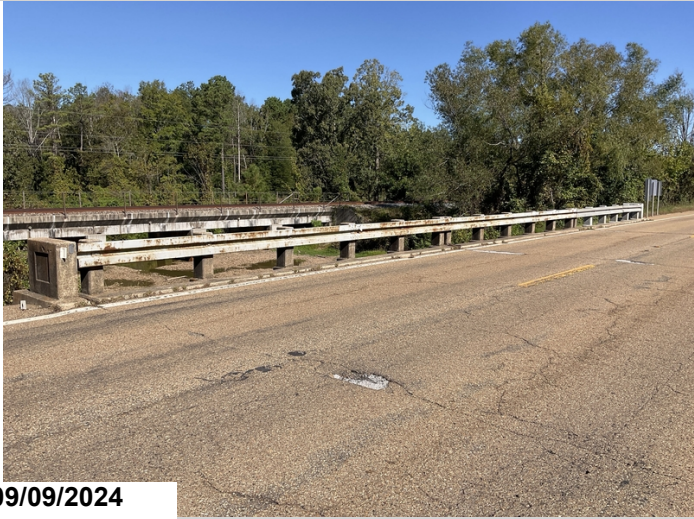
Bridge railing.

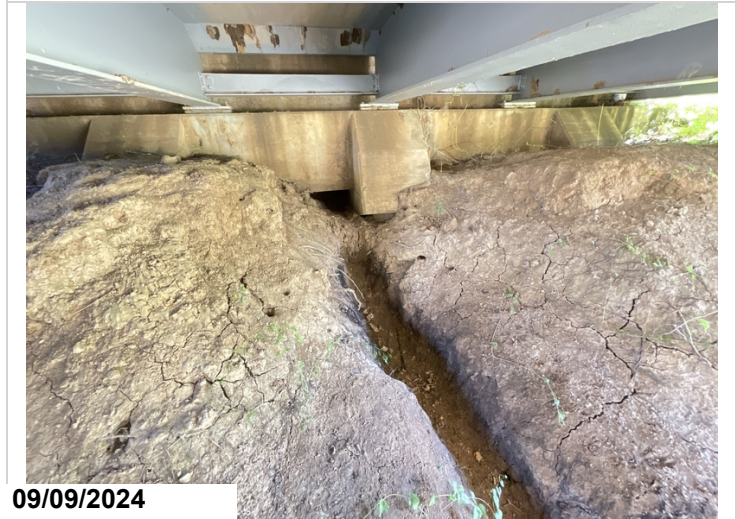
(303) Joints are covered by an asphalt overlay, CS4.							
311	Movable Bearing	EA	15	0	0	15	0
1000	Corrosion	EA	15	0	0	15	0
(311) All movable bearings have minor to moderate corrosion, CS3.							
313	Fixed Bearing	EA	15	0	0	15	0
1000	Corrosion	EA	15	0	0	15	0

Joints are covered by an asphalt overlay.

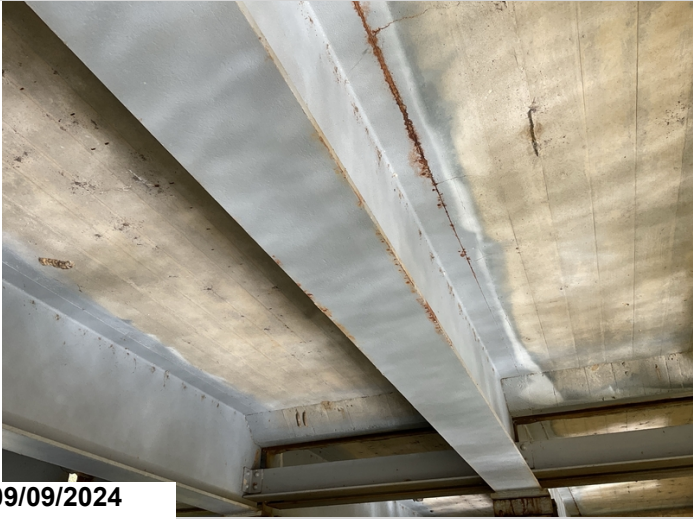
(107) Bent 1, beam 1, left side, 1' of section loss, CS3.							
Bent 4, beam 5, right side, 1' of section loss, CS3.							
(1000-107) Section loss beam 1 span 1							
215	Reinforced Concrete Abutment	LF	67	67	0	0	0
226	Prestressed concrete piles	EA	8	8	0	0	0
234	Reinforced Concrete Pier Cap	LF	49	47	2	0	0
1080	Delamination/Spall/Patched Area	LF	1	0	1	0	0
1090	Exposed Rebar	LF	1	0	1	0	0

Bent 1, beam 1, left side, 1' of section loss, CS3.

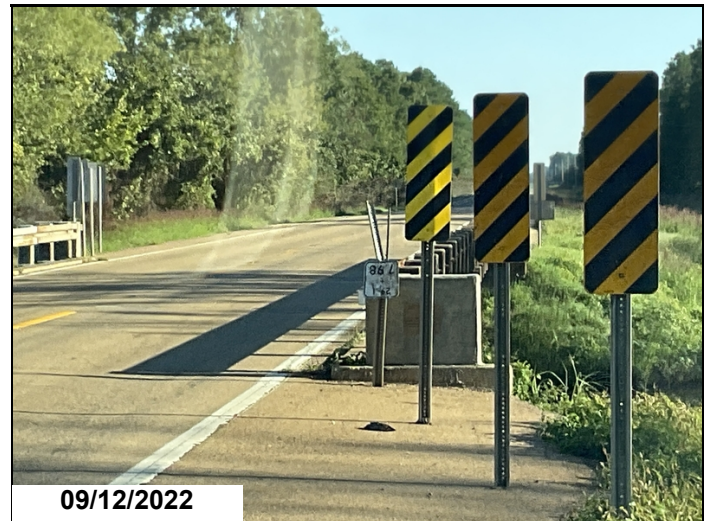
Repaired
