Bridge #05077(Routine)

US 71 SEC 17B, SB over Mud Creek-Washington

Location: 6.24 MI N JCT US 71 & 62

Team Lead: Bob McEntyre Inspection Date: November 08, 2021

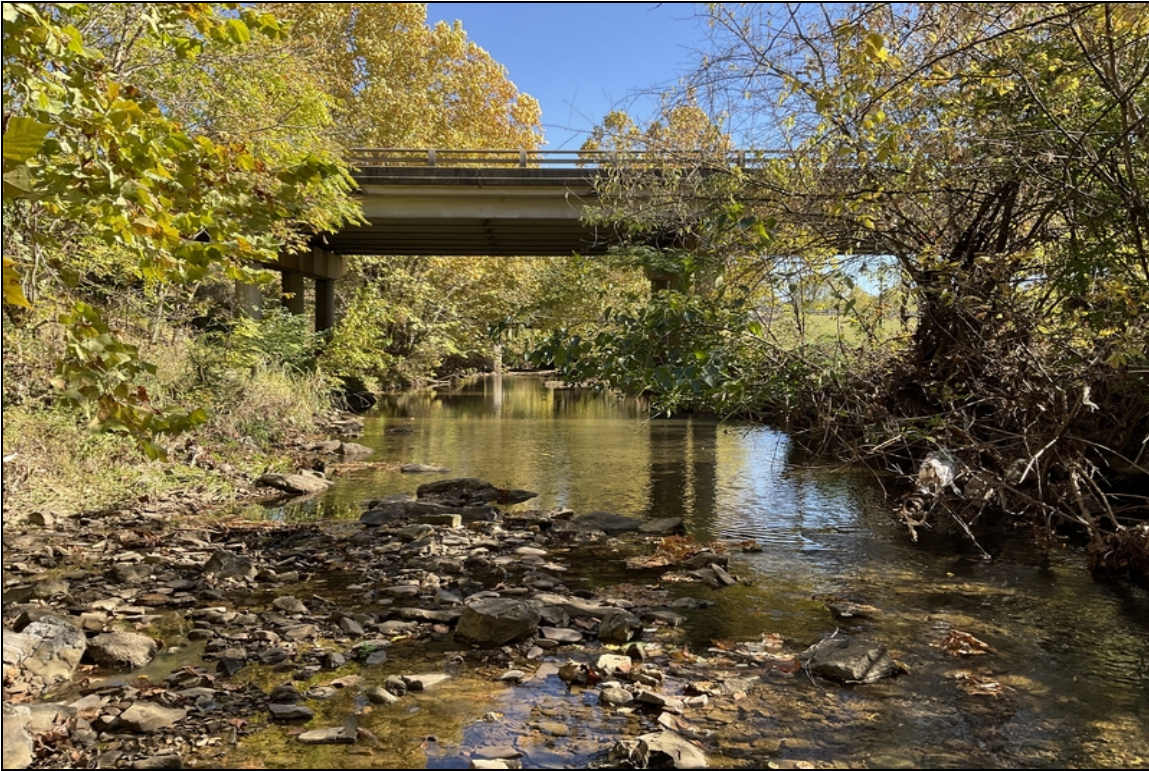
Elevation looking East.

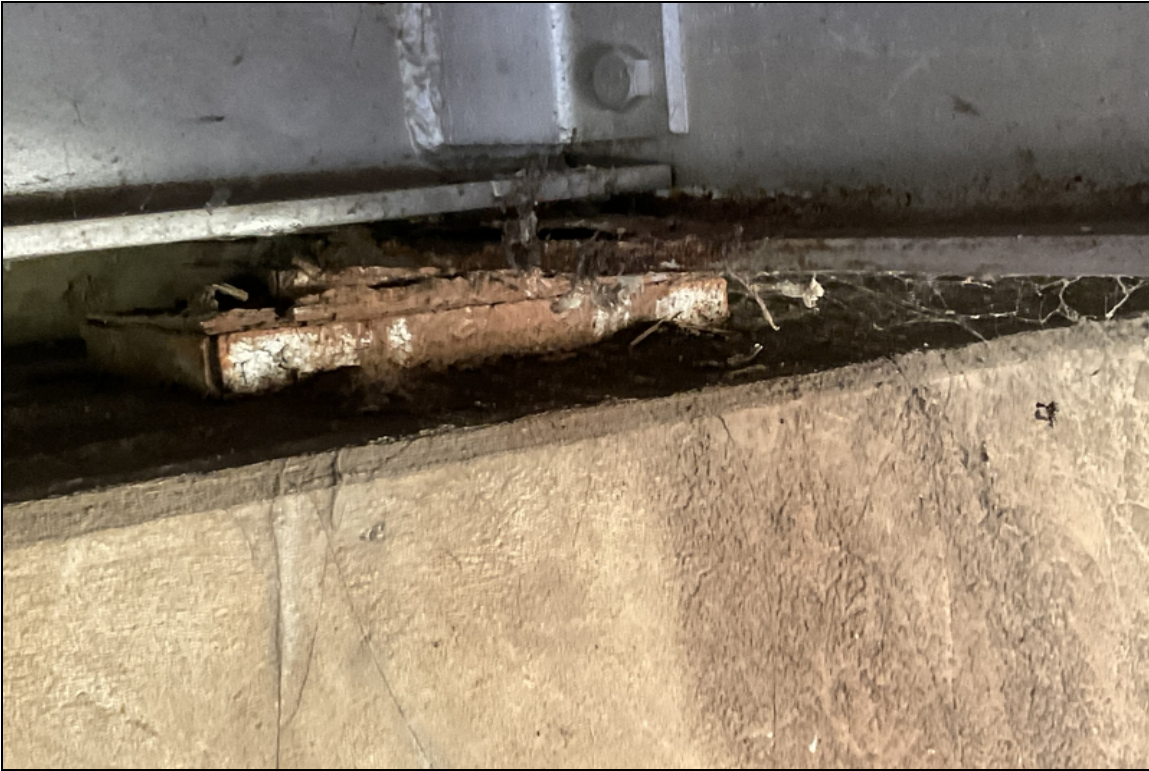
Abutment 2 beam #5

(107)							
-Superstructure has areas of active corrosion in the bottom flanges and the base of webs adjacent to the bearings where the deck joint seals leak water and debris. -The ends of the beams at abutment # 2 have flaking rust with up to approximately 1/16" of section loss to the bottom flange. -The exterior beams have active corrosion in the top flanges adjacent to the expansion joints.							
205	Reinforced Concrete Column	EA	9	3	6	0	0
1130	Cracking (RC and Other)	EA	1	0	1	0	0
1190	Abrasion/Wear (PSC/RC)	EA	5	0	5	0	0

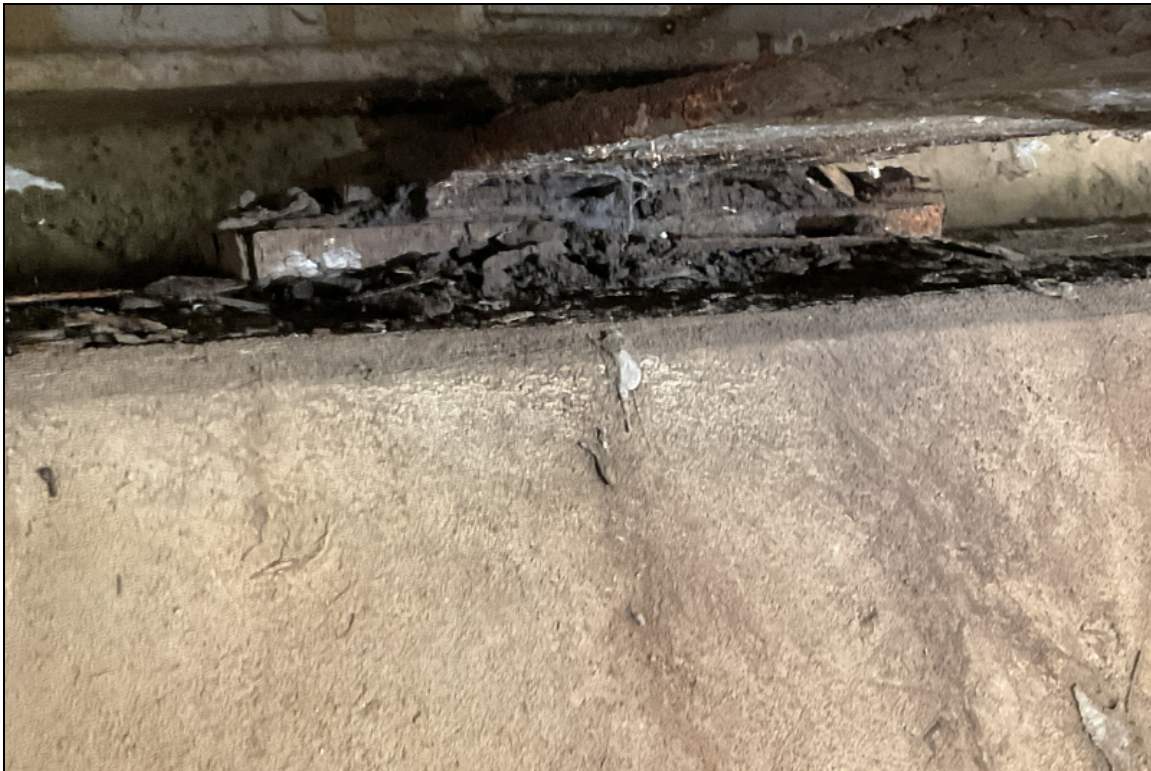
Abutment 2 bearing #3

(313)							
-Bearings have active corrosion with layers of rust between the masonry plate and the sole plates.

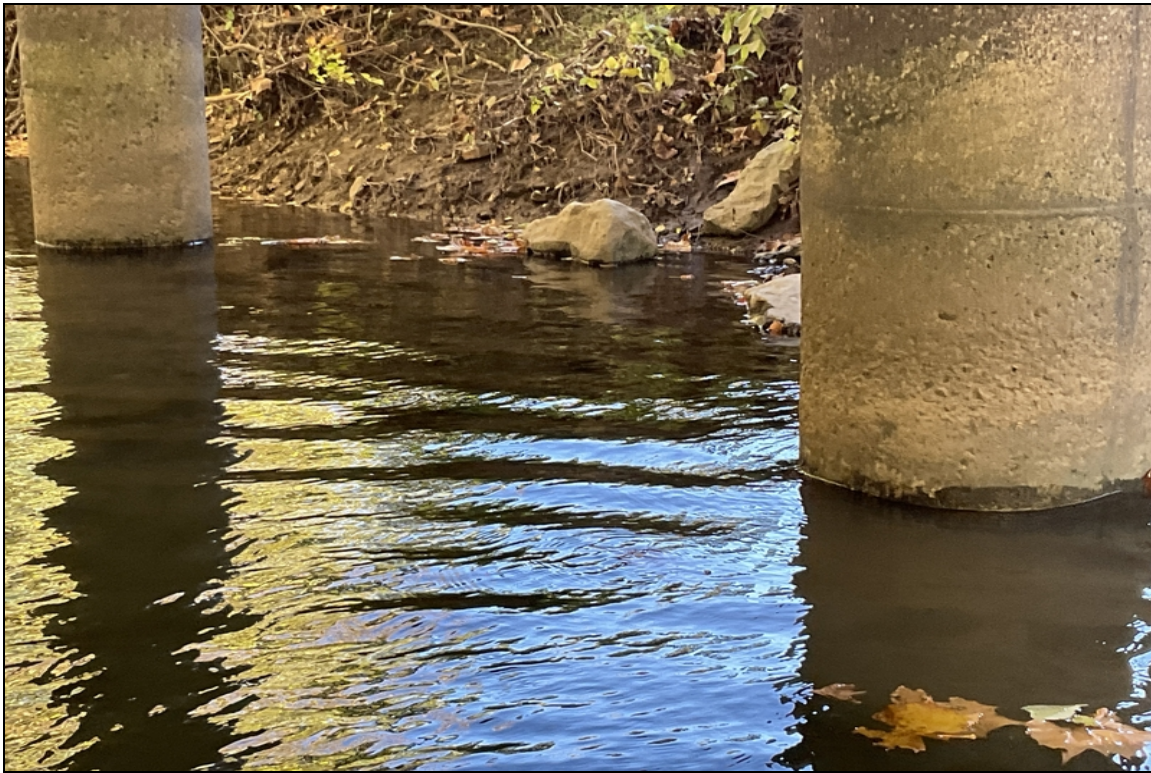
Columns 2&3 bent 3

(205)							
-There is light abrasion at the base of columns at bents # 3 & 4. -Bent # 3, column # 3 has vertical cracking located 1' foot from the bottom of cap.							
215	Reinforced Concrete Abutment	LF	114	104	10	0	0
1080	Delamination/Spall/Patched Area	LF	9	0	9	0	0
1130	Cracking (RC and Other)	LF	1	0	1	0	0

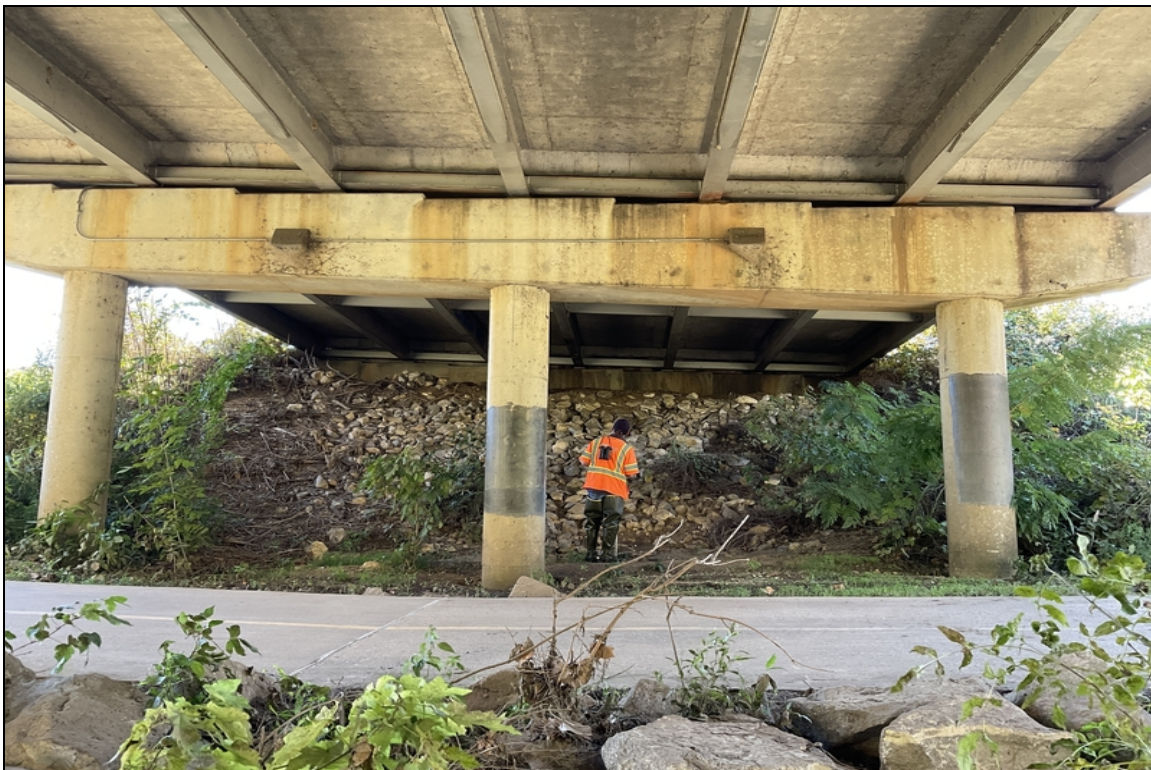
Bent 2.

(234)							
-Bent # 2 cap, left end appears to have 2 baseball sized spalls with exposed reinforcing steel. -The right side of bent # 2 has two 3" spalls with exposed reinforcing steel visible from the undersurface of the cap. -The caps at bents # 3 & 4 have minor 3" spalls with exposed reinforcing steel visible from the undersurface of the edges of the caps. -Substructure caps have water stains and debris accumulation where the deck joints leak.							
302	Compression Joint Seal	LF	215	5	32	28	150
2310	Leakage	LF	150	0	0	0	150
2330	Seal Damage	LF	28	0	0	28	0
2360	Adjacent Deck or Header	LF	32	0	32	0	0

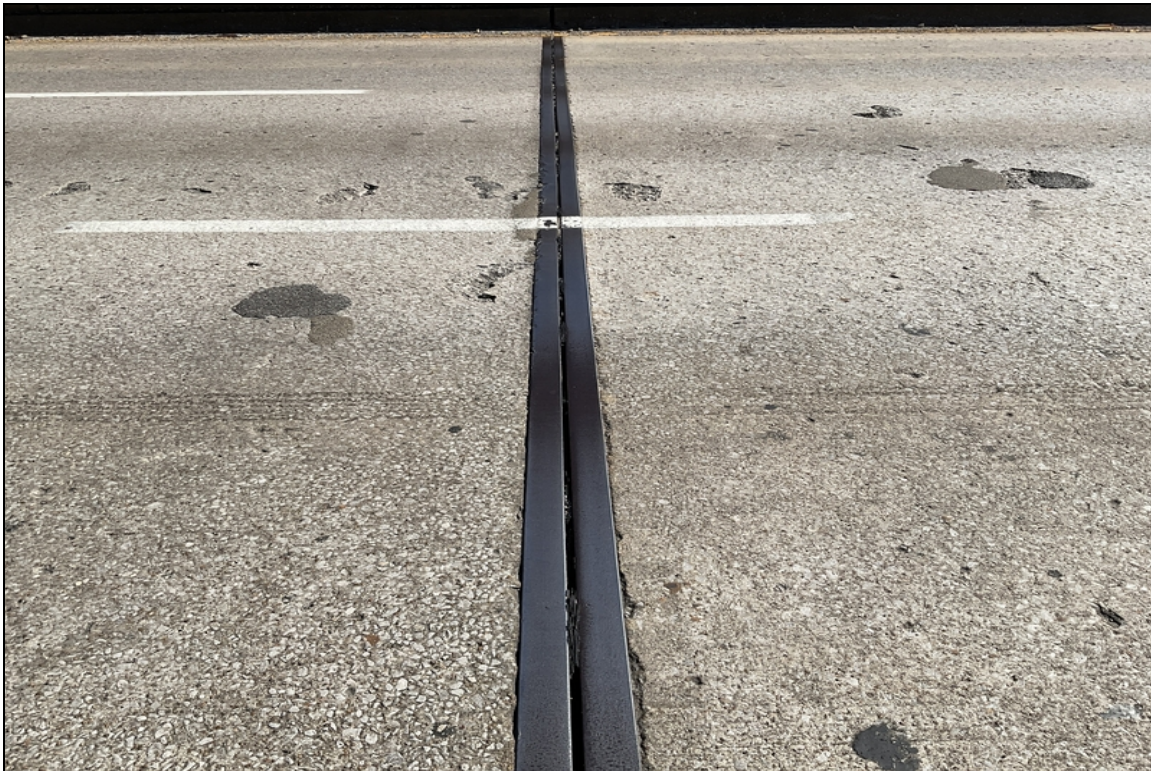
Bent 3 expansion joint.

(302)							
-Compression joint seals are torn, deteriorated, and leak water and debris on the substructure caps, bearings, and ends of the beams. -Portions of the deck joint seals are missing during this inspection. -There are numerous patched areas adjacent to the expansion joints.							
311	Movable Bearing	EA	28	13	0	15	0
1000	Corrosion	EA	15	0	0	15	0
515	Steel Protective Coating	SF	28	20	0	0	8
3440	Effectiveness (Steel Protective Coatings)	SF	8	0	0	0	8
